WARRANTY BULLETIN

DATE : NOVEMBER 2012 SECTION : 01 - Engine EXPIRATION: NOVEMBER 2014 SUBJECT : DIPSTICK REPLACEMENT- D13 US07 AND US10

REVISION : B THIS WARRANTY BULLETIN SUPERSEDES PREVIOUS VERSION. VIN range to show detailed US10 & US07

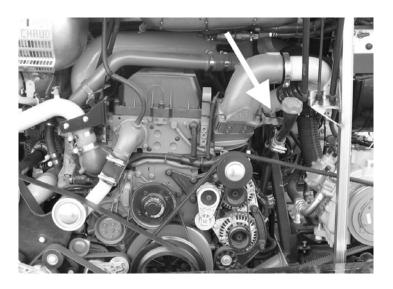
1. Locate the dipstick on the Engine
