PREVOST

**WARRANTY
BULLETIN**

WB13-28

DATE :	AUGUST 2013	SECTION :	18 - Body
EXPIRATION:	AUGUST 2015		
SUBJECT :	REINFORCEMENT OF ENGINE COMPARTMENT DOOR PANTOGRAPH ARM

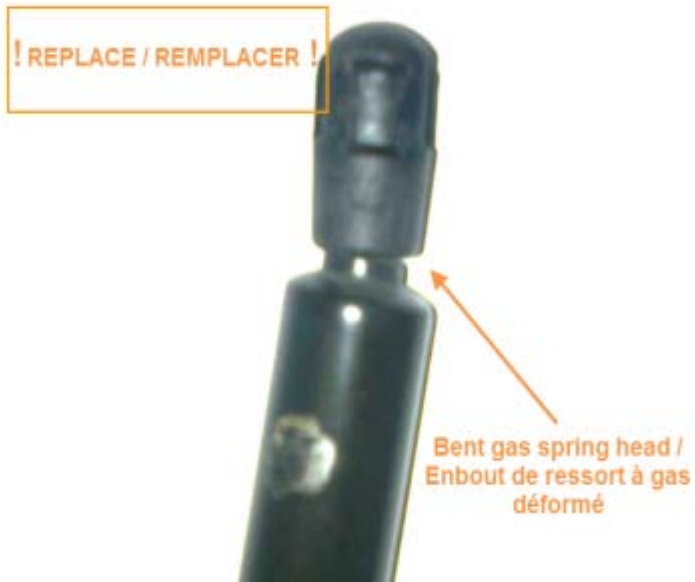
Fig.4

If both welds of the pantograph arm bracket are missing, the three (3) gas springs must be inspected to ensure that their mounting points (heads) are not bent or distorted.

Both heads on each gas springs must be parallel to the gas spring body.

If any gas spring head is bent (as shown in Fig.4), the gas spring must be replaced.

The engine compartment door is heavy and must be supported before any of the gas spring can be removed from the bracket.
