PREVOST

WARRANTY BULLETIN

WB14-06G

| SUBJECT : | "BITZER" LARGE A/C SYSTEM IMPROVEMENT | | |

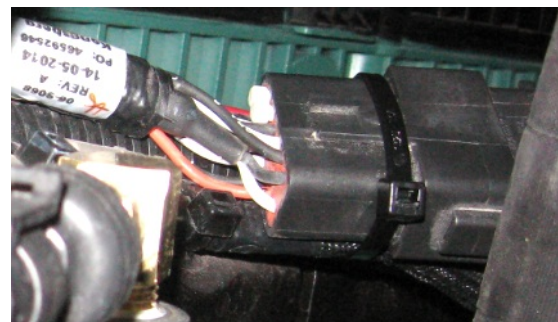
Figure 4 Connector C228

Look on cable management bracket located on the right hand side of the engine. (Fig 5)

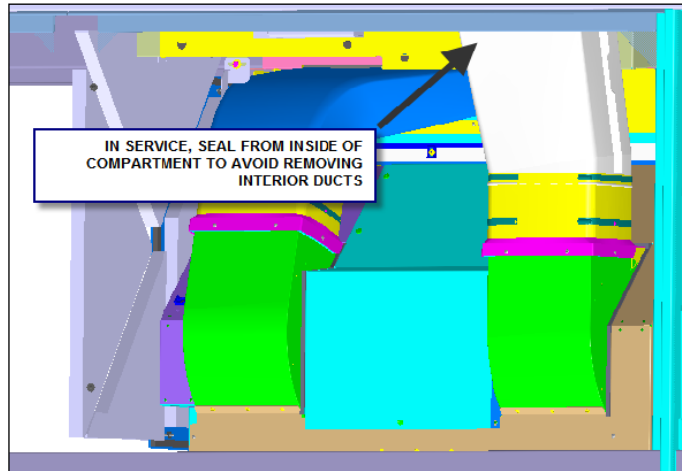
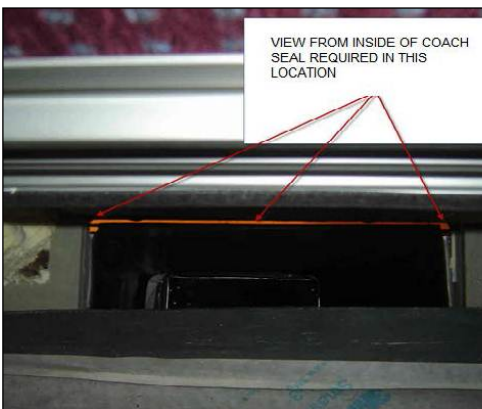
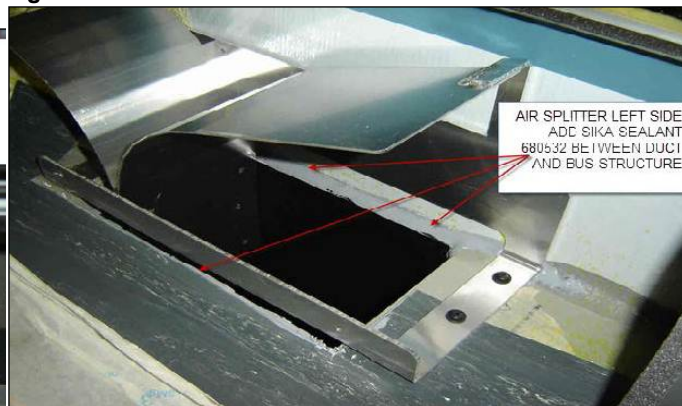
Inspect before performing any work. Some vehicles up to **E-5526** may present a gap between the road side air flow splitter, floor and vehicle structure.

To avoid removing the passenger side floor ducts, sealing can be performed from the evaporator compartment.

Add a Sika sealant #680532 between discharge duct and structure and between duct and floor.

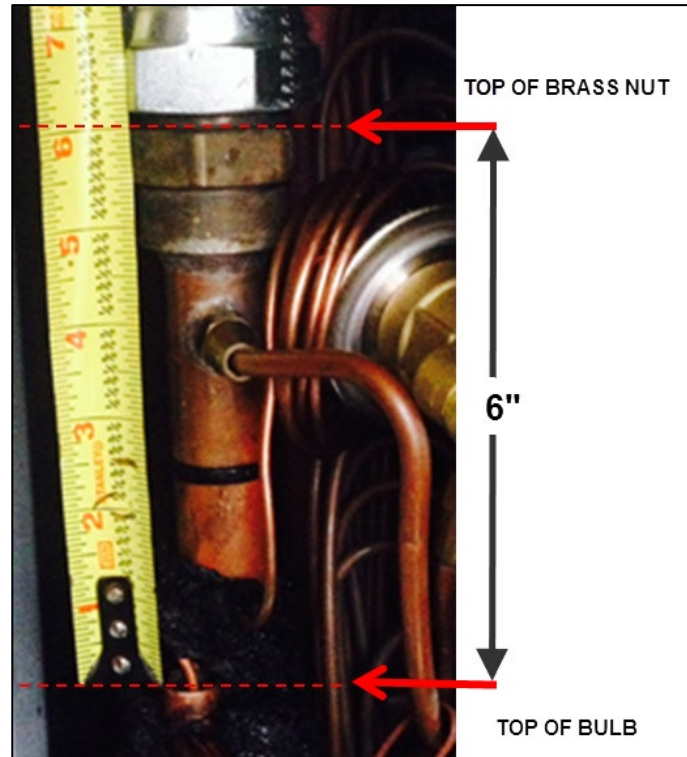
Figure 28

On the evaporator, inspect the expansion valve bulb position.

Adjust to 6" from top of brass nut, as indicated in fig 31.

Clean thoroughly the contact surfaces on the tube and on the bulb with a "scotch brite" type scouring pad.

Isolate bulb and tube section with insulating tape #680091.

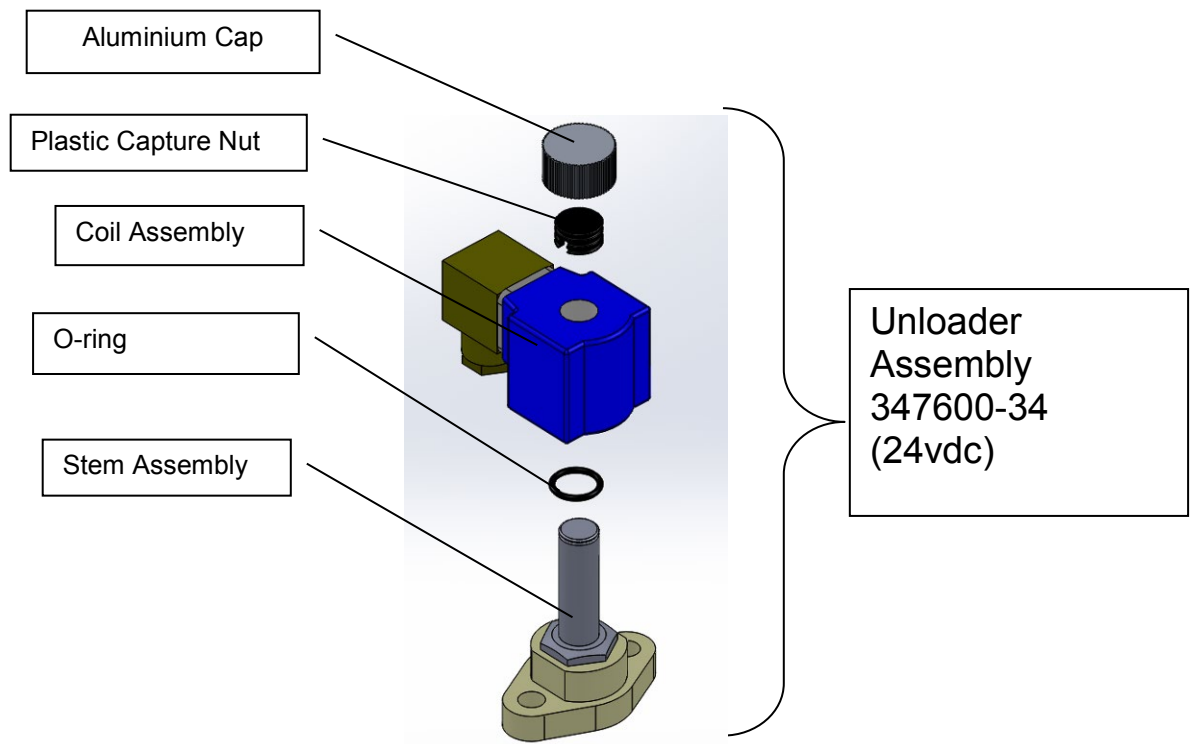
Due to a number of claims relating to unloader caps coming loose, BITZER US, Inc. has developed a procedure for reliably securing the unloader cap to the unloader coil and stem assembly.

- If the cap comes loose from the unloader assembly it will be necessary to replace to maintain good operating order with the unloader.
 - The replacement part number for new cap components is 375068-02. This will include a new aluminum cap, capture nut and o-ring.

- All 3 parts should be replaced during the exchange
1. Remove the existing capture nut, coil and o-ring
 2. Install a new o-ring over the stem assembly
