PREVOST

**WARRANTY
BULLETIN**

WB14-47B

DATE :	OCTOBER 2014	SECTION :	04 - Exhaust
EXPIRATION:	OCTOBER 2016		
SUBJECT :	UREA DOSING SYSTEM UPDATE - X AND H SERIES

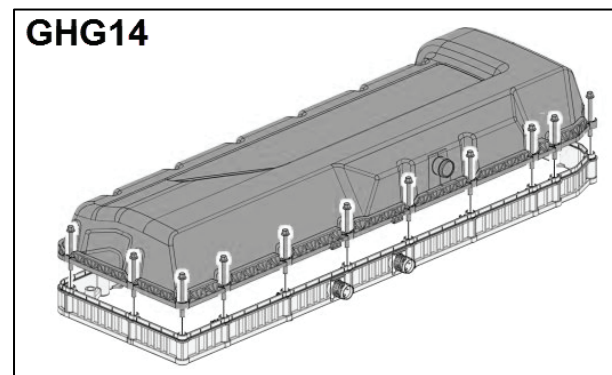
Figure 2 GHG14 valve cover

GHG14 engines have a "split" cover (Fig 2).

Update according to steps **A** et **B** below. And add a VECU update
