FRONT AXLE SWAY BAR CLAMPS BECOMING LOOSE VOLVO 9700 (B13R)

Date	Expiration	Group	No.	Page
11.2014	11.2015	762		3(4)

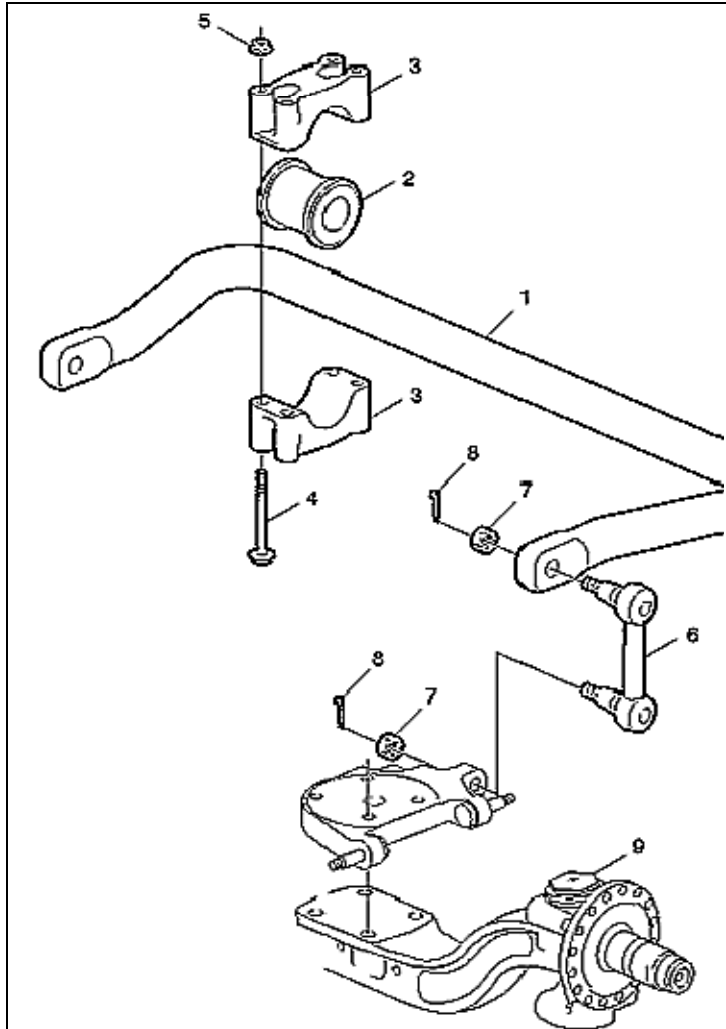
FIGURE 1: FRONT AXLE SWAY BAR ARRANGEMENT

On the vehicles affected by this bulletin, it is necessary to verify if the front axle sway bar might have become loose.

It is important that a check of the clamping of the sway bar be performed according to following instruction. The clamps must be firmly attached. Gap between the clamp halves is not allowed when the bolts are tightened to correct torque.

- 1) Lift the vehicle using mobile column wheel lifts so that the suspension is at the normal ride height.
- 2) Make sure that sway bar clamps are tight. There must be no gap between the lower and upper clamp halves when the bolts are tightened to proper torque.
- 3) Check that clamp bolts (4 bolts each side) are tightened to prescribed torque. If fasteners have become loose, new fasteners should be used.

- **8.8 class bolts** = 63 ± 11 lbf-ft (85 ± 15 Nm)
- **10.9 class bolts** = 77 ± 15 lbf-ft (105 ± 20 Nm)

- 4) If gaps are detected after the correct torque is applied on vehicles with 8.8 class bolts, the bolts must be replaced with 10.9 class bolts and tightened to the higher torque level. In some cases,

depending on the installation, the old bolts must be cut and the new ones installed in reverse position. There is no need to replace the clamps or the rubber bushing.
