PREVOST

Warranty Bulletin

95-14

Date: **April 1995**
Section: **14**
Subject: **Power Steering Pump**
Application:

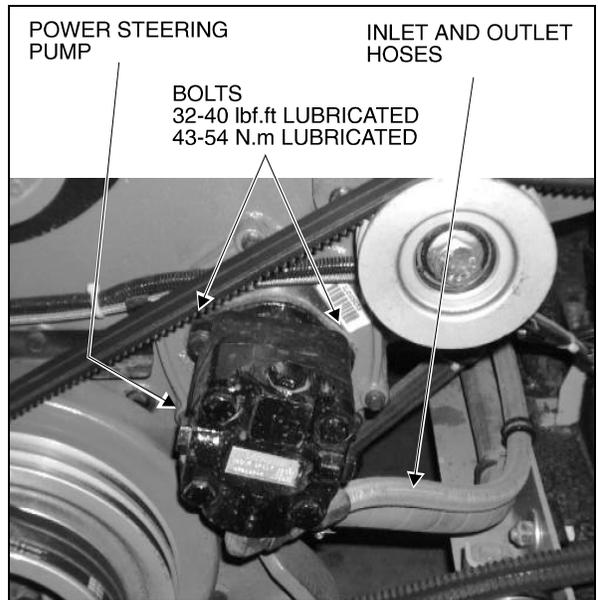
FIGURE 1

On some of the above-mentioned vehicles, it is possible that power steering pump leaks at the flange where the pump is mounted to the Series 60 engine. The leak is caused by a defective gasket and an inadequate torque of bolts. Therefore, you should verify it on your vehicle, and make modification described in the following procedure if necessary.

Open engine compartment door(s), locate power steering pump (Fig. 1), and inspect pump flange region for oil leaks. If leak is detected, proceed with step B, otherwise, don't perform it.

2. Unscrew the two bolts (Fig. 1) retaining power steering pump and remove it without disconnecting it from inlet and outlet hoses.
3. Remove gasket and thoroughly clean assembling surfaces. Apply a silicone sealant (Prévost #680053, *General Electric RTV 103* silicone rubber adhesive sealant black) on the two assembling surfaces (pump and engine).
4. Place new gasket (Prévost #510488), then power steering pump.
5. Apply a removable threadlocker (Prévost #680038, *Loctite 242*) on threads of bolts. Torque bolts to 32-40 lbf•ft lubricated (43-54 N•m lubricated).
