**WARRANTY
BULLETIN**

Wb99-39

DATE : NOVEMBER 1999	SECTION : 06 - Electrical
EXPIRATION: NOVEMBER 2000	
SUBJECT : TIGHTENING OF BATTERIE TERMINAL NUTS

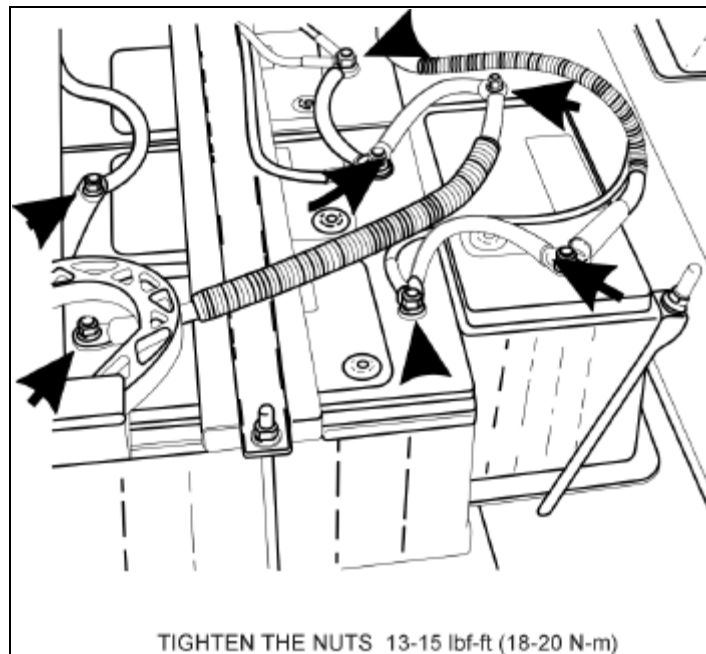
FIGURE 1 : TYPICAL VIEW OF THE BATTERY CABLES

On the above mentioned vehicles, the battery cables may have been improperly tightened on the batteries. To make sure that the cables will stay in place, it is necessary to check the torque of the terminal nuts.

1. In the main power compartment, remove the battery plastic protective cover.
2. Using a torque wrench, tighten the terminal nuts to a torque of 13-15 lbf•ft (18-20 N•m).
3. Reinstall the battery plastic protective cover.

1. Locate the batteries in the rear baggage compartment.
2. Using a torque wrench, tighten the terminal nuts to a torque of 13-15 lbf•ft (18-20 N•m).

1. Locate the batteries in the engine R.H. side access compartment.
2. Remove the battery plastic protective guard.
3. Using a torque wrench, tighten the terminal nuts to a torque of 13-15 lbf•ft (18-20 N•m).
4. Reinstall the battery plastic protective guard.
