## WHEEL LUG NUTS TIGHTENING INSPECTION 9700 (B13R)

### DESCRIPTION

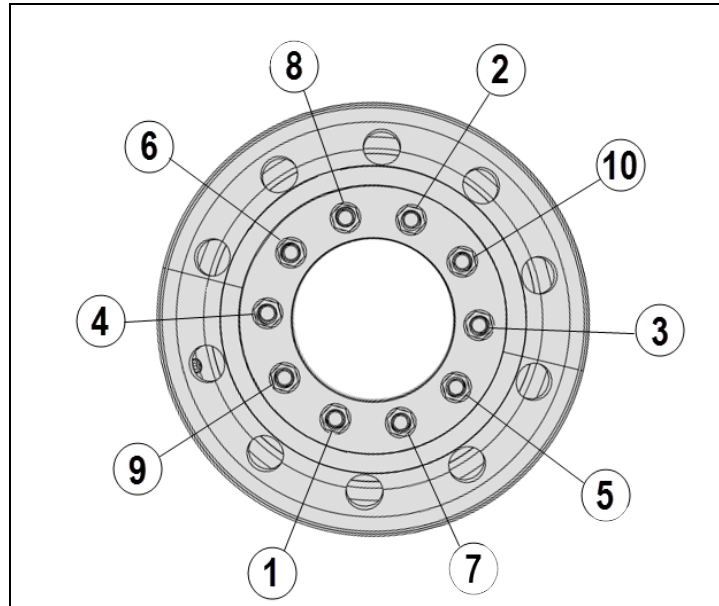
Tightening sequence Volvo 9700

On the vehicles affected by this bulletin, the equipment used to tighten the wheel lugs in a visit to one of our Service Center between November 2014 and June 2015, was found to be out of specification, possibly delivering a torque value inferior to the specified 670 Nm (494 ft-lb). Please verify and correct as necessary the wheel lug torque on the concerned vehicles, or bring the vehicle at a Prevest Service Center for verification at your earliest convenience.

- 3) If one or more nuts is not sufficiently tightened, all the wheel nuts on the wheel should be loosened and retightened following this order:
- Tighten the wheel nuts to 148+/-6 ft-lb (200+/-8 Nm) following the sequence above.
  - Rotate the wheel 90deg.
  - Apply final torque of 494 ft-lb (670Nm) using the same sequence.
