**PREVOST**

**WARRANTY  
BULLETIN**

**WB15-39**

DATE :	OCTOBER 2015	SECTION :	18 - BODY
EXPIRATION:	OCTOBER 2017		
SUBJECT :	H3 VIP Entrance Door Improvement

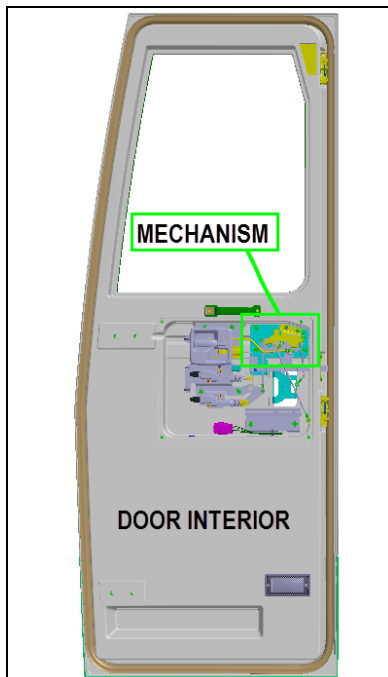
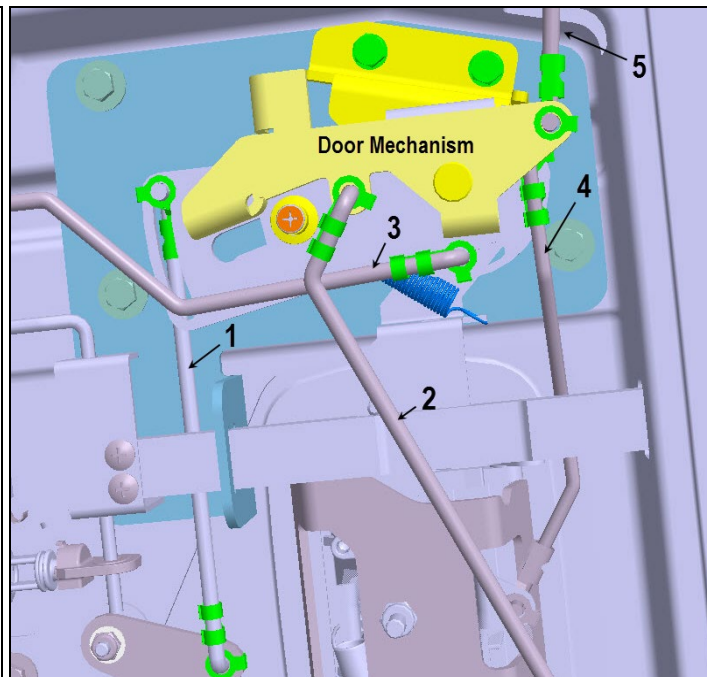
1. Remove the door interior trim panel (This operation will vary from vehicle to vehicles depending on their configuration).
2. Locate the door locking mechanism and the five actuating rods connected to it (see Fig.1 and 2 below).

3. Disconnect rods # 2, 3, 4 and 5 identified above at the *door mechanism* end of the rods.
