SAFETY RECALL

SR15-85

EXHAUST CLAMP REPLACEMENT AT TURBOCHARGER DIFFUSER PIPE 9700 (B13R)

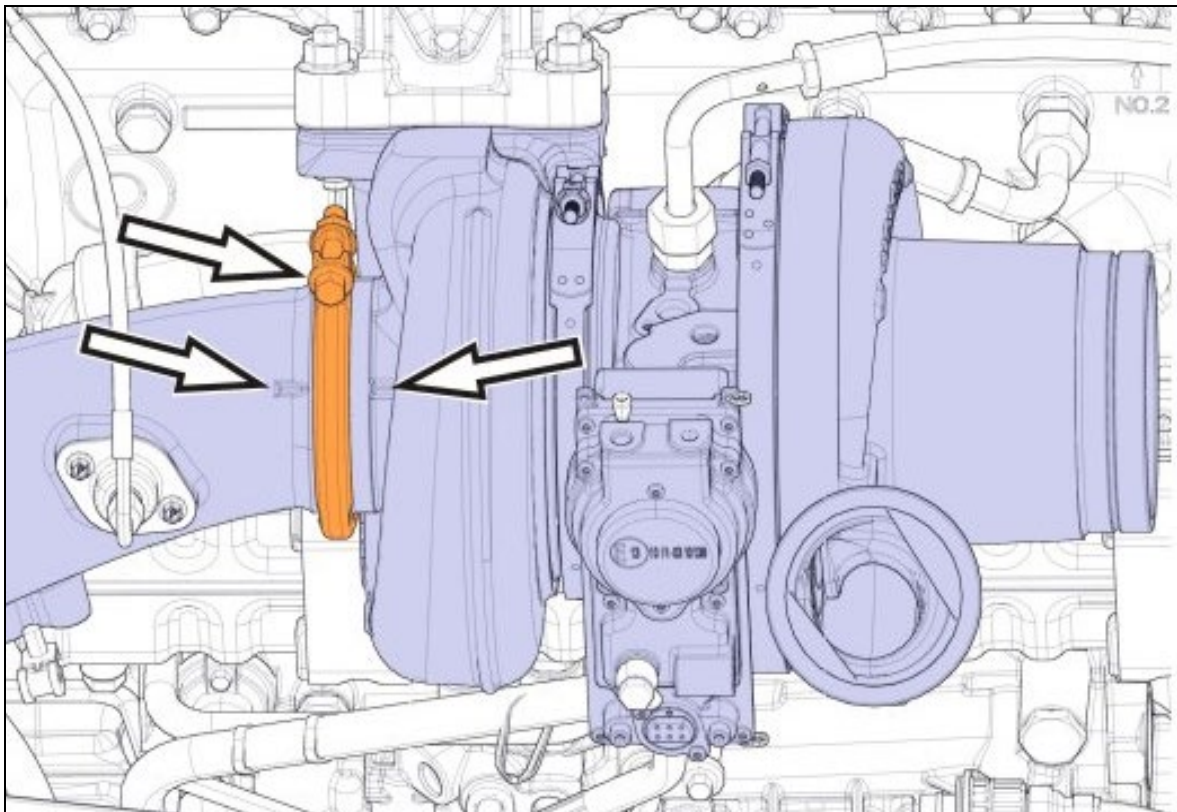
On the vehicles affected by this bulletin, the exhaust clamp that connects the turbocharger to the diffuser pipe may prematurely fail.

If this occurs, hot exhaust gases can leak and potentially ignite materials inside the engine compartment, which will increase the risk of an engine compartment fire.

- Identity: 131589750 Engine Turbocharger, Replacement
 - Identity: 121793153 Radiator, Removal
 - Identity: 121786092 Radiator, Installation
- 1) Remove the radiator (refer to: Function group 26).
 - 2) Replace the turbocharger outlet pipe V-band clamp. Use a new gasket between the diffuser and turbocharger. Turn the diffuser pipe to the correct position (see figure below). Tighten the clamp to the proper specification. **V-band clamps..... 12 ± 2 Nm (106 ± 17 in-lbf).**

NOTE: WHEN POSITIONING THE DIFFUSER PIPE, ALIGN THE MATCH MARKS ON THE DIFFUSER AND ENGINE TURBOCHARGER, IF EQUIPPED.
