PREVOST

SAFETY RECALL

SR23-14

DATE :	May 2023	SECTION :	06 ELECTRICAL
SUBJECT:	Power Cable Missing Grommet

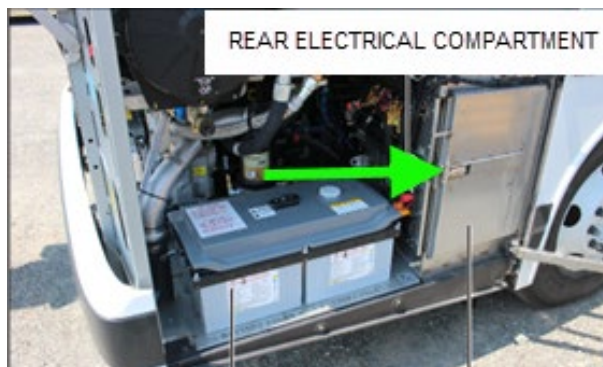
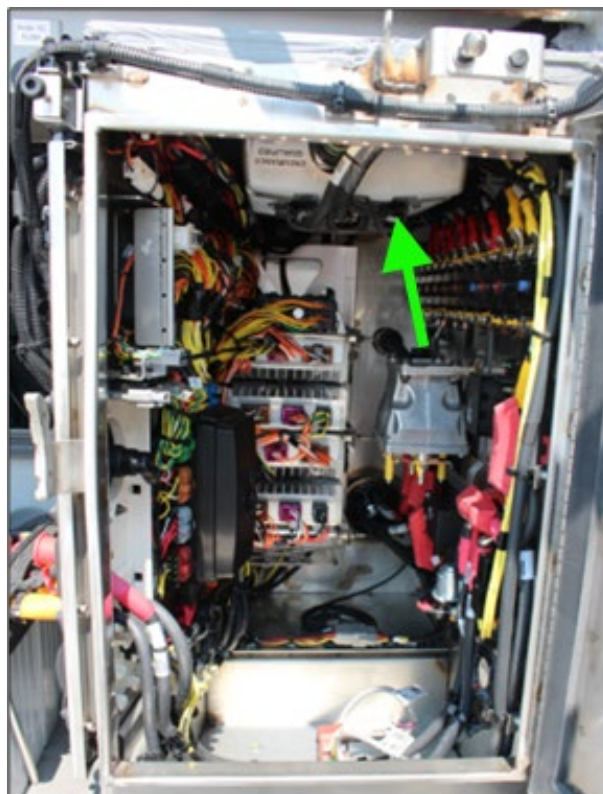
1. Locate the missing grommet location in the rear electrical compartment.
 - Open the vehicle curb side engine door.
 - Open the rear electrical compartment (next to the batteries).
 - In the compartment, the missing grommet must be installed in the cable pass through hole located at the top right corner of the compartment (hidden behind the battery equalizer).

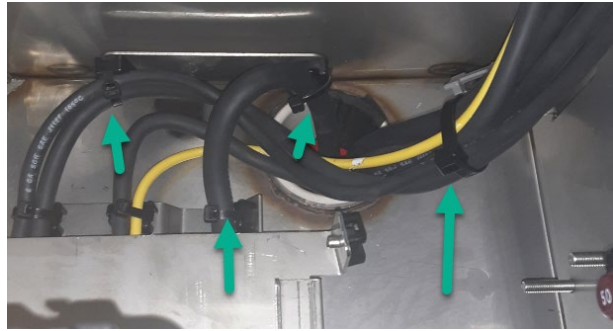
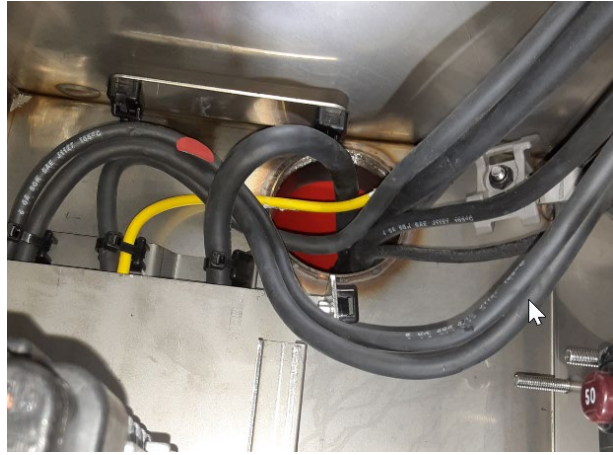
2. Cut all the cable ties holding the power cables passing through the hole.
3. Make sure that the cables insulation is not damaged.
 - If damage is noticed, replace the cable(s) before installing the grommet (do not repair power cable(s)).
