SAFETY RECALL

SR23-305

DATE :	June 2023	SECTION :	18 BODY
SUBJECT:	FLIP-UP SEAT PIVOT BOLTS

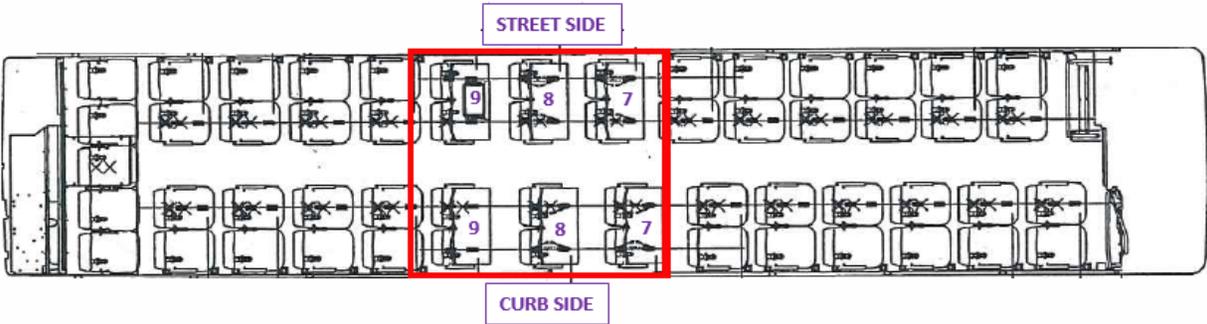
On the vehicles covered by this campaign, the two bolts securing the flip-up seat cushions to the seat frames can loosen and disengage, allowing the seat cushions to come loose.

VEHICLE SEAT CONFIGURATION SHOWING FLIP-UP SEATS POSITION

Therefore on the affected vehicles, threadlocker adhesive (Loctite) must be applied to all seat cushion bolts (see reference picture below).

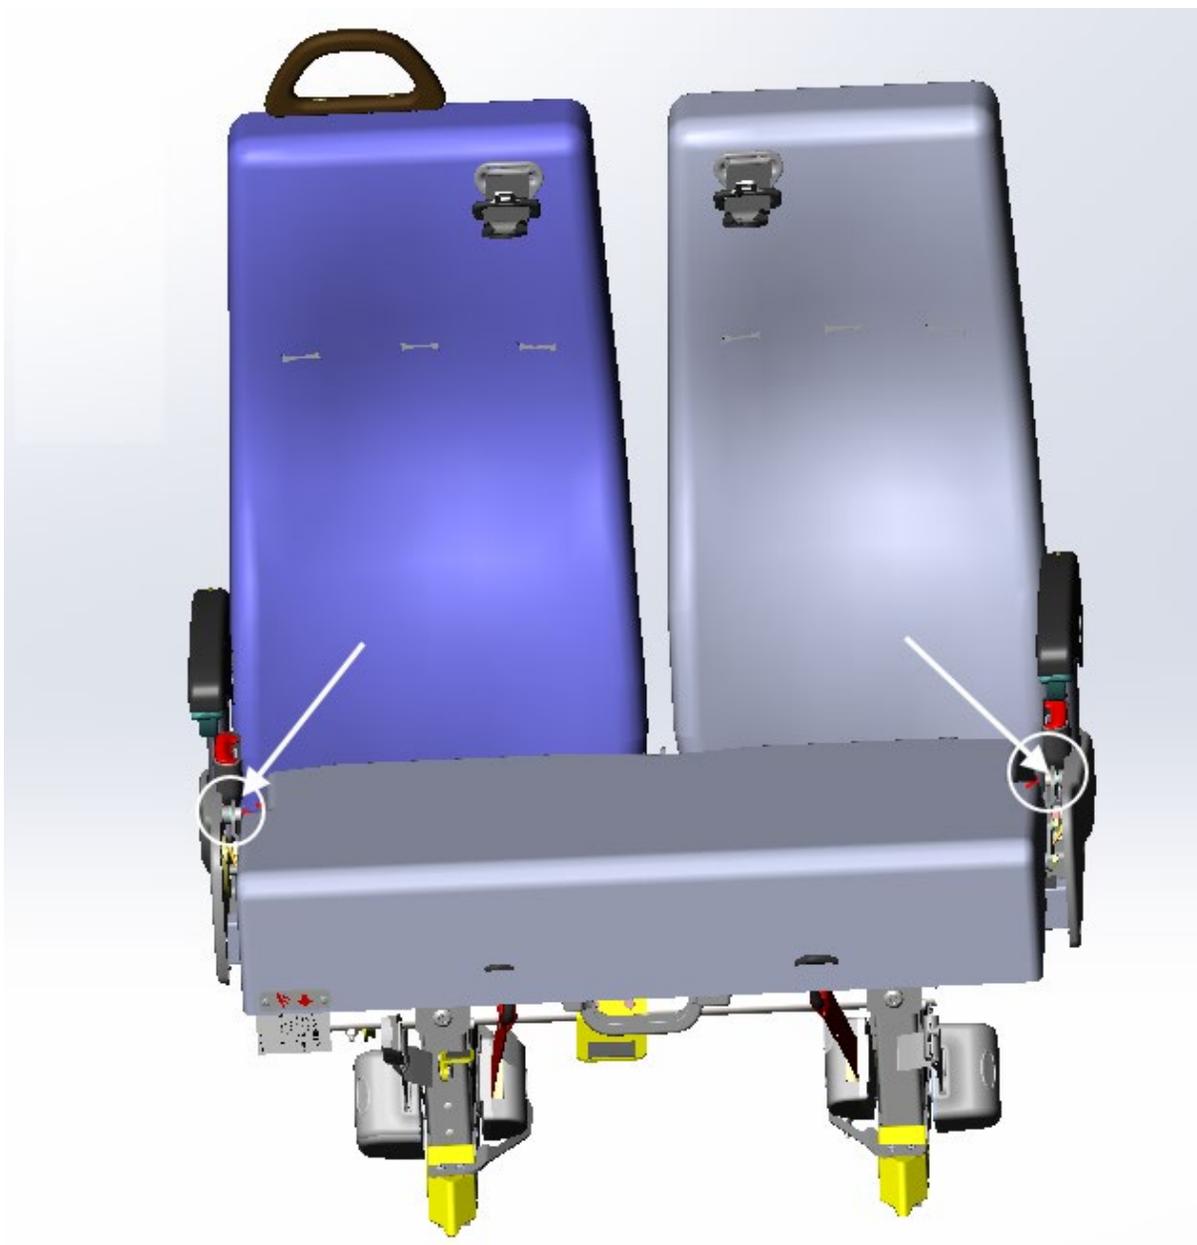
AMSECO SOLUTION : Add high-strength threadlocker (red) to flip-up pivot bolts.

- Remove the pivot bolt.
- Add a good quality, high-strength thread-locking adhesive to the bolt threads.
- Reinstall the pivot bolt (tighten firmly).
- Repeat for all seat bolts concerned.
