MAINTENANCE INFORMATION

MI23-15

SUBJECT: Window Gaps Minimum Clearance on

Converted Shells

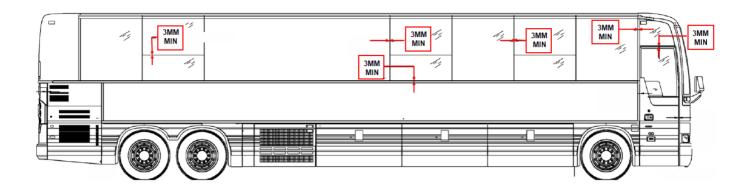
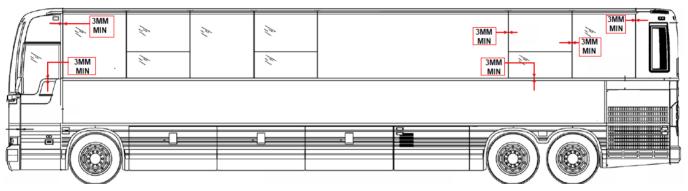
This gap is important to compensate for the inherent chassis flex during normal operation of the vehicle. Without this minimum gap, the glass may contact the vehicle structure and crack.

FIGURE 1: 3MM (0.118in) MINIMUM GAP TO BE RESPECTED (X3 VIP SHOWN)

When converting a Prevost VIP vehicle to either a motorhome or a specialty vehicle, it is important to note that all lateral windows removed during the conversion process be reinstalled with a **minimum 3mm gap** all around the glass.

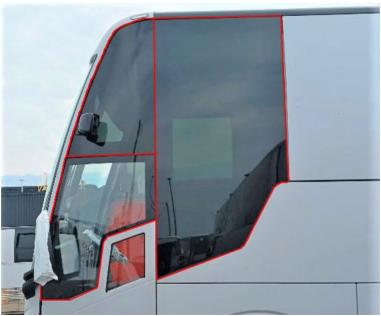
FIGURE 2: FRONT PART OF A H3 VIP SHOWING GAP AREA

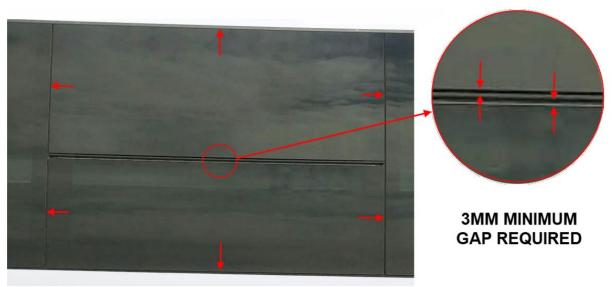
Please note that slide-out windows must also follow this 3mm rule since they are subjected to even more flex due to their mobile conception.

FIGURE 3: SLIDE OUT 3MM GAP DETAILS
