PREVOST

WARRANTY BULLETIN

WB23-40

SUBJECT: **JUMPER ON CONNECTOR A175**

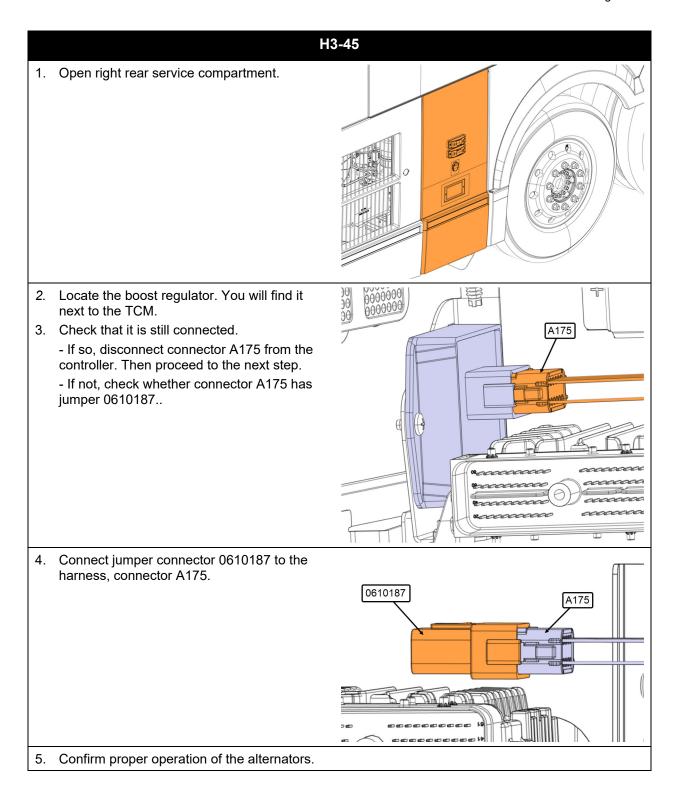
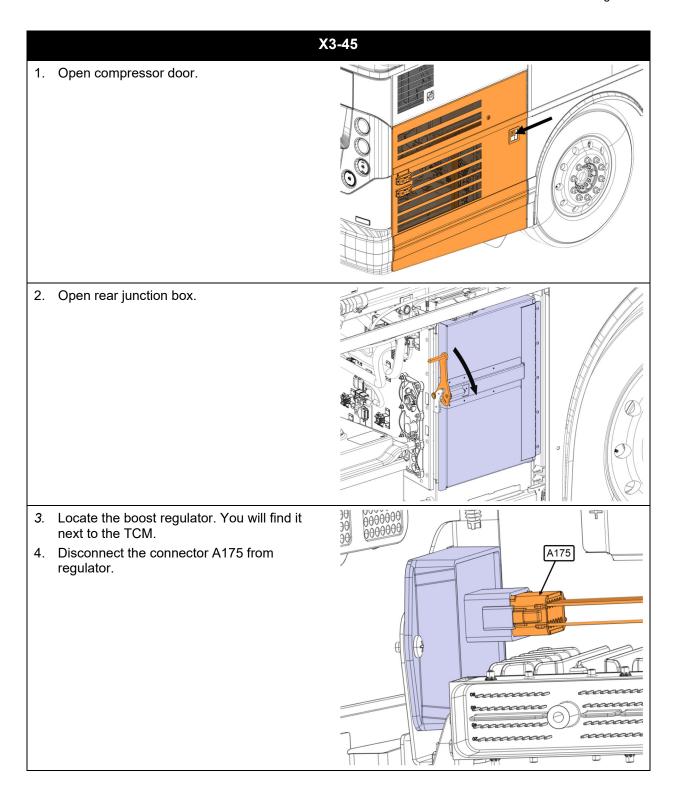
On the vehicles affected by this bulletin add a jumper on connector A175.

5. Connect jumper connector 0610187 to the harness, connector A175.

6. Confirm proper operation of the alternators.
