Guideline to Evaluate Warranty Claims Heavy-duty Shock Absorbers

2) “Misting“

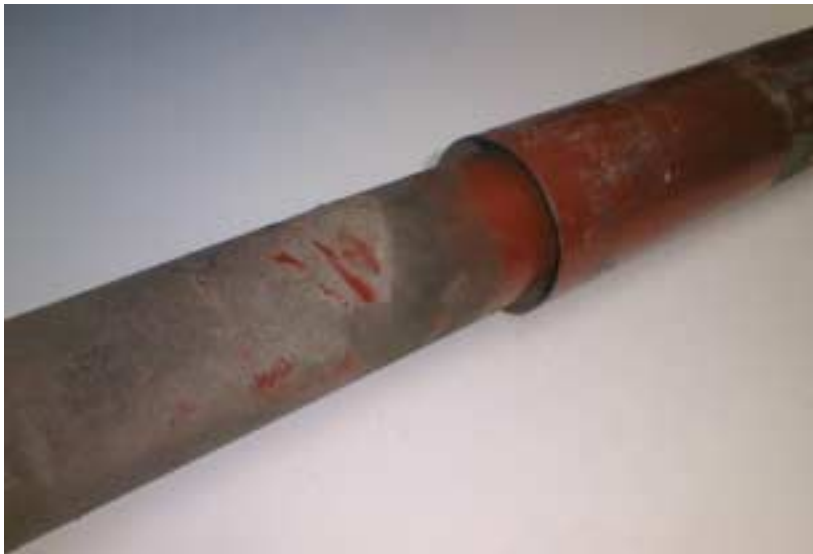
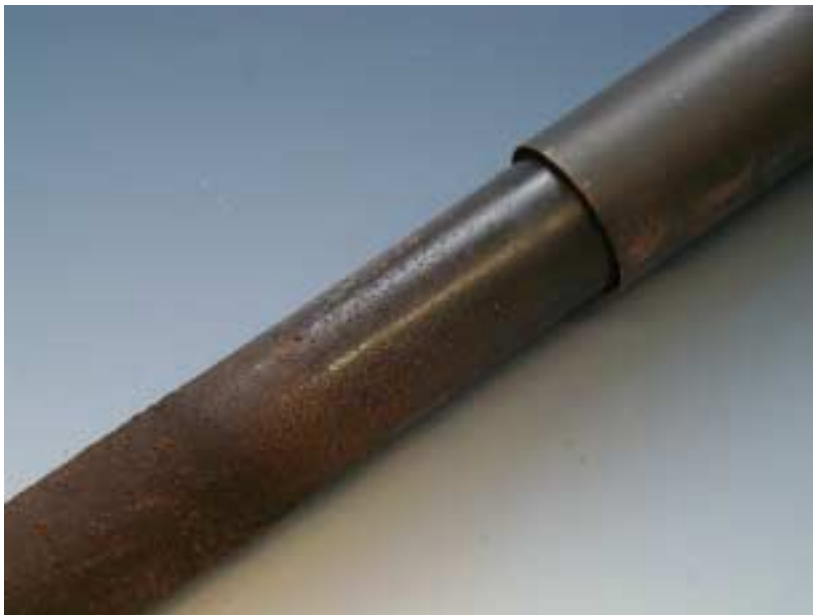
“Misting“

A precipitation of oil mist on the outside of the shock is visible.

Carefully touch shocks with dry finger. (Use caution: shocks may be hot!) If the finger remains dry, the shock is not leaking.

Oil vapor is necessary to lubricate the rod seal. At high operating temperatures this results in oil mist and precipitation.

none

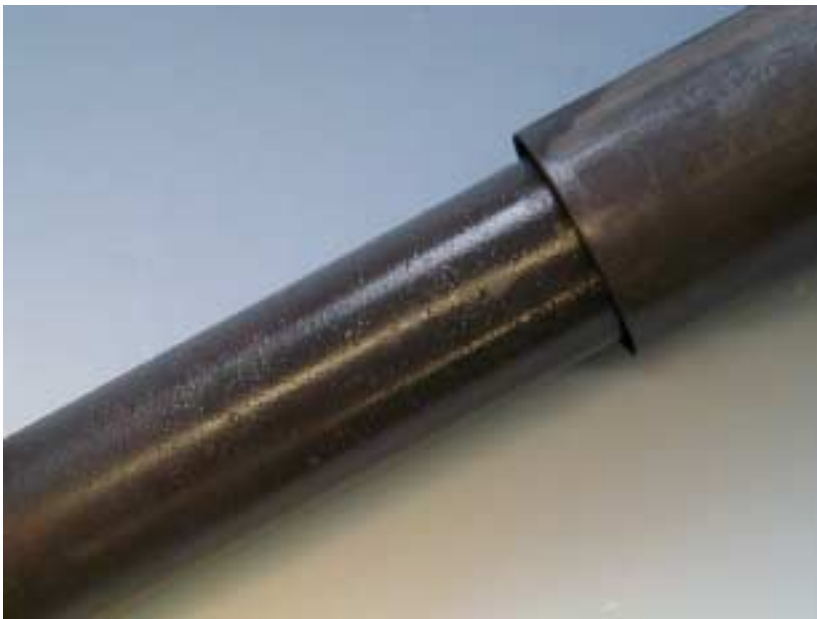
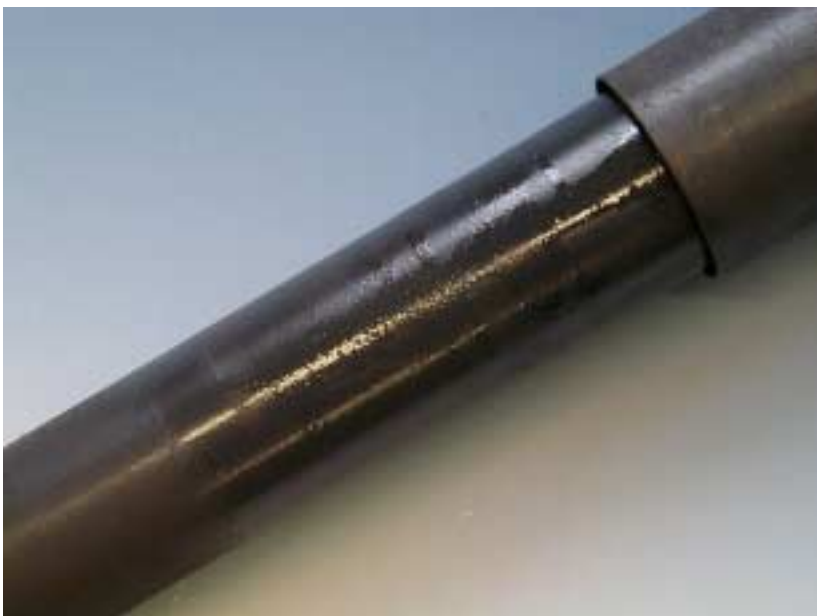
3) „Leaker“

- the reservoir tube (smaller diameter) is largely covered with oil
- finger gets wet, when touching shock (see „Misting“)

- after above finger test, shock exhibits a glossy film of oil and/or dirt, or an oil droplet forms on reservoir tube

- a film of oil is also visible in the upper area of the reservoir tube, after extension of the shock. If oil is only visible around the bottom, it likely stems from an outside source

- worn, damaged or overheated seal

- loss of oil
- loss of damping function
- loss of ride control and safety

replace leaking shock

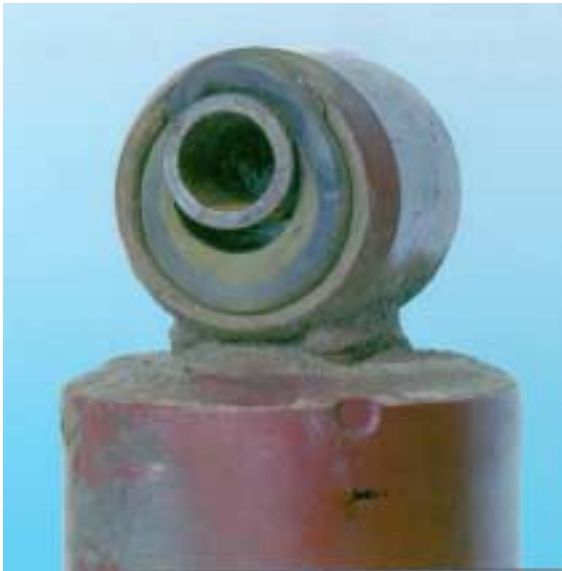
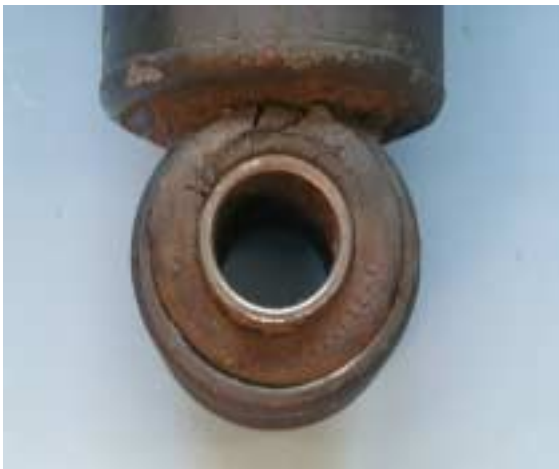
Rubber bushing „worn“ or „deformed“

- rubber bushing is visibly deformed or damaged
- eye (or „loop“) is eccentrically deformed
- sleeve is not centered within bushing

- extensive use of rebound stop, incorrect ride height, shock may be too short for application
- extremely high conical angles, not suitable for this design

noise, increased wear of shock and suspension

- verify ride height
- verify that shock is suitable for this application
- replace defective shock absorber

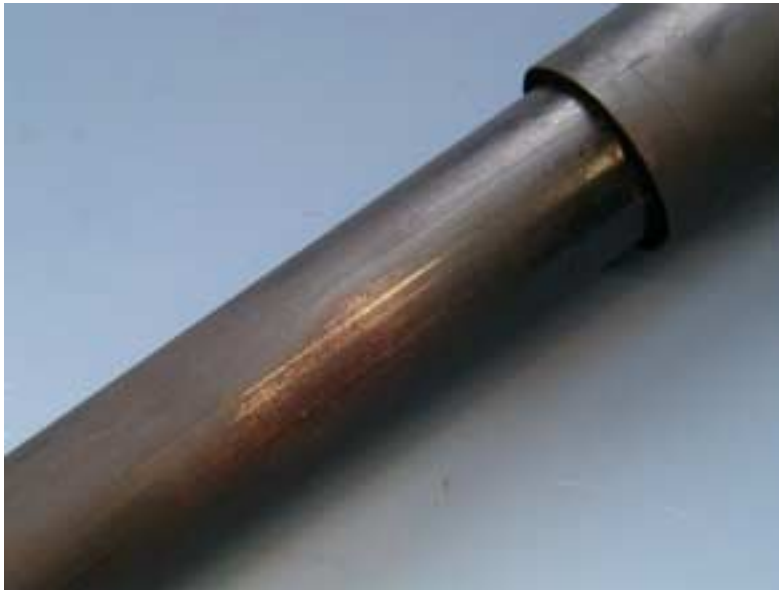
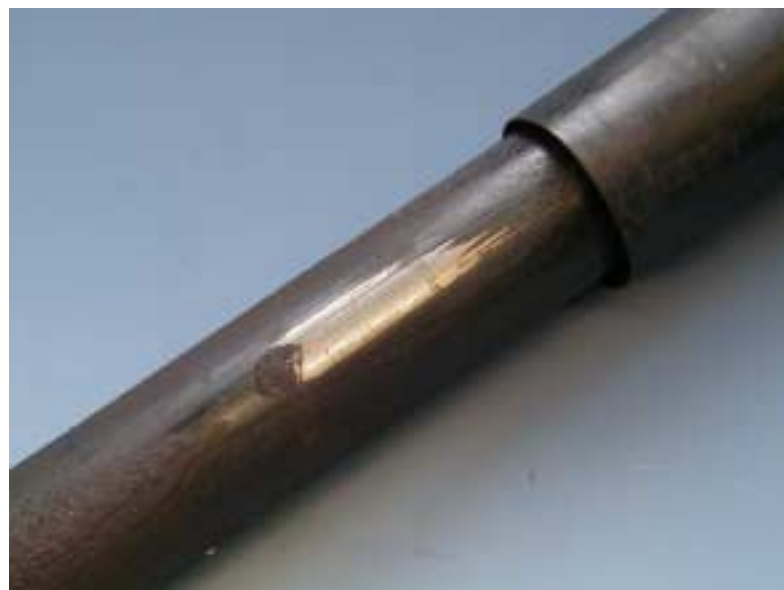
„Metal dust cover scratches reservoir tube“

- Paint scratched off reservoir tube

- suspension is misaligned, shock is under unintended lateral or longitudinal preload

- noise
- corrosion of reservoir tube
- subsequently wear of rod seal, leakage and loss of function

- check suspension, while vehicle is at design height
- replace shock only, if significant amount of paint is already scratched off or loss of oil is visible
