WARRANTY	
BULLETIN

WB18-03

EVOST

DATE :	February 2018	SECTION :	06 ELECTRICAL
EXPIRATION:	February 2020		
SUBJECT :	EQUALIZER REI	PLACEMENT

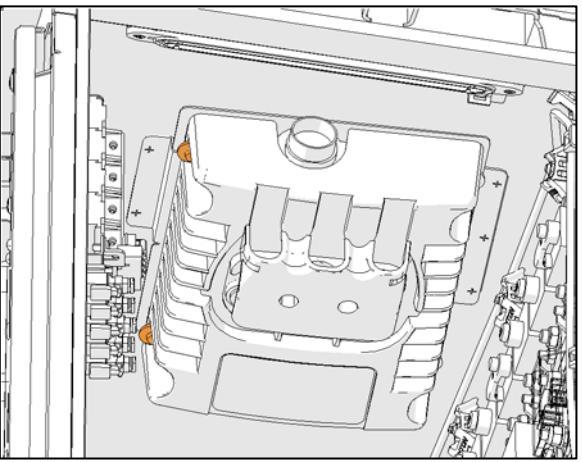
Figure 2

2. The battery equalizer is located in the upper section of the compartment.

- 3. Remove cable cover.
- 4. Keep cover and hardware.
