MAINTENANCE INFORMATION

MI15-45

DATE :OCTOBER 2015SECTION: 18 - BodySUBJECT :H3 Series Rear Frame Stress Crack Repair

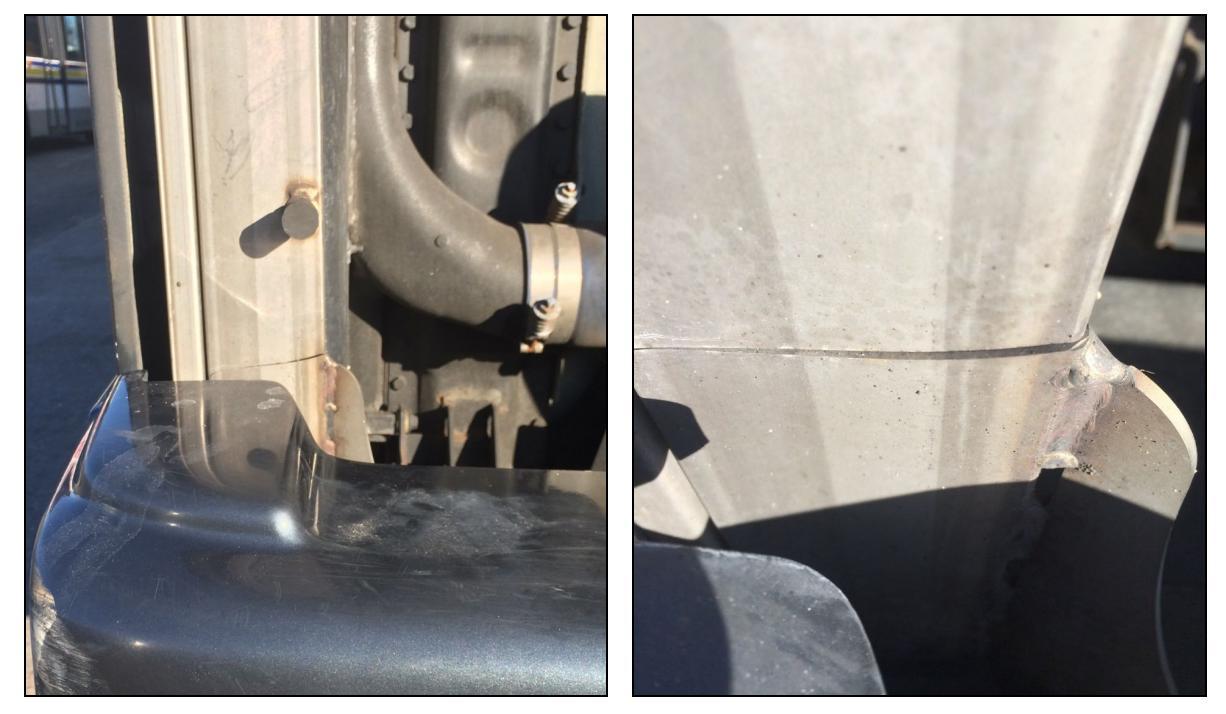
On some 2014 – 2015 H3 Series vehicles, a stress crack can develop in the left rear frame support beam as shown in the pictures below.

On these vehicles, it is possible to install and weld a frame reinforcement in the rear frame support beam to repair the affected area.
