WARRANTY BULLETIN

WB15-19H

BITZER A/C COMPRESSOR VIBRATION – ADDITION OF A REINFORCEMENT BRACKET TO THE MOUNTING

Rev H: THIS WARRANTY BULLETIN SUPERSEDES PREVIOUS VERSIONS

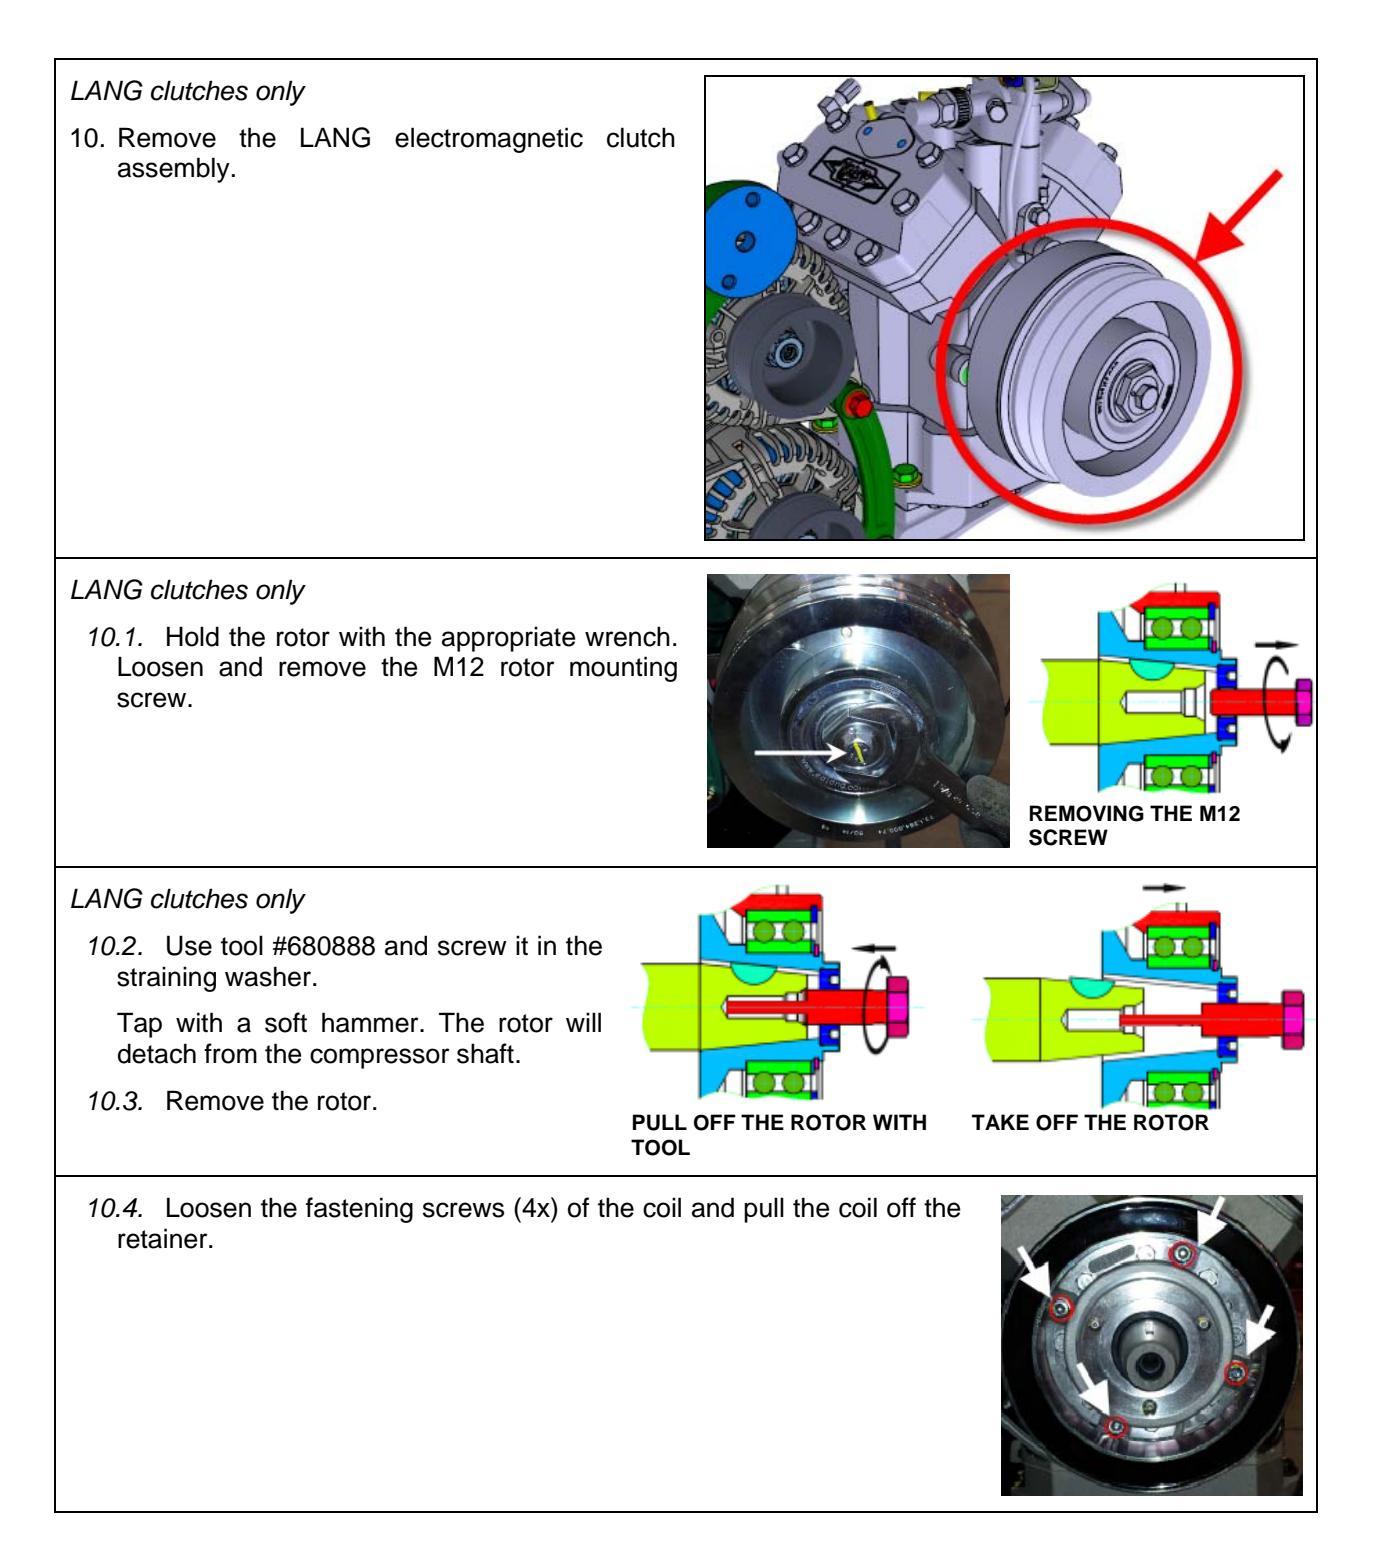
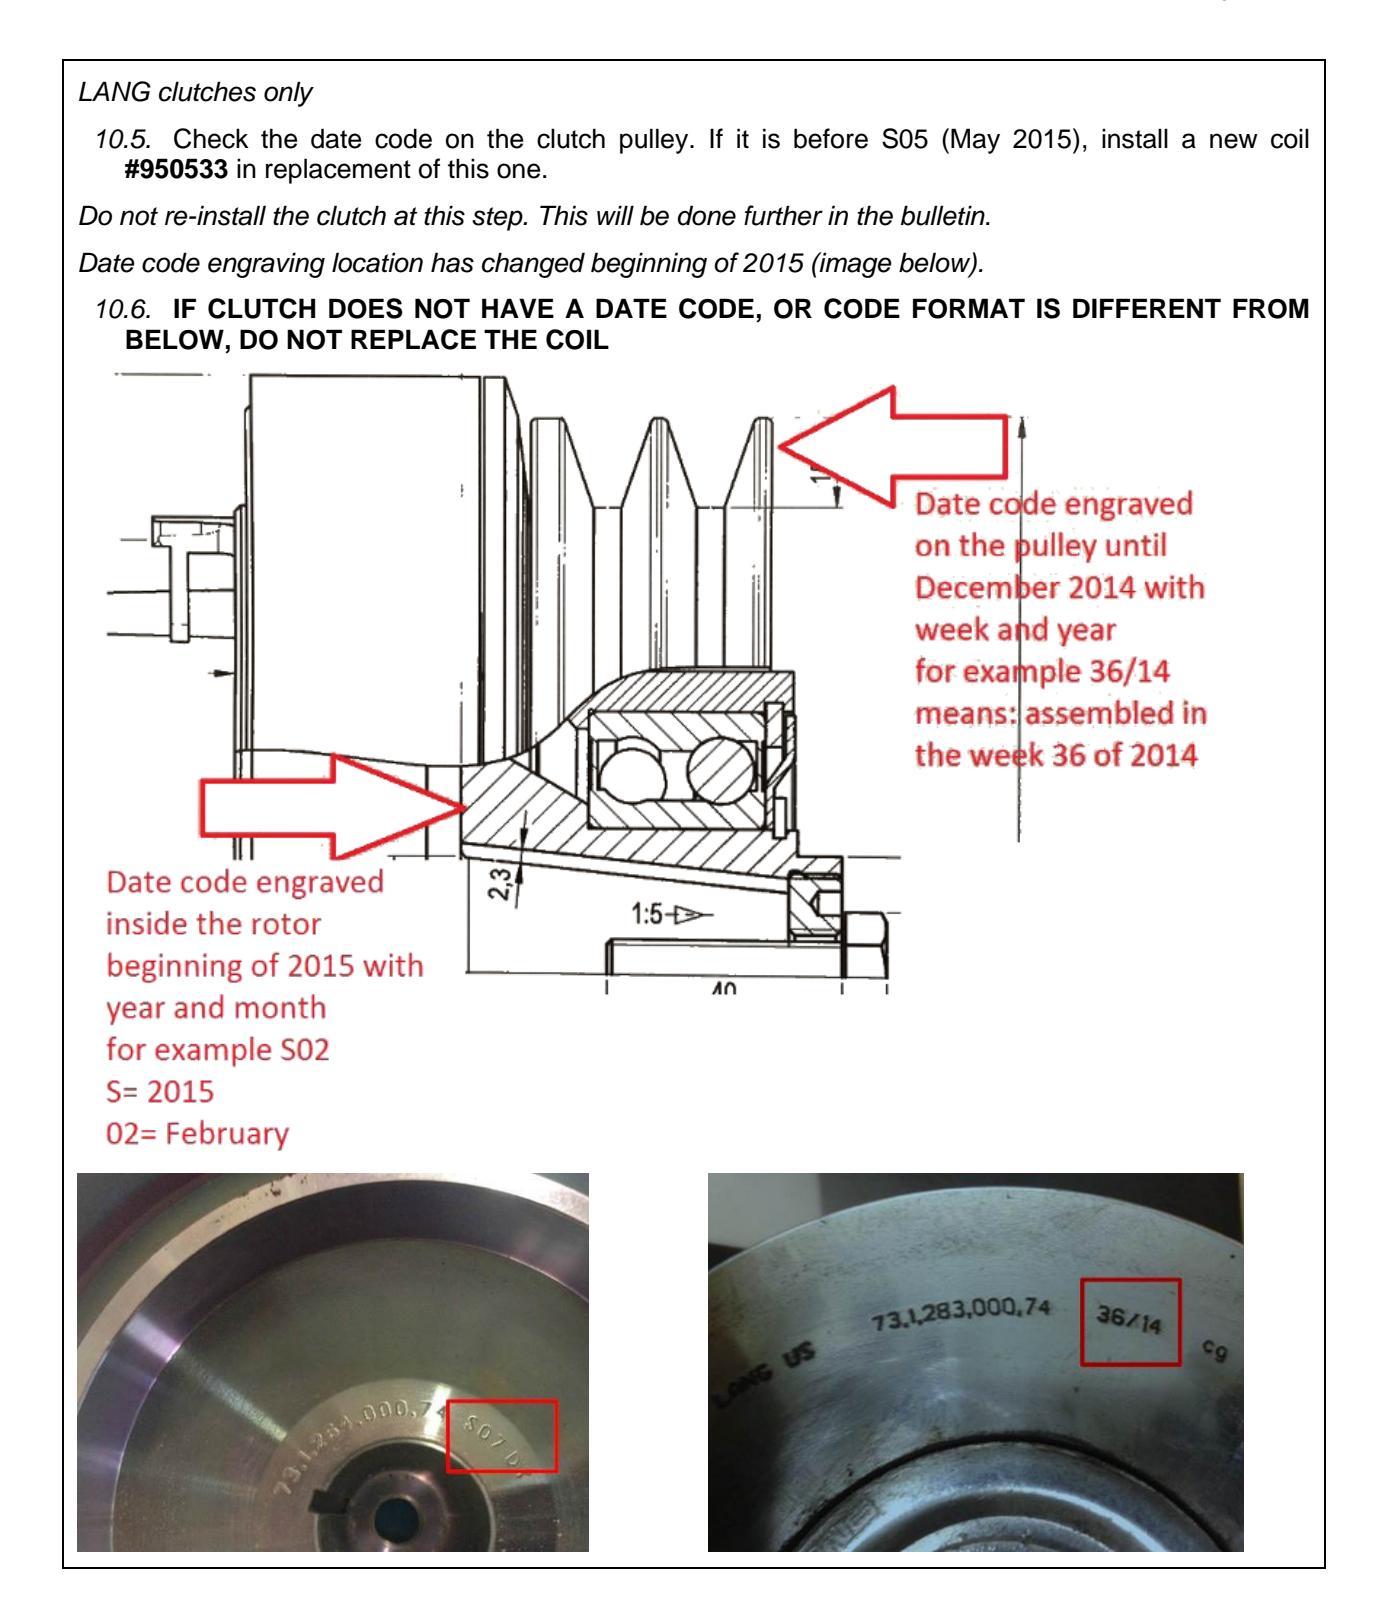
7. AT THIS POINT, IDENTIFY THE TYPE OF CLUTCH INSTALLED ON YOUR VEHICLE.

LANG TYPE: SHARP EDGE COIL LINNIG TYPE: ROUND EDGE COIL 8. As an alternate way to confirm LANG Type clutch, locate "LANG" engraving on the hub center. Note for this type: Confirm you have two #5001616 socket head cap screws in your available material. These additional screws will be used to install the reinforcement bracket on the compressor. 9. If a LINNIG Type clutch is installed, refer to "LINNIG ELECTROMAGNETIC CLUTCH INSTALLATION / REMOVAL" at the end of this document.

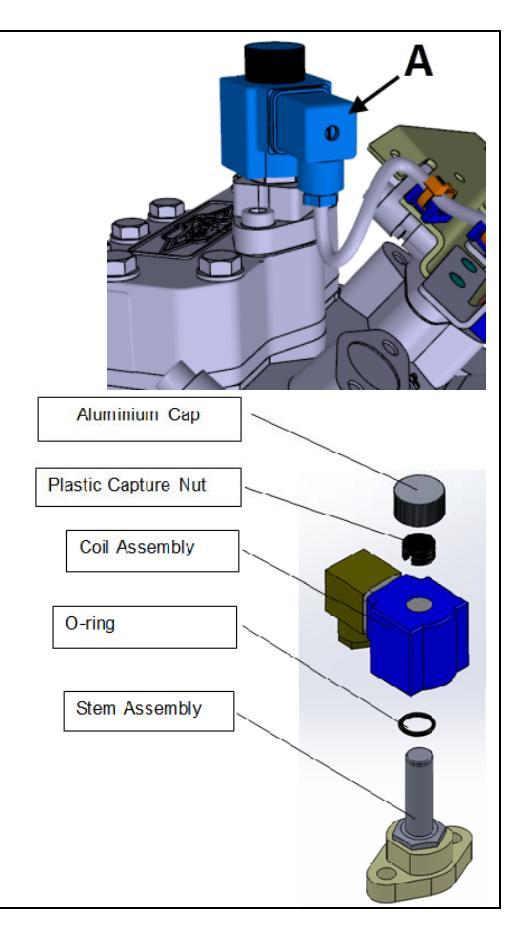
A new "clip-on" type unloader coil must be installed in order to avoid unloader failure.

- Loosen the screw securing the connector to the coil and then unplug the connector (A). Keep the screw and the connector rubber gasket for later use.
- 2. Unscrew the aluminum cap and discard.
- 3. Remove the plastic capture nut and discard.
- 4. Remove the coil and discard
- 5. Keep the O-ring on the stem.
