**SAFETY
RECALL**

SR24-11

DATE :	March 2024	SECTION :	14 STEERING
SUBJECT:	STEERING JOINT REPLACEMENT

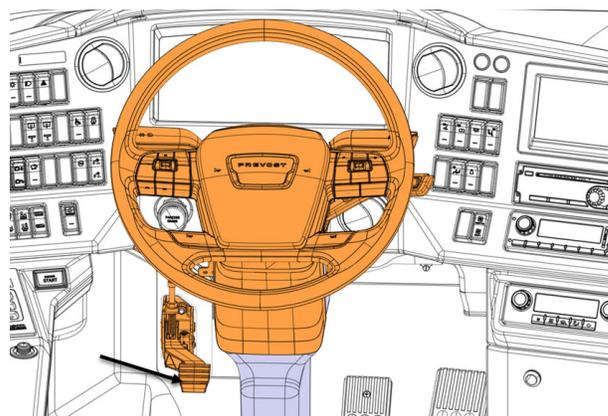
1. Set the steering column at the top position.

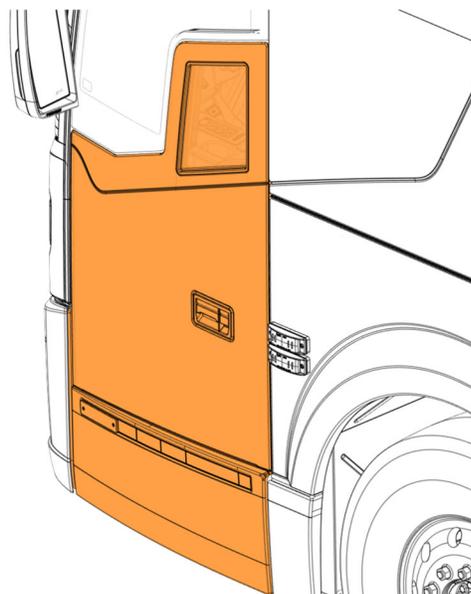
2. Open the front service door.

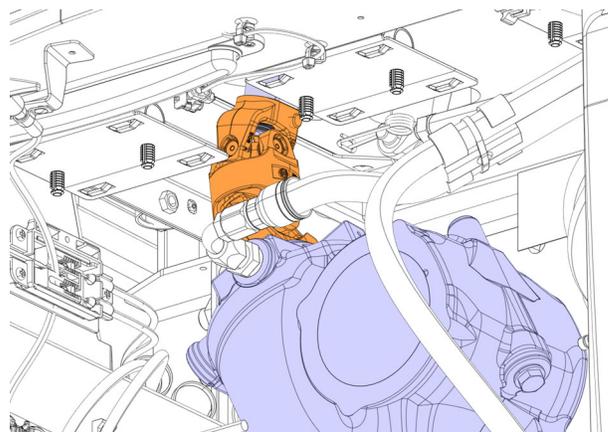
3. Locate the joint.

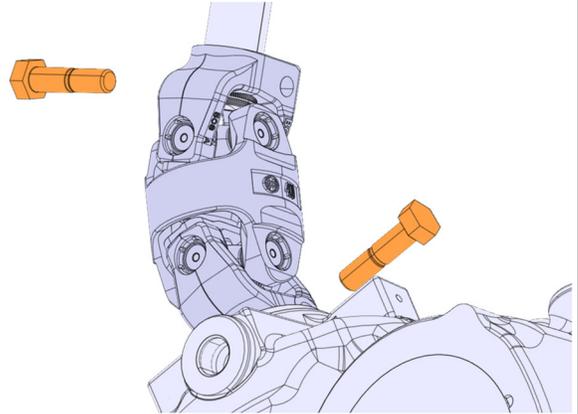
4. Remove bolts 660072 and discard.

Note: To help you can turn the steering wheel to get the better position to remove bolts.

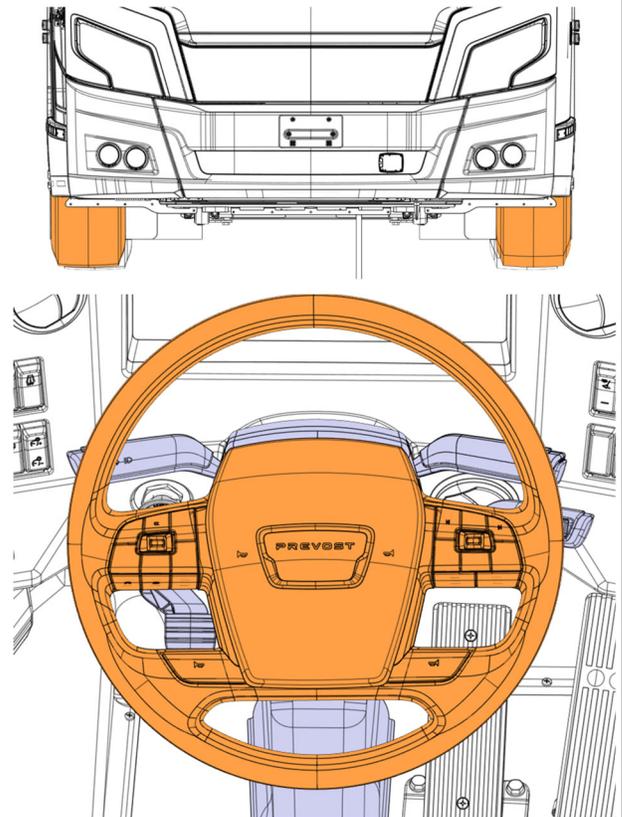
5. Position wheels straight and the steering wheel center position.

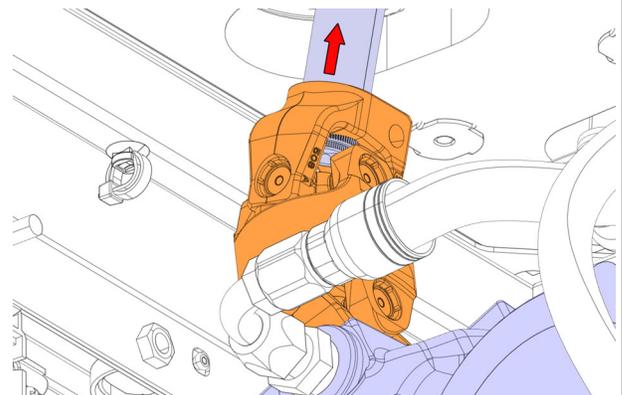
6. Push up the joint and steering column shaft to disconnect the joint from the steering gearbox.

Note: Do not turn the steering shaft, as this may damage the steering clock spring.

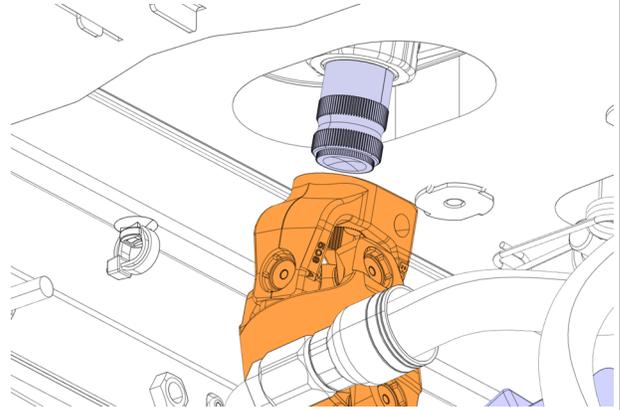
7. Remove the older joint from the steering column shaft and return.

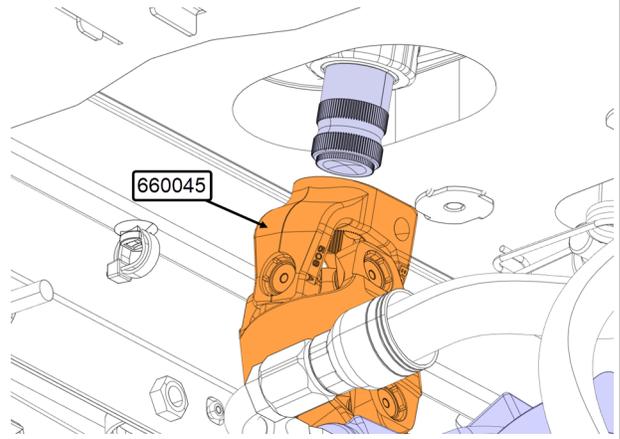
8. Install the new joint 660045 on the steering column shaft.

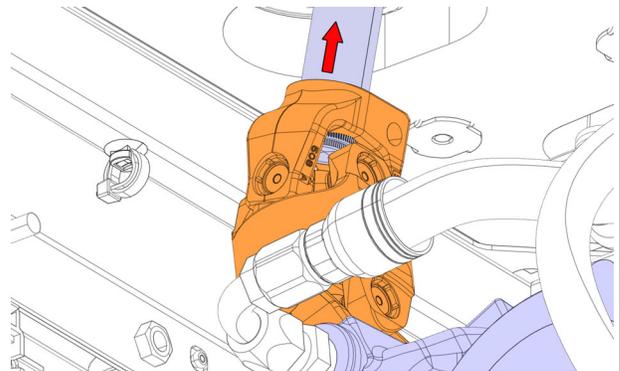
9. Push up the joint and steering column shaft to connect the joint on the steering gearbox.

Note: Do not turn the steering shaft, as this may damage the clock spring.

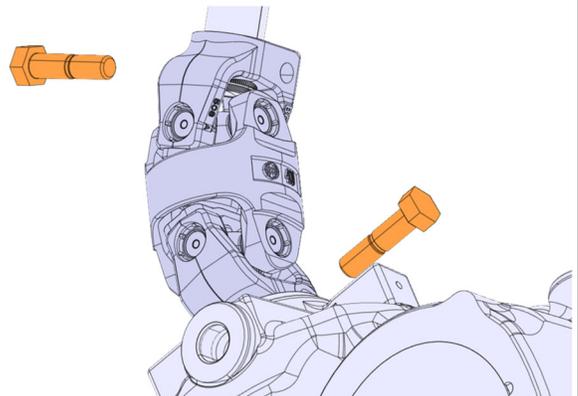
10. Install new bolts 660072.

Note: To help you can turn the steering wheel to get the better position to remove bolts.

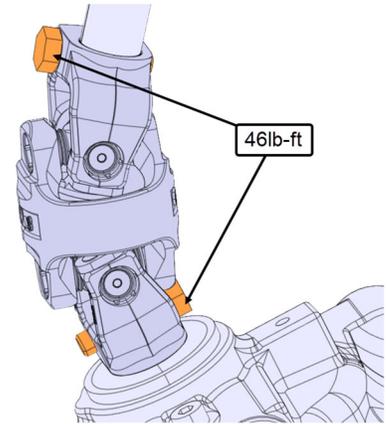
11. Torque to 46lb-ft.

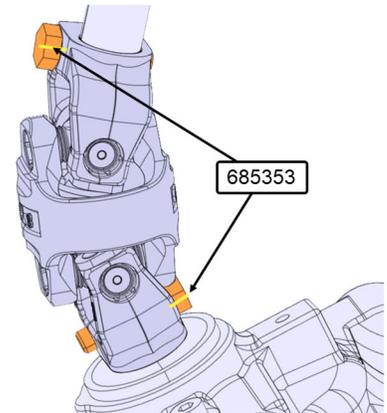
12. Apply torque seal 685353 on each bolts.

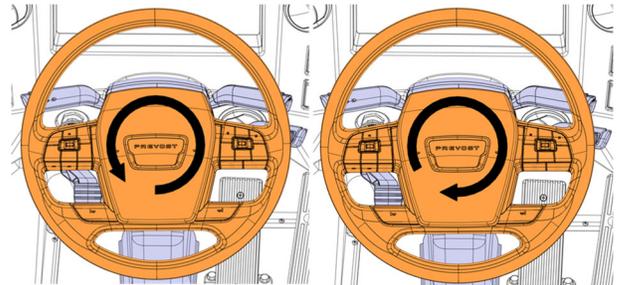
13. Start engine and verify the steering wheel turn correctly without interference and noise.

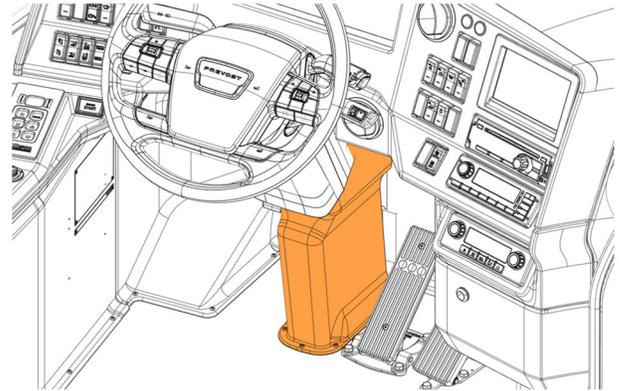
1. Locate the cover.

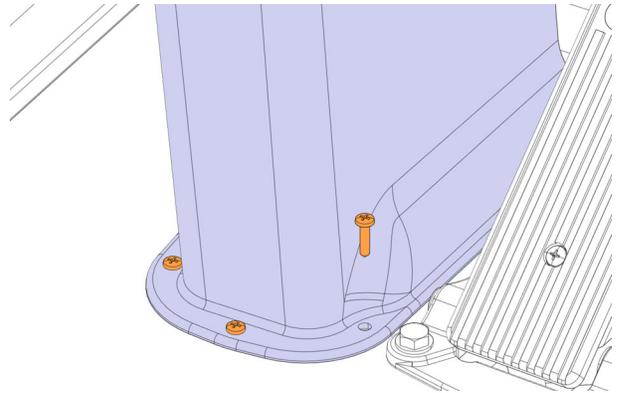
2. Remove screws (5x) and the cover.

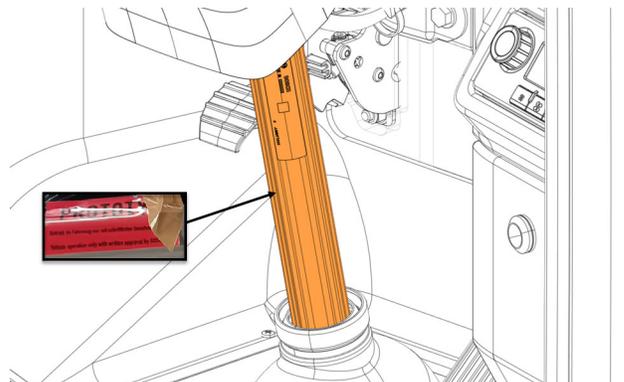
3. Verify if you have the red sticker
"PROTOTYPE".
If yes, remove it.

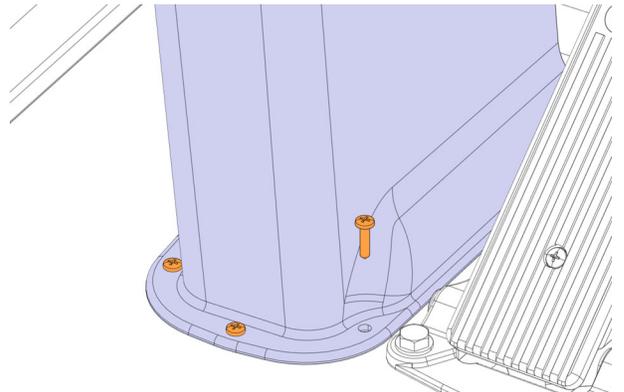
4. Reinstall the cover with screws (5x).
