# MAINTENANCE INFORMATION

**MI20-85**

DATE : 01	September 2020	SECTION : 06 GENERAL
SUBJECT :	<b>OBD CONNECTOR USCAN</b>

Model
Volvo 9700 Model Year : 2013 - 2020

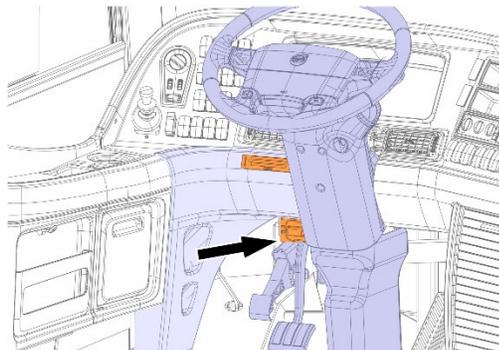
FIGURE 1

1. Locate the OBD connector under the dashboard, next to the steering column.

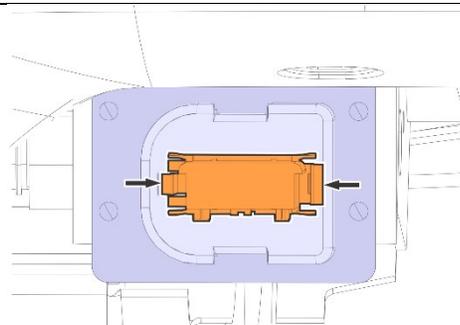
FIGURE 2

2. Remove the connector from its bracket.

Carefully press the locks and push the connector

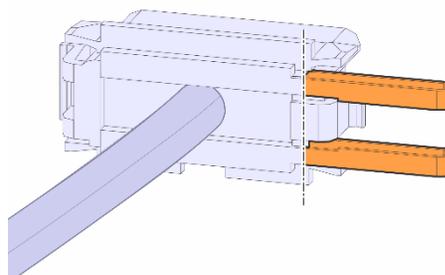
FIGURE 3

3. Cut excess of plastic from the connector.

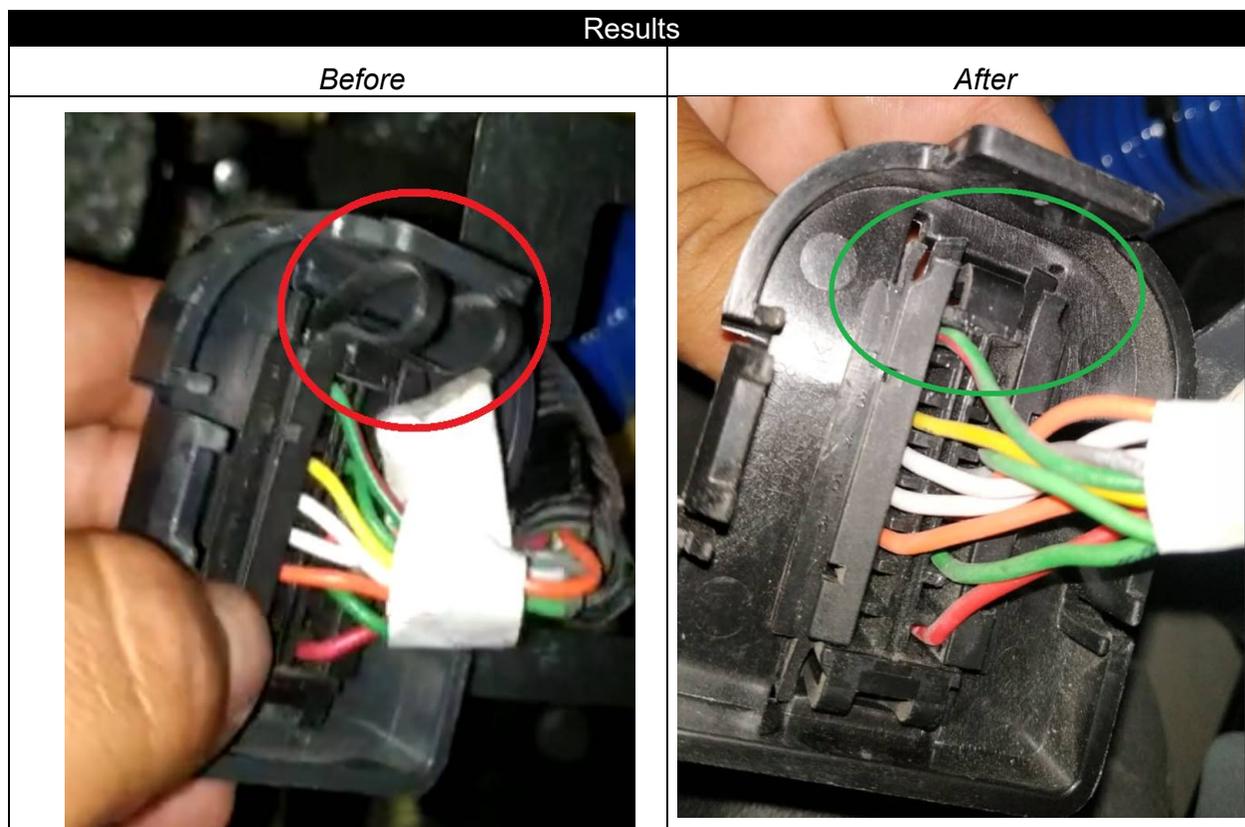
4. Install the connector back to its support.
