**SAFETY
RECALL**

SR22-08C

DATE :	June 2022	SECTION :	18 BODY
SUBJECT:	ROSCO MIRROR ADJUSTMENT – R-H SIDE

Revision: C

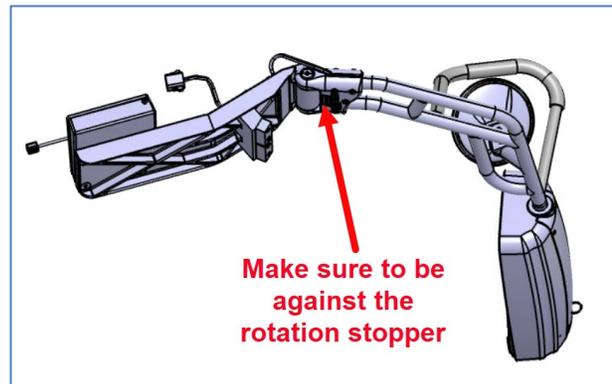
Figure 1

1. Locate the right (curb side) mirror.
2. Make sure the mirror arm rests against the rotation stopper.

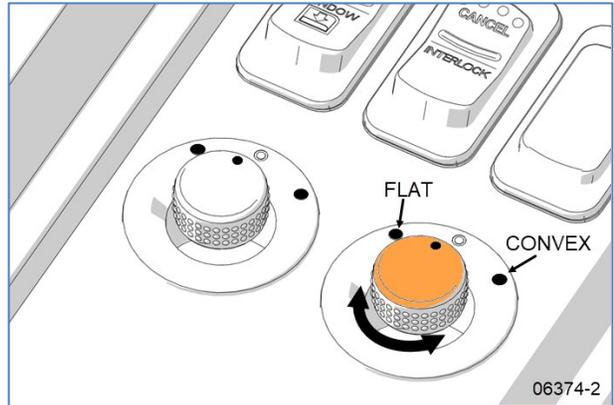
Figure 2

- Using the control switch on the left console, turn the flat mirror towards the inside until it stops.

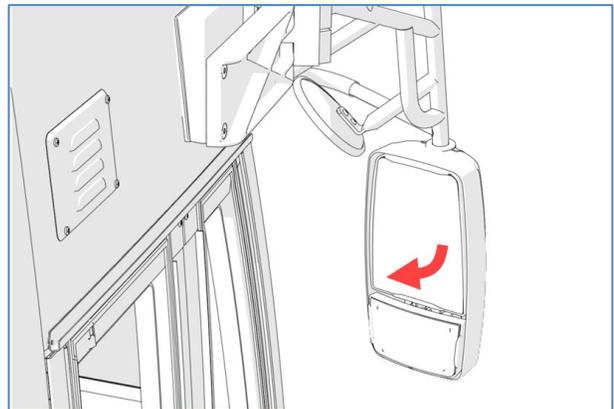
Figure 3

-
4. The side molding shown on the image must be seen along the outer edge of the flat mirror **when looking at the mirror from the driver seat.**

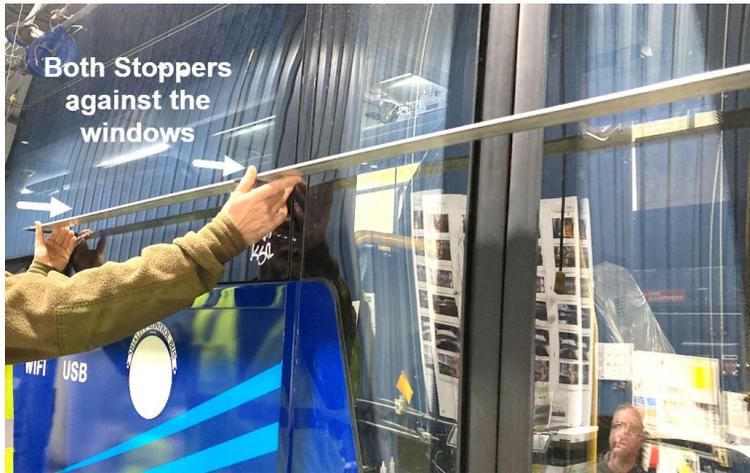
Figure 7

keep the jig 37918 level.

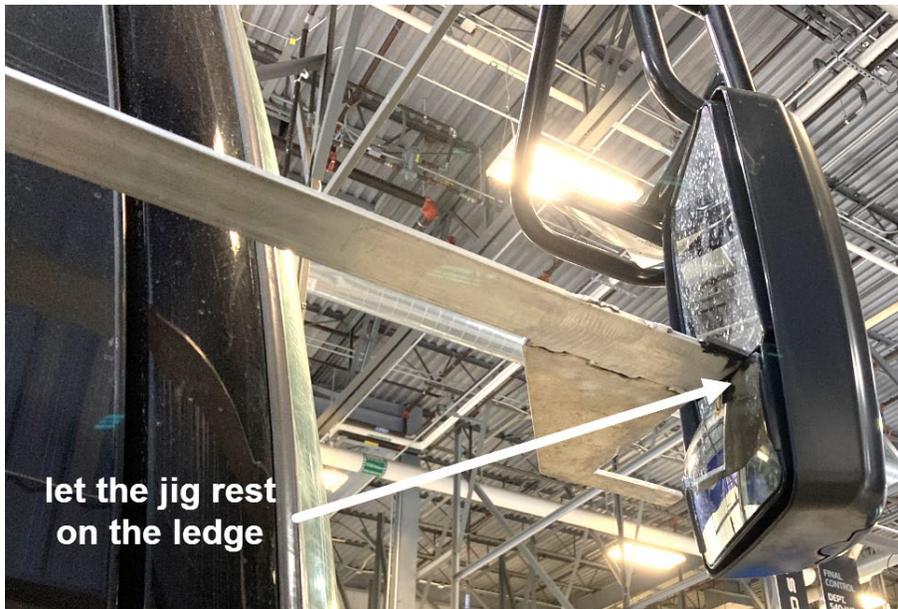
Figure 8

Apply a small pressure on the mirror towards the driver (to make sure we are in full detent position).
Only to take the play we can have.

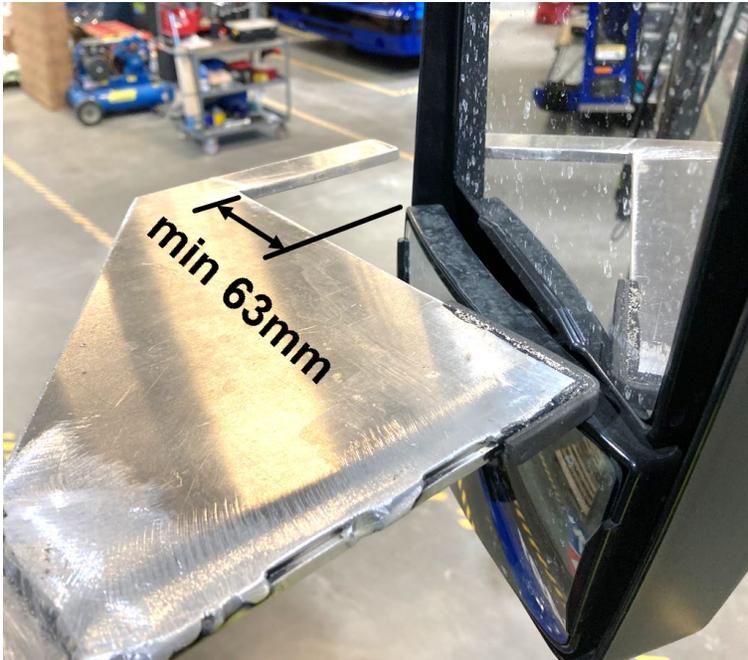
Figure 9

Requirement: minimum 63 mm (2 ½ in)
