# PREVOST

## WARRANTY BULLETIN

**WB23-18**

DATE :	August 2023	SECTION :	18 BODY
EXPIRATION:	August 2025		
SUBJECT :	<b>MISSING GLUE REARVIEW MIRROR SUPPORTS</b>

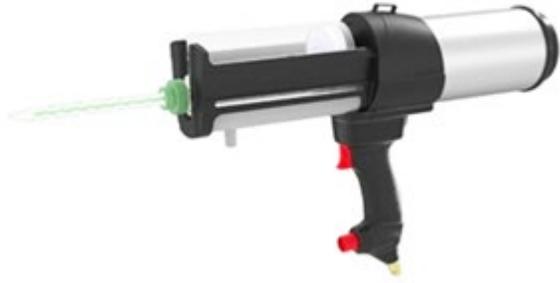
<p><b>PNEUMATIC GLUE GUN RATIO 10.1 PREVOST 688467(INCLUDE RATIO 10:1)</b></p>

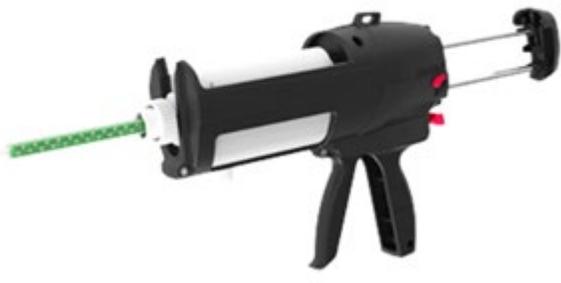
<p><b>MANUAL GLUE GUN RATIO 10.1 PREVOST 680951(INCLUDE RATIO 10:1)</b></p>

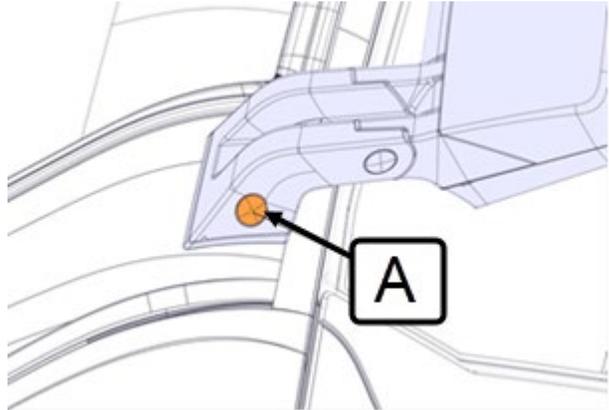
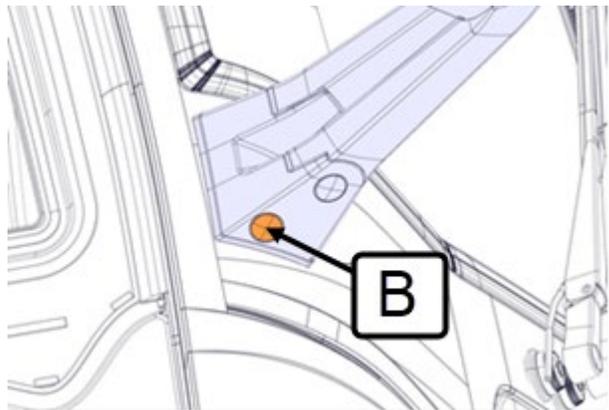
1. Remove cap
  - A left mirror
  - B right mirror

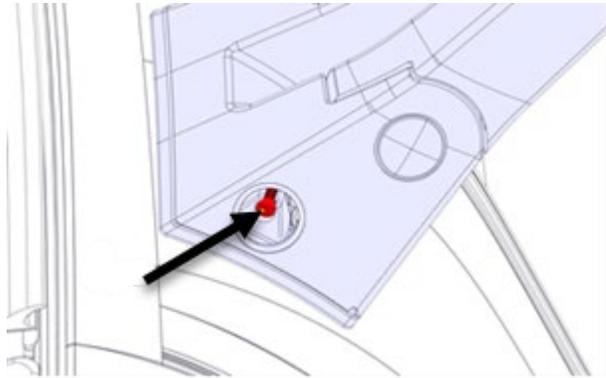
2. Unscrew bolt.

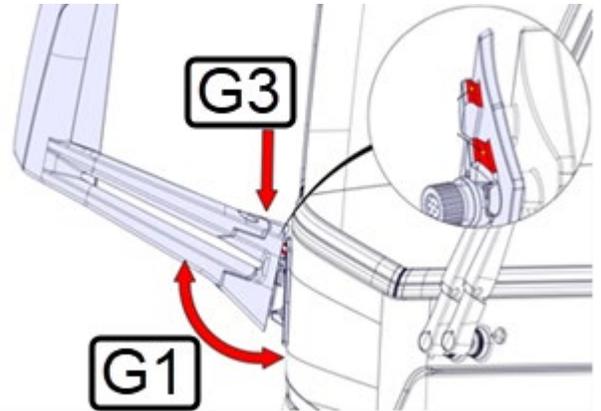
3. Lift mirror arm (G1) and slide up (G3) to remove it from its anchoring plate.

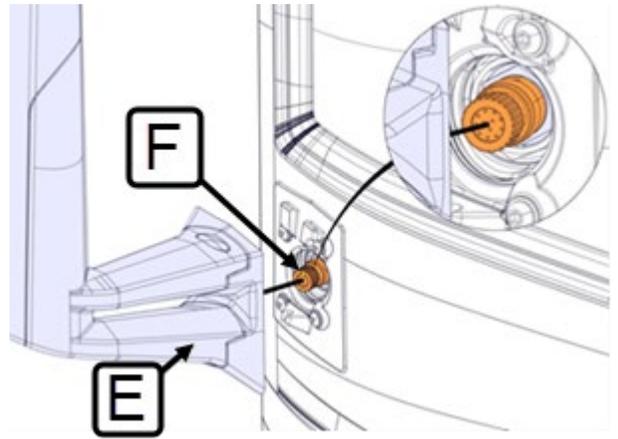
4. Disconnect the mirror (E) connector (F).

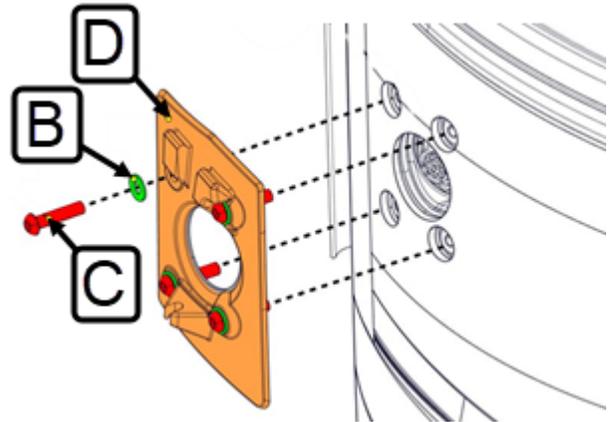
5. To Remove anchor plate (D) unscrew bolts (C) and washers (B).

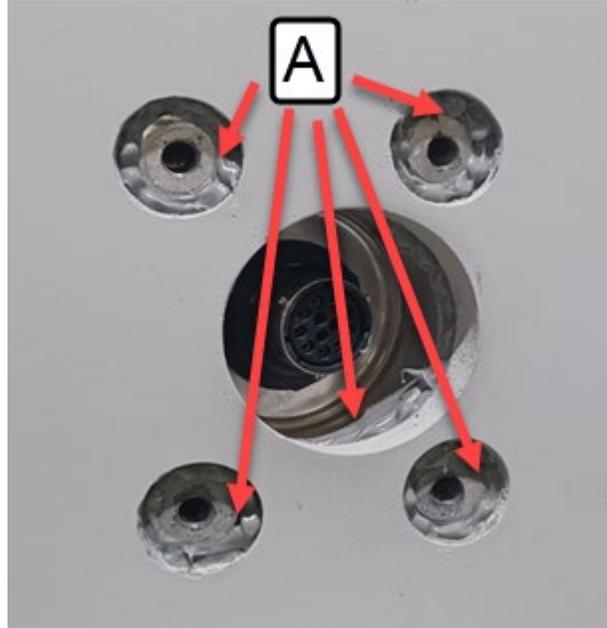
1. Check if you see glue or not

A) With sufficient glue go to mirror re-installation section.

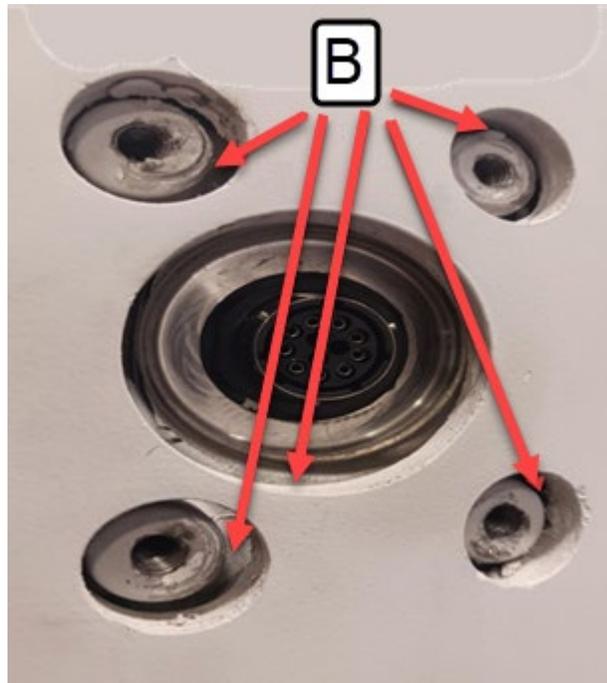
On the vehicles affected by this bulletin it is possible that there is a lack of glue on the mirror support. If this is the case, you will need to add it to eliminate the risk of the front-end fiber cracking when tightening the mirror bolts.

B) With insufficient glue go to add glue section.
