PREVOST

WARRANTY BULLETIN

WB23-35

DATE:	March 2024	SECTION:	06 ELECTRICAL
EXPIRATION:	March 2026		
SUBJECT:	DPF HARNESS REPLACEMENT

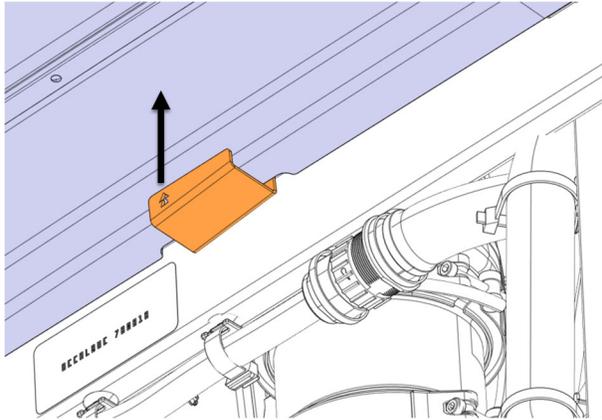
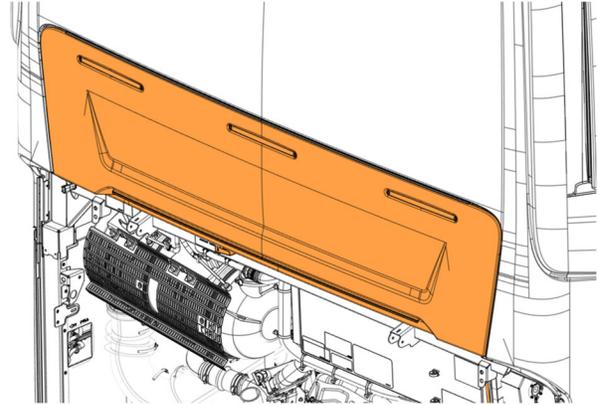
1. Push up the handle to open DPF door.

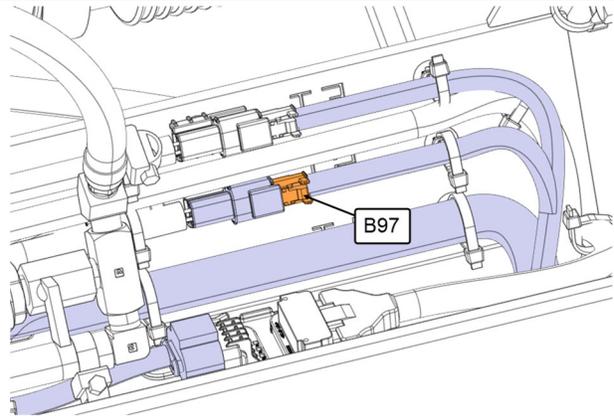
2. Locate connector B97.

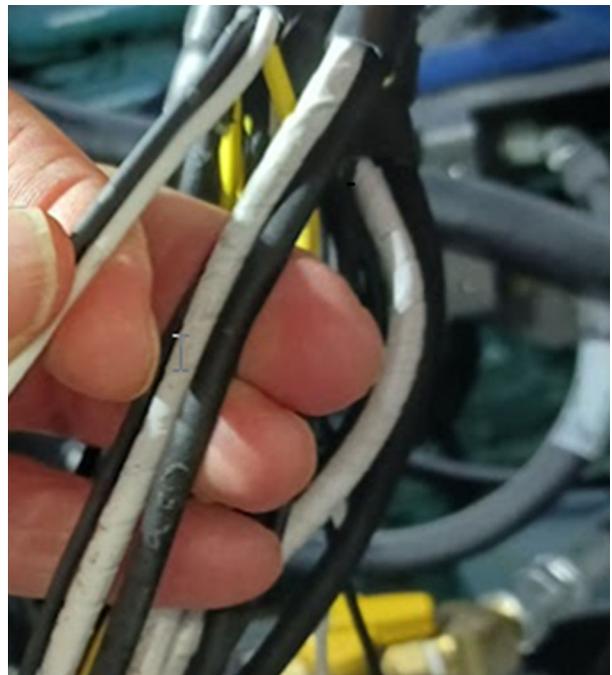
3. Remove one foot of the loom from connector B97.
4. Verified if you have wires with a splice see the picture.
 - If yes, go to the next step.
 - If no, reinstall the loom and secure the cable to complete the procedure.

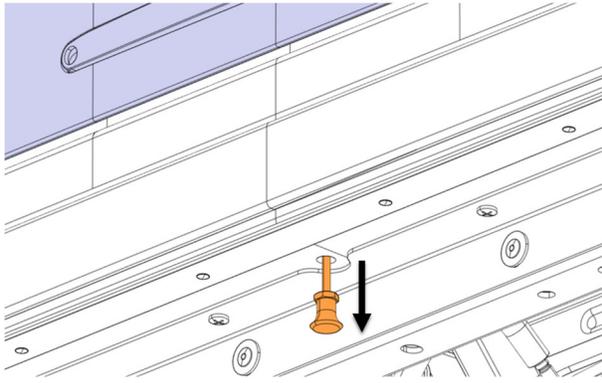
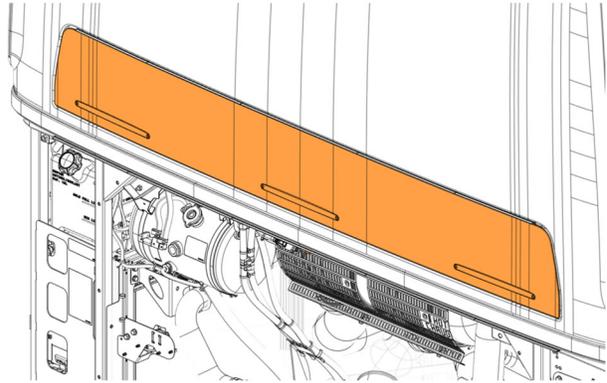
1. Pull down the rod to open DPF door.

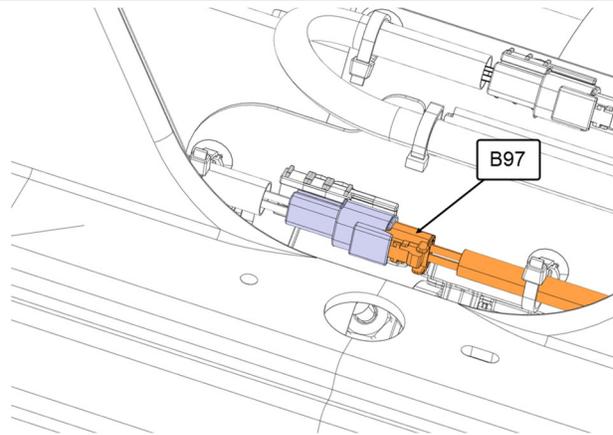
2. Locate connector B97.

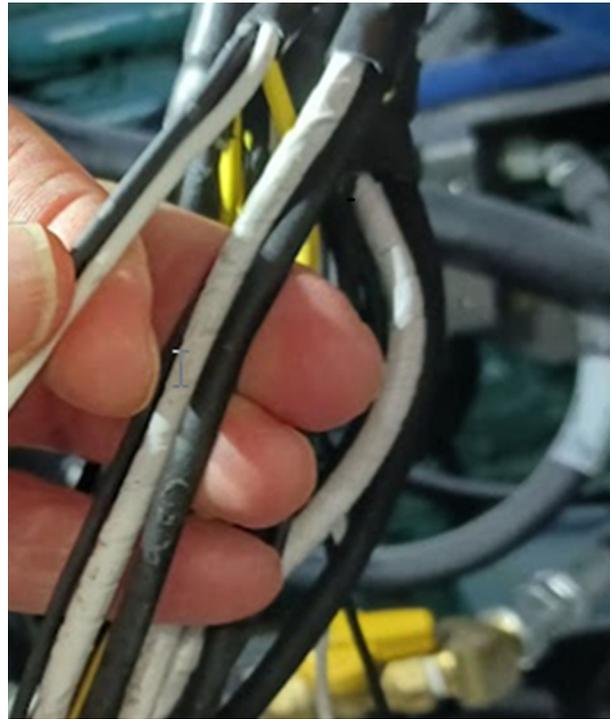
3. Remove one foot of the loom from connector B97.
4. Verify if you have wires with a splice see the picture.
 - If yes, go to the next step.
 - If no, reinstall the loom and secure the cable to complete the procedure.
