**WARRANTY
BULLETIN**

Wb11-09

DATE : MAY 2011	SECTION :	18 - Body
EXPIRATION: MAY 2013		
SUBJECT : REPLACING CONDENSER COMPARTMENT DOOR TWO HINGES

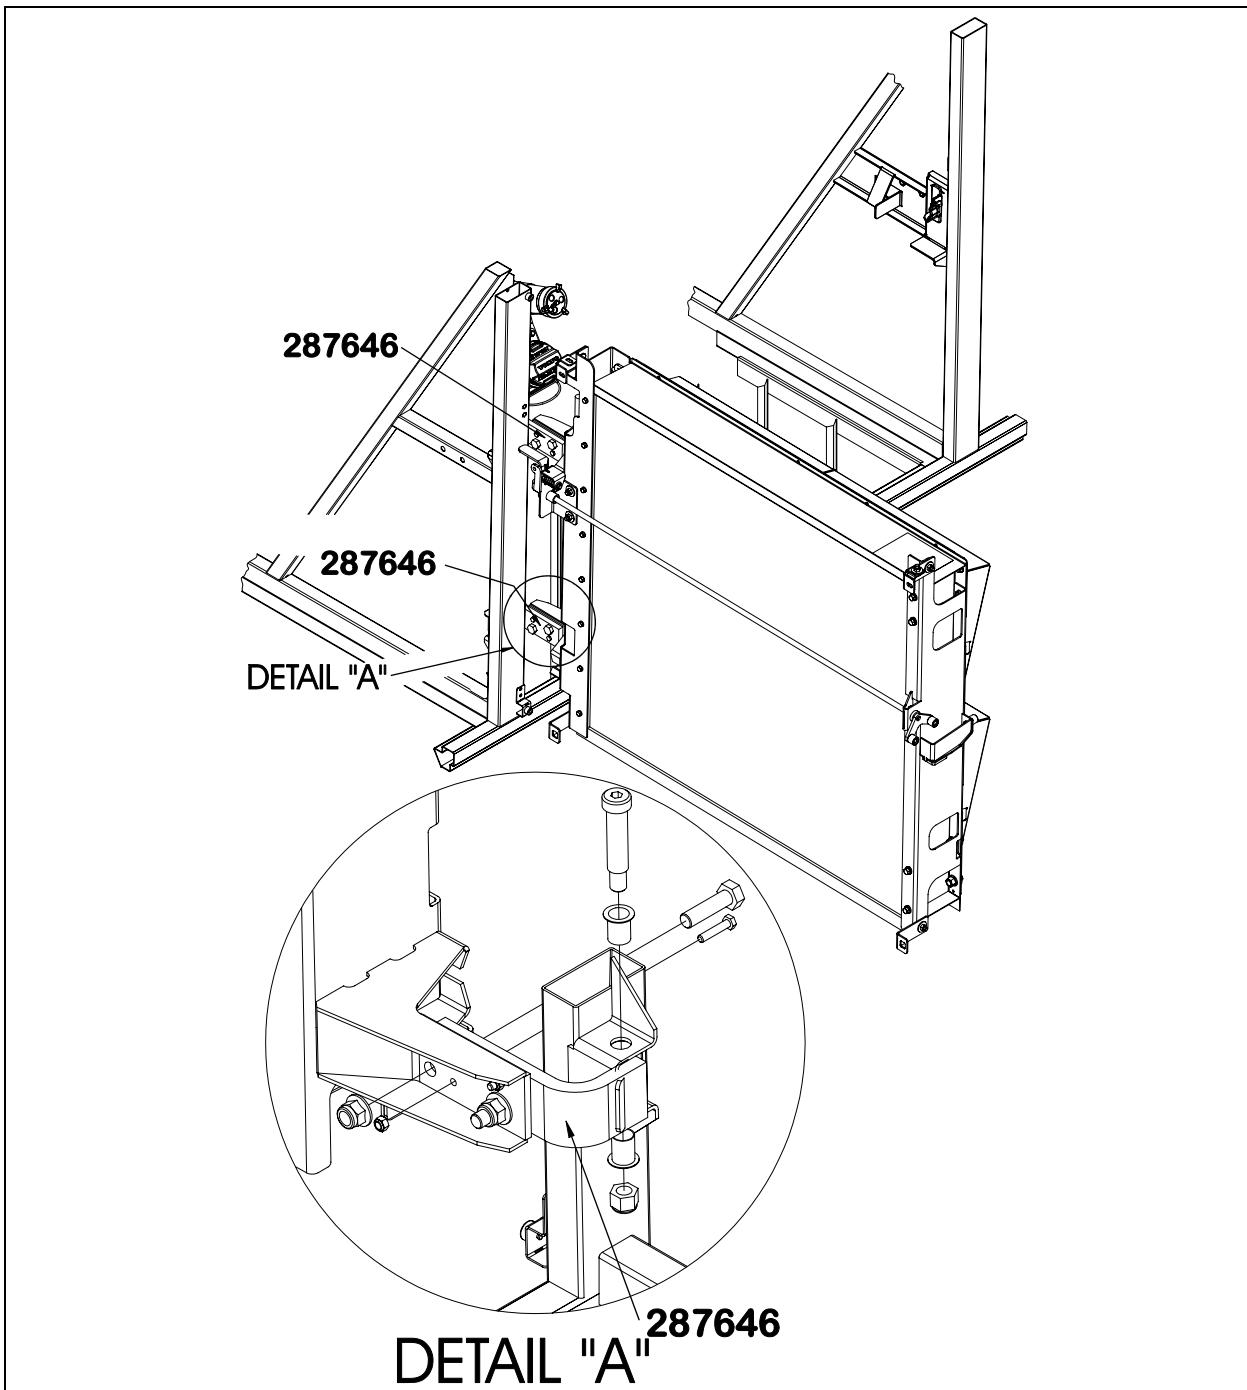
On the vehicles affected by this bulletin, there is a possibility that the condenser door hinge pivot weld be defective and result in breaking.

If breaking occurs when the door is opened, the condenser and door might fall down.

1. Open condenser door.
2. Safely support condenser door while replacing door hinges.

Replace one hinge at a time.

3. Remove top hinge and replace with new part. Reinstall shims if applicable.

4. Remove bottom hinge and replace with new part. Reinstall shims if applicable.
5. Close condenser compartment door.
6. Check for proper operation of door hinges,
