**PREVOST**

**WARRANTY  
BULLETIN**

**WB13-77**

DATE :	NOVEMBER 2013	SECTION :	22 - HVAC
EXPIRATION:	NOVEMBER 2015		
SUBJECT :	PRE-HEATING SYSTEM THERMOSTAT REPLACEMENT

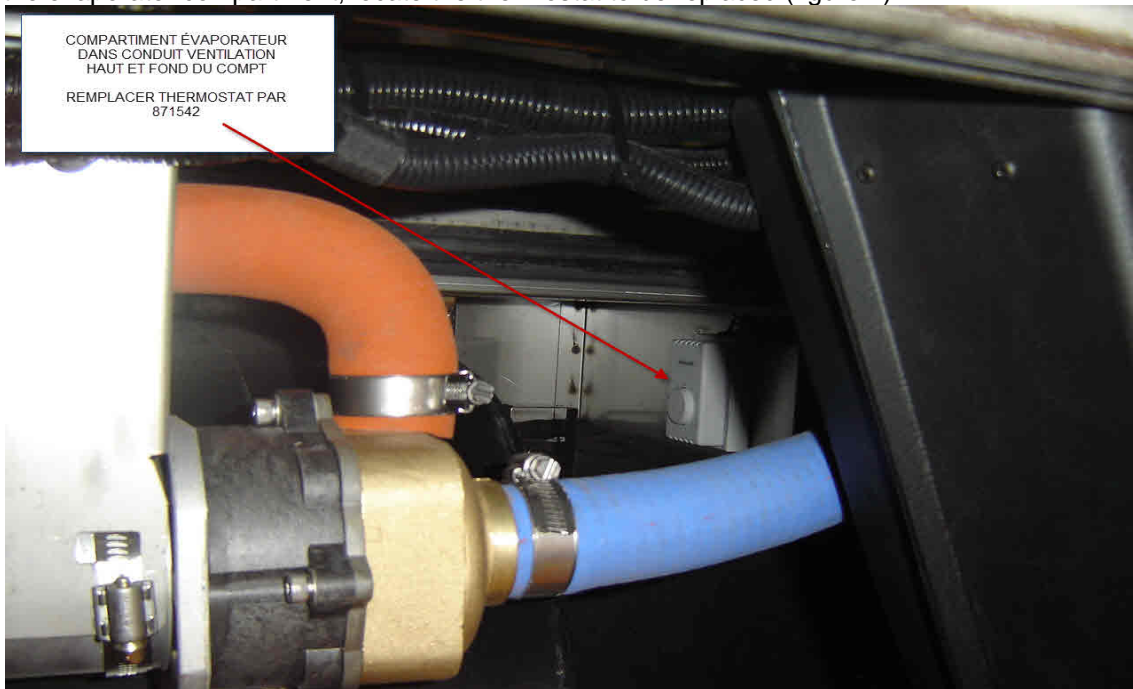
1. In the evaporator compartment, locate the thermostat to be replaced (figure 1).

**Figure 1 :** Location of the thermostat to be replaced, in the evaporator compartment

2. Replace the thermostat and add 500804 flat washers (figure 2).
