# PREVOST

## WARRANTY BULLETIN

**WB15-46**

DATE :	OCTOBER 2015	SECTION :	18 - BODY
EXPIRATION:	OCTOBER 2017		
SUBJECT :	EPA Emission Control Decal Replacement

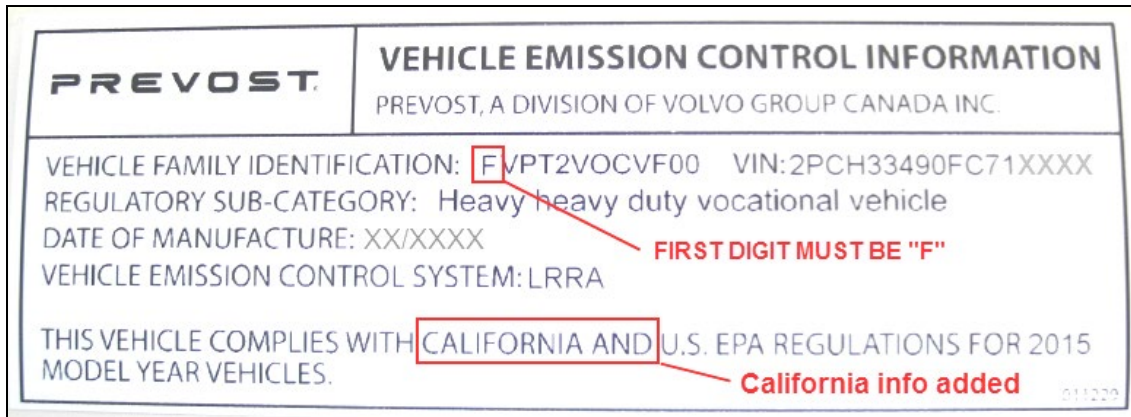
On the vehicles affected by this bulletin the EPA (US Environment Protection Agency) decal located in the engine compartment displays incorrect information related to the vehicle emission control.

Specifically, the first character, indicating the model year in the vehicle family identification number is incorrect and the California state EPA compliance notice is missing.

FIG.1 CORRECT INFORMATION ON NEW EPA DECAL – CANADIAN BUILT VEHICLE SHOWN

1. Validate that the new EPA decal information is correct:
  - Vehicle family Identification number first digit must be "F" (see Fig.1).
  - Regulation compliance must include California (see Fig.1).
  - Vehicle VIN must match VIN on the new decal (see Fig 2).
2. Remove the vehicle EPA decal located in the engine compartment (see Fig.3). Do not install the new decal over the old one.
3. Carefully clean the decal area from all traces of dirt, road grime and old adhesive.
4. Reinstall the new decal at the same location on the vehicle, make sure of proper adhesion.
