**PREVOST**

**WARRANTY  
BULLETIN**

**WB15-50**

DATE :	DECEMBER 2015	SECTION :	18 - BODY
EXPIRATION:	DECEMBER 2017		
SUBJECT :	REAR JUNCTION BOX DECAL, R34 RELAY INFO

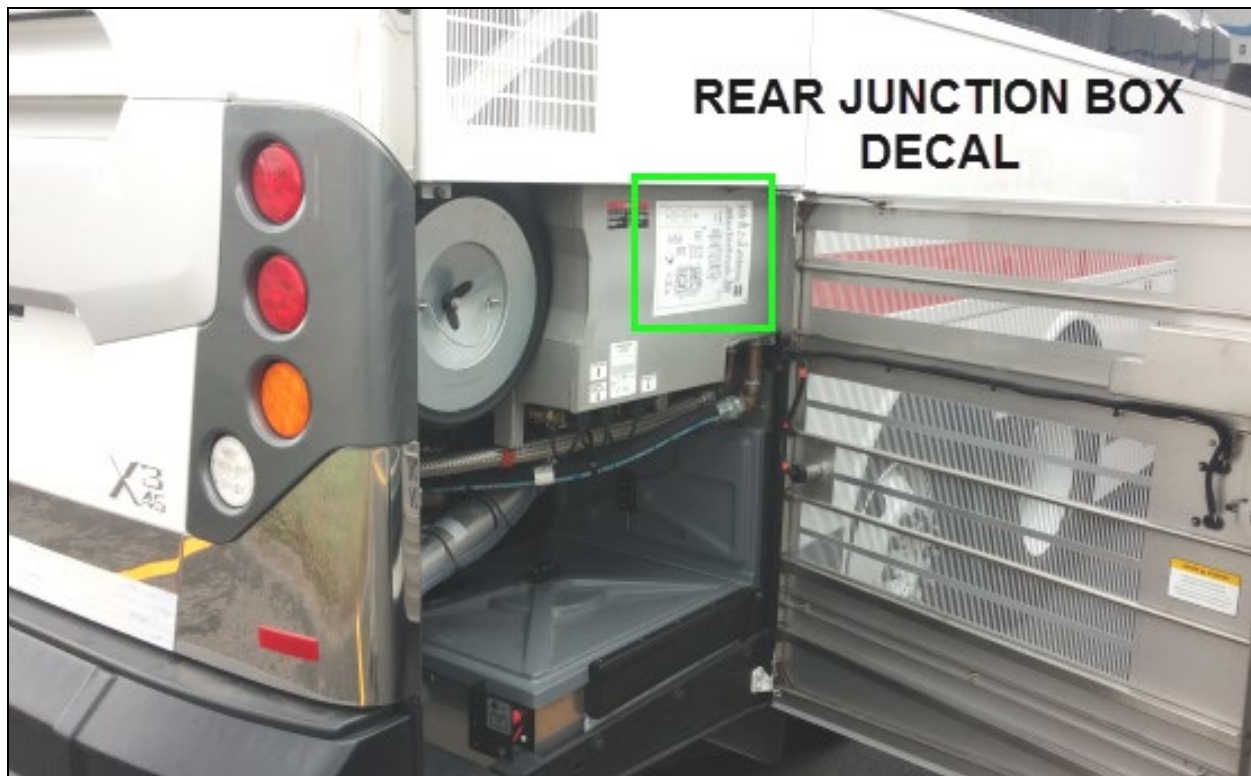
Fig.1 Typical Rear Junction Box localisation in engine compartment (X3 Coach shown)

1. Open the vehicle right engine door and locate the rear junction box decal (Fig.1 & 2).

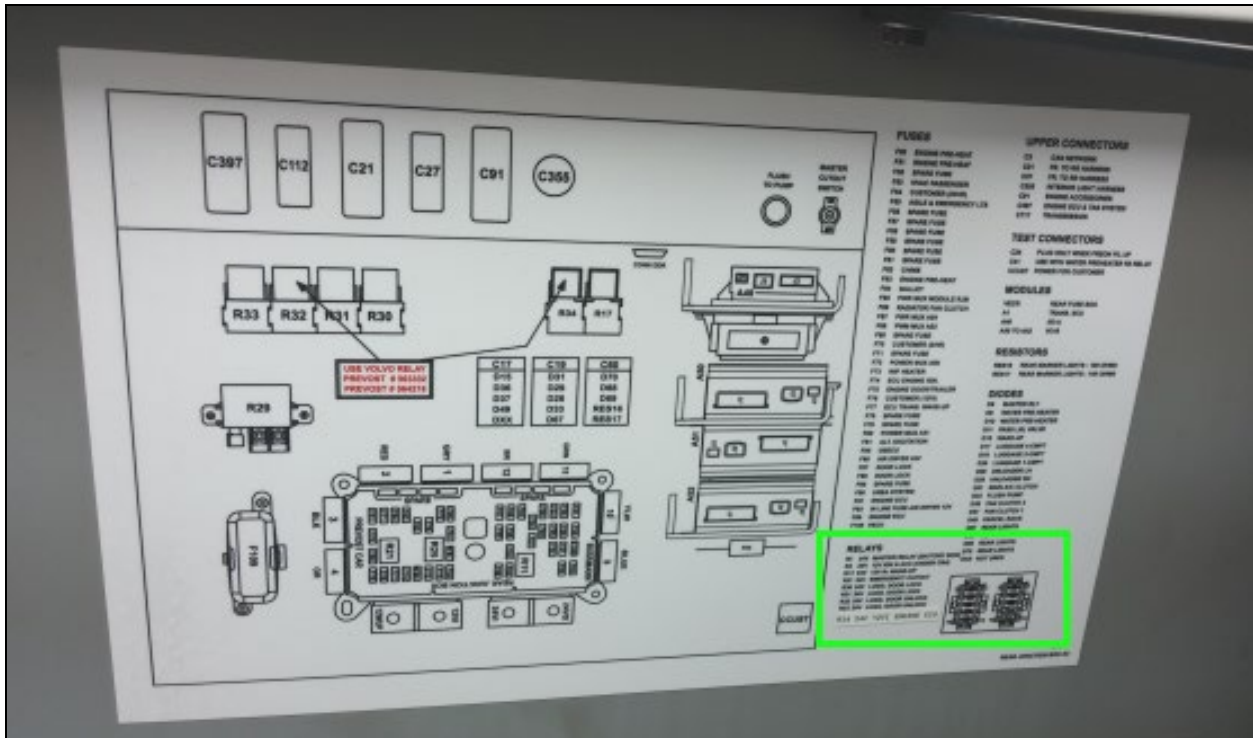
Fig2. Typical relay identification area - Rear Junction Box decal (X3 Coach Shown).

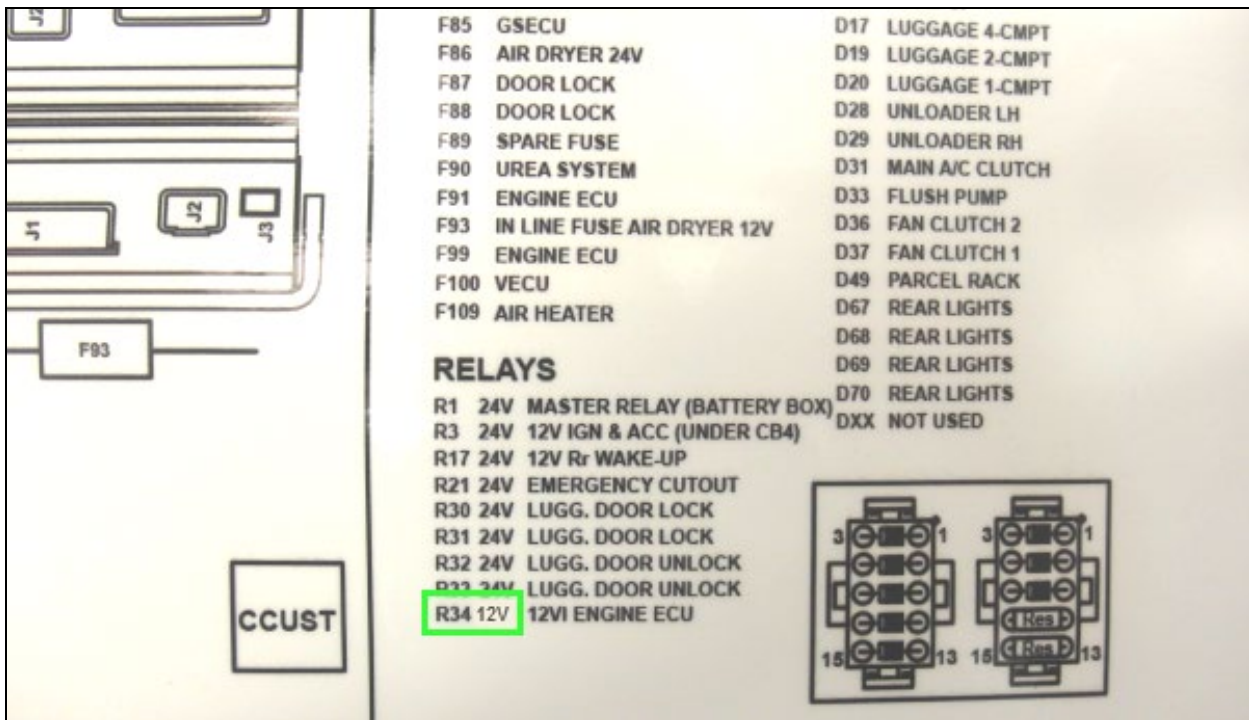
On the vehicles affected by this bulletin the rear junction box decal located in the right engine compartment is displaying incorrect information regarding the R34 relay voltage.

Specifically, the R34 relay should be identified as a 24 volt relay instead of a 12 volt relay.

- On the decal lower right corner, validate that the R34 relay description is inaccurate (Fig.3) and identifies the relay as being a 12 volt relay (12V) instead of a 24 volt (24V).

Fig.3 R34 Relay incorrect 12V information (X3-45 Coach Shown).

Consequently, all affected vehicles must have a small decal displaying the correct information applied over the rear junction box decal R34 relay description.

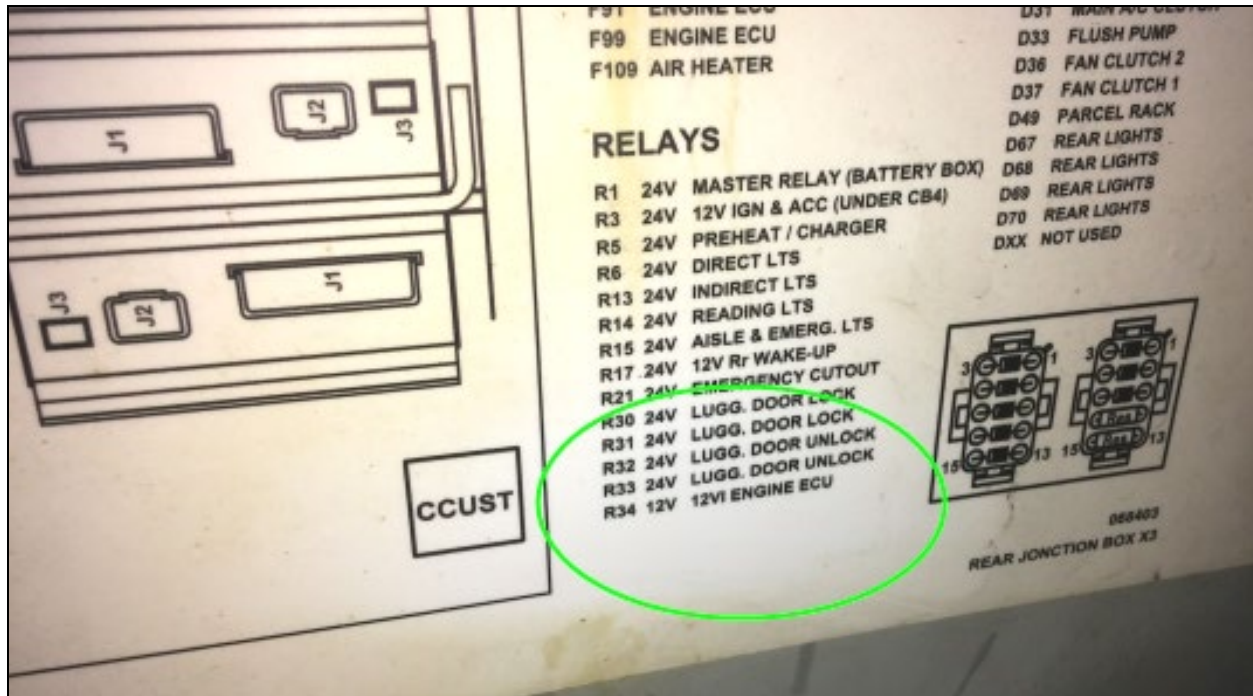
Fig.4 Cleaned area before decal application (Older X3-45 Coach Shown).

3. To ensure proper adhesion of the new decal, carefully clean the area from grease, dirt and road grime (Fig.4).

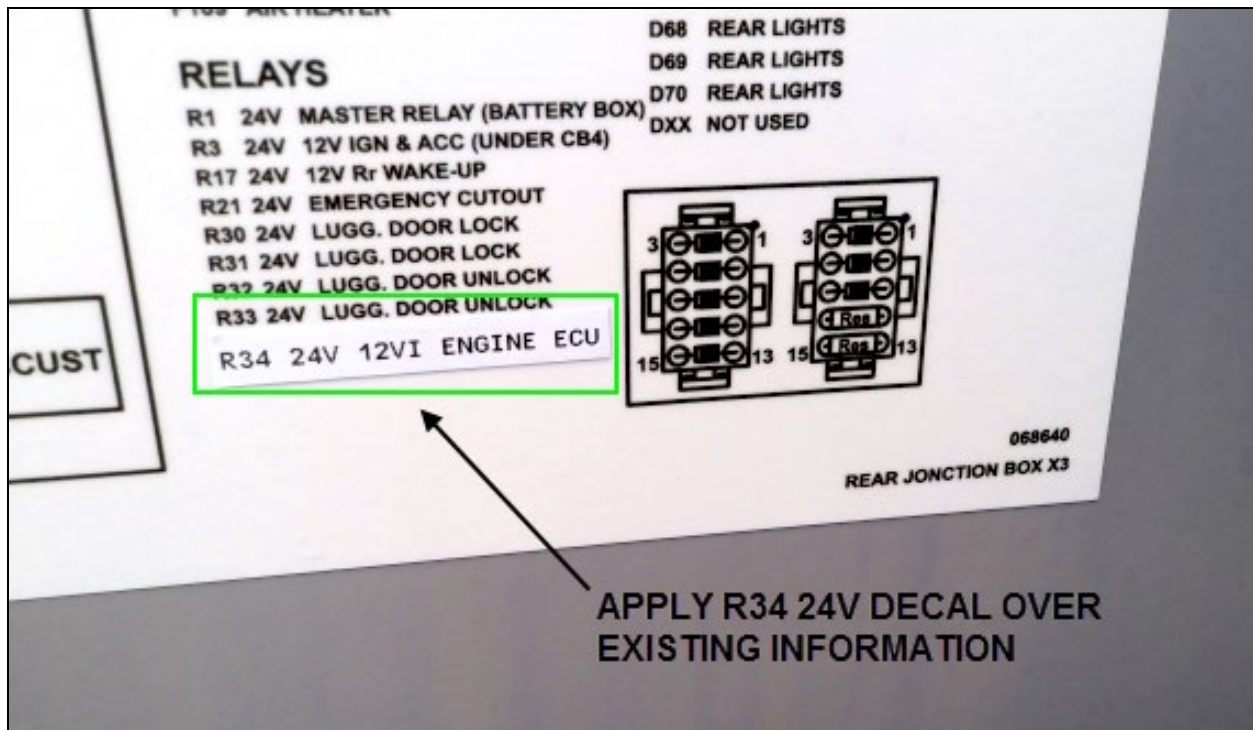
Fig.5 Decal showing correct R34 voltage (X3 Coach Shown).

4. Apply the new decal over the existing 12 volt information as shown on Fig.5 and make sure of proper adhesion (apply pressure on the entire area with a plastic card or scraper. In cold weather, apply moderate heat as necessary).
