Rev A, April 28 2016: p/n modification, was 22855593  
now wb16-80.

## EPA Emission Control Decal Replacement 9700 (B13R)

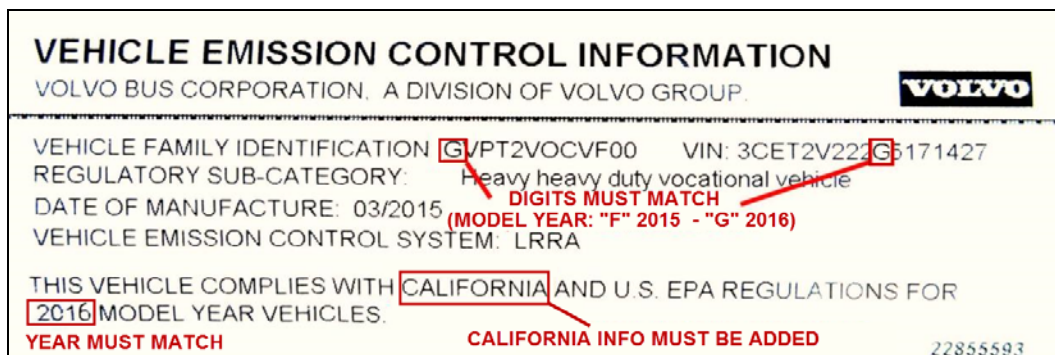
FIG.1 CORRECT INFORMATION ON NEW EPA DECAL (2016 VEHICLE SHOWN)

1. Validate that the new EPA decal information is correct:
  - Vehicle family Identification number first digit must match vehicle VIN 10<sup>th</sup> digit (see Fig 1).
  - Regulation compliance must include California (see Fig 1).
  - Vehicle VIN must match VIN on the new decal (see Fig 2).

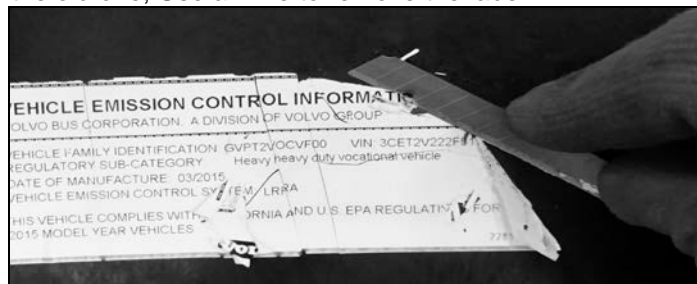
FIG.3 REMOVAL

2. Remove the vehicle EPA decal located in the engine compartment (see Fig.3 & 4). Do not install the new decal over the old one; Use a knife to remove the label.

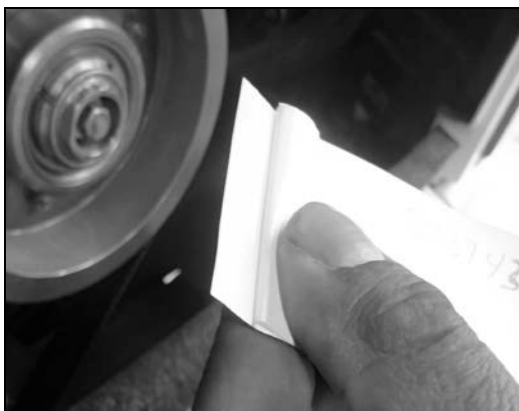
FIG.5 INSTALLATION OF THE LABEL

- Carefully clean the decal area from all traces of dirt, road grime and old adhesive.
- Once the area is dry, reinstall the new decal at the same location on the vehicle; make sure of proper adhesion (see Fig 5).

Note: The label is very sensitive and can break easily, **make sure to handle with care!**
