**SAFETY
RECALL**

SR16-18A

DATE :	APRIL 2016	SECTION :	05 - Cooling
SUBJECT:	TRANSMISSION OIL COOLER – AIR PURGE LINE REMOVAL

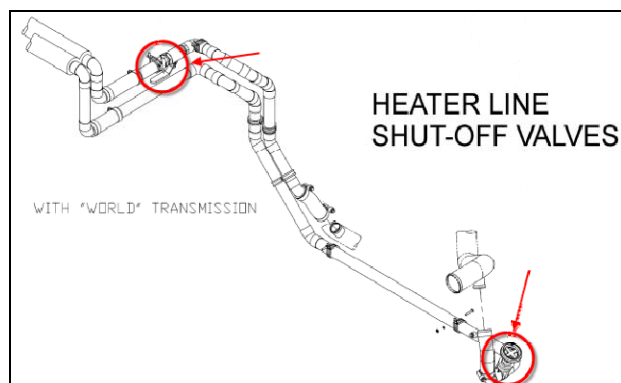
FIGURE 1 : X3 SERIES SHUT-OFF VALVES

On X3 Series, the valves are located in the engine compartment. One is located under the radiator fan drive mechanism support; another valve is on the L.H. side of the engine compartment in front of the radiator (FIGURE 1).

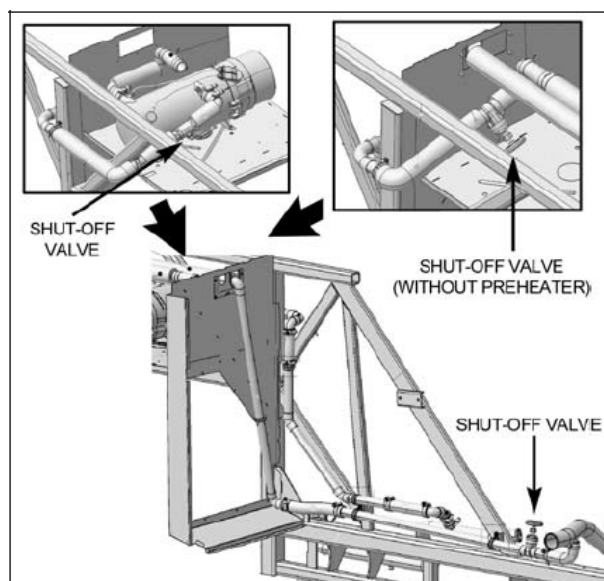
FIGURE 2 : H3 SERIES SHUT-OFF VALVES

On H3 Series, one valve is located in the engine compartment near the water pump. Another valve is located behind rear fender, above the L.H. rear wheelhousing near the optional coolant heater (FIGURE 2).
 - b) Place a cloth on the surge tank pressure cap. Unscrew the surge tank pressure cap counterclockwise $\frac{1}{4}$ turn to let air enter the system and release the pressure gradually.
 - c) Connect coolant extractor (FIGURE 3). Use coolant extractor to drain the coolant from the engine. An alternate method is to unscrew the drain plug and drain the coolant into a suitable container using a drain hose.

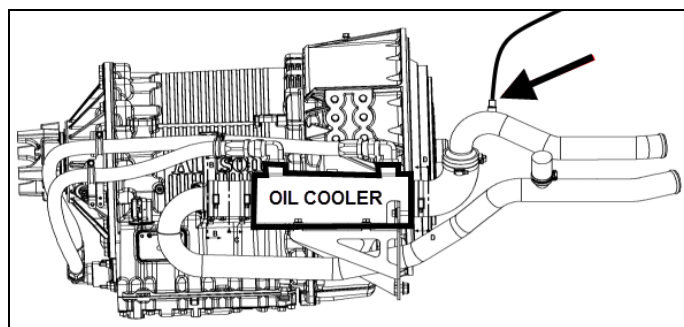
FIGURE 5: AIR PURGE LINE

On the vehicles involved, an air purge line may have been routed or secured incorrectly, which result in the air can purge line rubbing against a braided fuel hose at the aftertreatment hydrocarbon doser.

4. Disconnect the transmission oil cooler air purge line at the coolant pipe near the oil cooler (see FIGURE 5). Discard the air purge line. Put Loctite 567 thread sealant on ¼ hex socket plug (#501800) and then screw the plug to the coolant pipe fitting.

PLUG TIGHTENING: finger tighten then tighten 2 additional turns

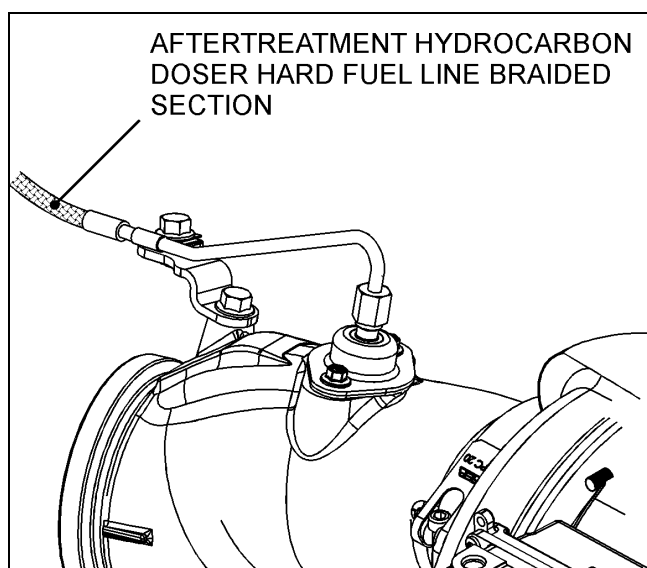
FIGURE 6: HARD FUEL LINE BRAIDED SECTION

1. Locate the braided section of the aftertreatment hydrocarbon doser hard fuel line (FIGURE 6)

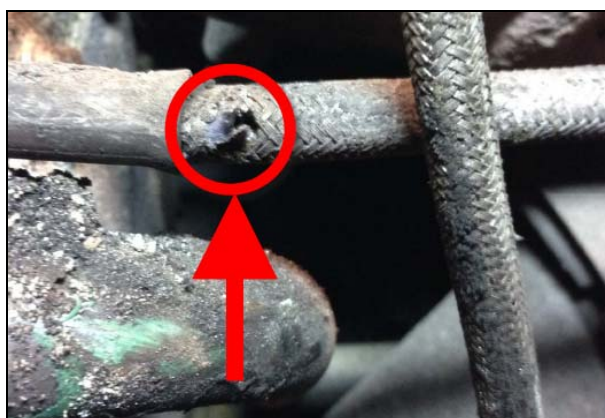
It was determined that rubbing between the air purge line (removed in Part 1) and the aftertreatment hydrocarbon doser hard fuel line may seriously damage the hard fuel line.

Perforation of the hard fuel line could result in spraying fuel onto hot exhaust components potentially resulting in an engine fire.

FIGURE 7: EXAMPLE OF DAMAGE ON THE HARD FUEL LINE BRAIDED SECTION CAUSED BY THE AIR PURGE LINE

2. If the hard fuel line braided section shows evidence of rubbing and is damaged (FIGURE 7), it must be replaced. In this case, refer to PART 3 of this Safety Recall.

Given the risks associated with the replacement and installation of fuel line located close to hot components such as turbocharger, you must make an appointment in a PrevoSt Service Center or PrevoSt Certified Service Provider to have the hard fuel line replaced free of charge, if the inspection performed in PART 2 revealed that the hard fuel line is damaged.
