**MAINTENANCE  
INFORMATION**

**MI16-31**

DATE :	OCTOBER 2016	SECTION :	18 - Body
SUBJECT :	LATCH REPLACEMENT ON LUGGAGE DOORS

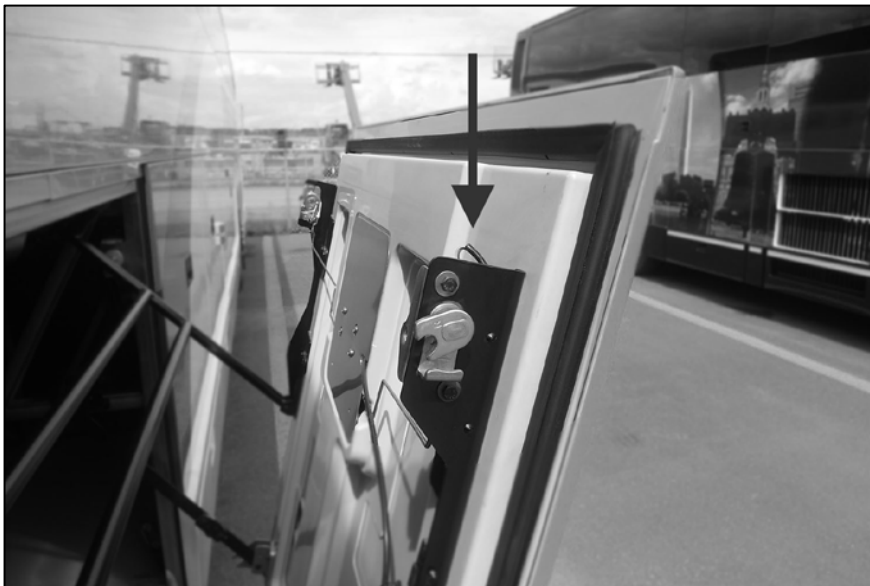
**Figure 1: Luggage door**

1. On the vehicles, locate the luggage doors. Open each door and find the lock assembly with micro switch. (Figure 1)
