PREVOST

WARRANTY BULLETIN

WB16-35A

DATE :	OCTOBER 2016	SECTION :	18 - Body
EXPIRATION:	OCTOBER 2018		
SUBJECT:	LATCH REPLACEMENT ON WHEELCHAIR LIFT ACCESS DOOR

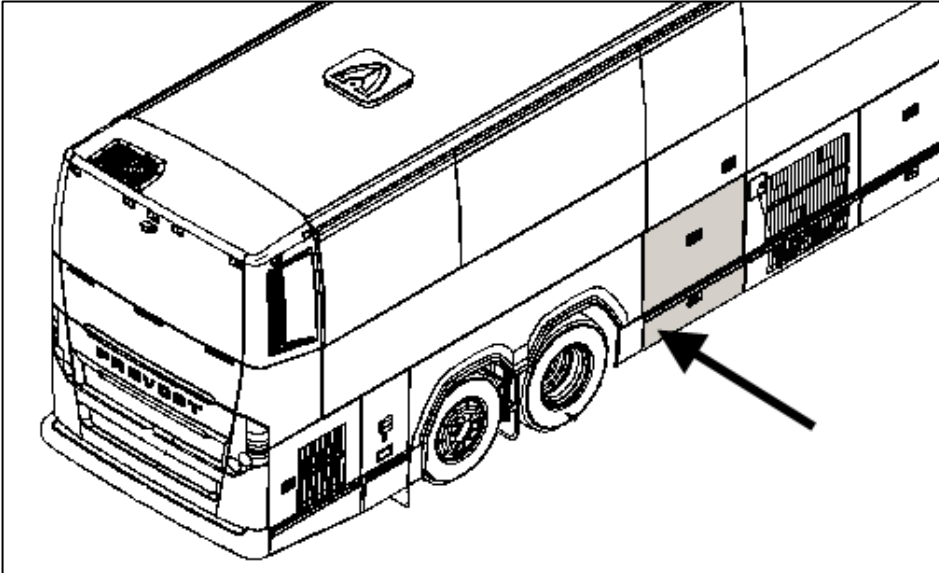
Figure 1: WCL access door

1. On the vehicles, locate the wheelchair lift access door.
2. Open the door. The latch assembly with micro switch is located in the lower left corner.

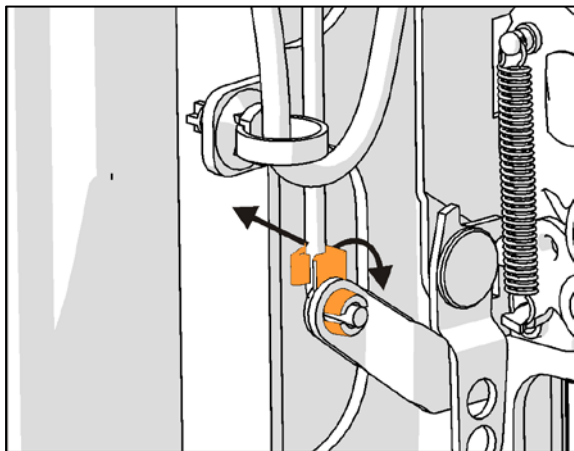
Figure 2: Control rod clip

Release clip by rotating it away from rod.
(Figure 2)

Then pull control rod out of clip. Remove clip
from latch lever. Discard clip.

8. Install clip 780340 on latch lever. Slide rod in
clip. Rotate clip on rod.

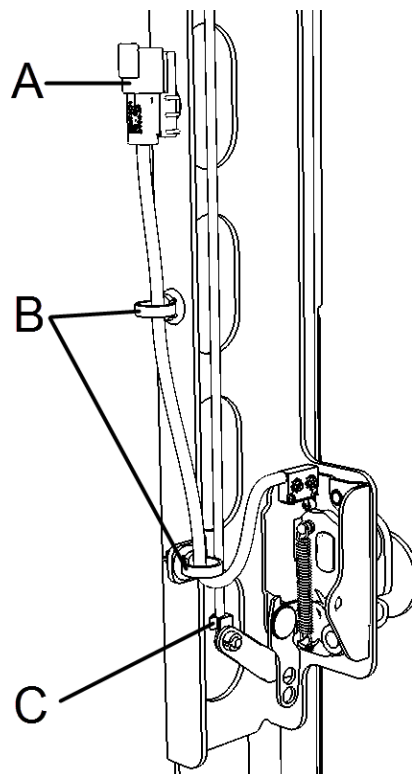
Figure 3

3. Prepare latch for disassembly. (Figure 3)

A Unplug the connector

B Cut the cable ties

C Release clip from control rod.

6. Plug connector to door harness (A, Figure 3)

7. Secure cable with new cable ties.
(B, Figure 3)

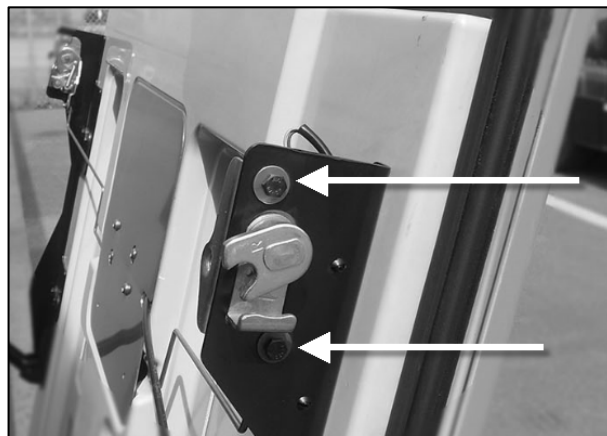
Figure 4

4. Remove the latch assembly
(Two screws). Discard hardware. (Figure 4)

5. Install the new latch with new screws
5001697 and washer **5001608**.

Tighten screws to **7 lb-ft**.
