**SAFETY
RECALL**

SR17-05A

DATE :	March 2017	SECTION : 14 STEERING
SUBJECT:	STEERING ARM CRACKING ISSUE

REVISION : A
08/14/2017

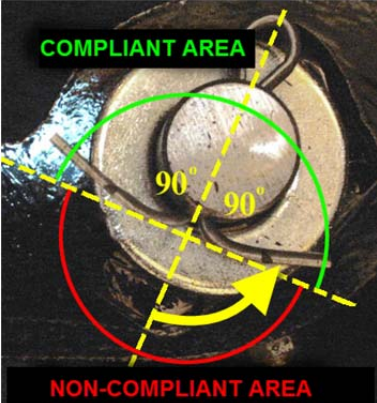
<p>Prongs must be bended at an angle of 90° or more</p>	<p style="text-align: center;">ACCEPTED</p>

The cutter pin prongs should be bended 90° or more to insure proper locking effect (see pictures below). The cutter pins should not be used twice or bended in such a way that they become ineffective.

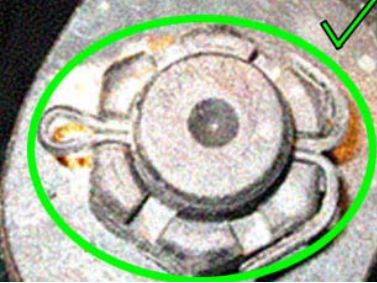
<p>Assembly on castellated nut</p>	<p style="text-align: center;">ACCEPTED</p>

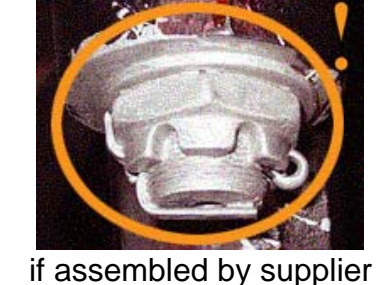
<p style="text-align: center;">if assembled by Prevost</p> <p style="text-align: center;">ACCEPTABLE</p>
