PREVOST

**SAFETY
RECALL**

SR17-28D

DATE :	December 2017	SECTION :	18 BODY
SUBJECT:	FUEL TANK CRADLE HARDWARE

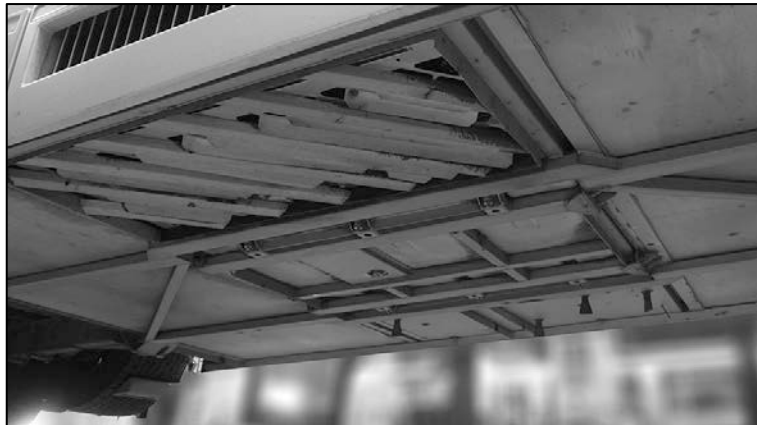
Figure 1: Vehicle Lifting

1. Raise vehicle with safe lifting equipment.
