MAINTENANCE INFORMATION

MI18-37

SUBJECT: LANG KK73.1 ELECTROMAGNETIC CLUTCH

Prevost coaches, from year model 2014, with the Bitzer air conditioning compressor

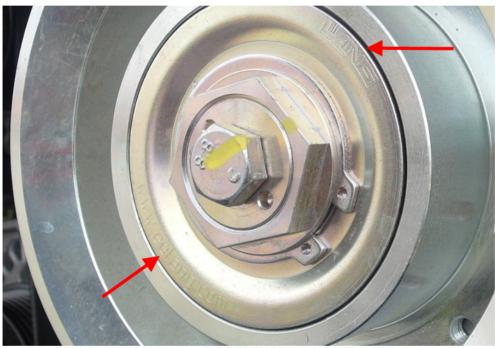
Figure 1: "LANG" & "WWW.EALANG.COM" ENGRAVED ON THE HUB

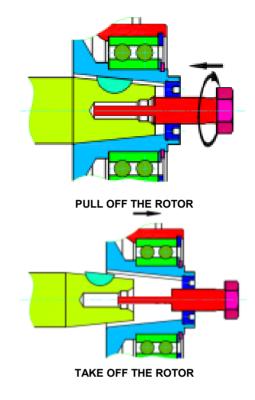
PULLING OFF THE ROTOR

4) Pull off the rotor with the extractor tool. Due to the back pressure, the rotor detaches from the shaft end (7, Figure 2) of the compressor.

DO NOT USE AN IMPACT WRENCH

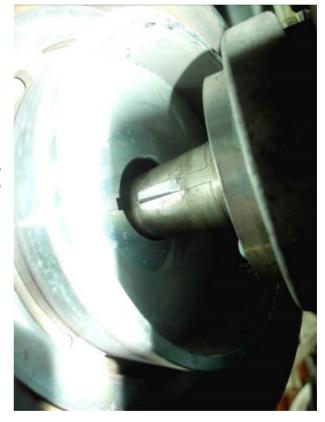
SLIPPING THE ROTOR

6) Carefully mount the rotor on the shaft end by hand.

Never use a hammer for pressing the rotor on.

To avoid damaging the bore of the rotor, feel the engagement of the key in the keyway and slip the rotor on the shaft end of the compressor till reaching the stop.

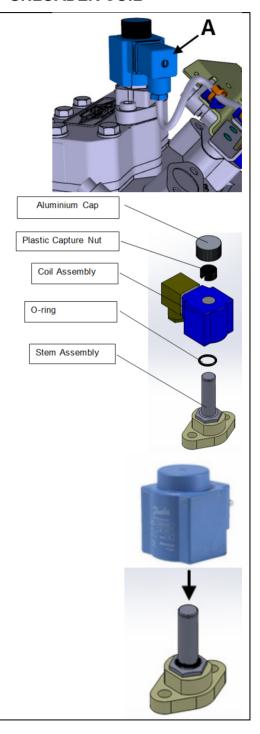
HOW TO INSTALL A NEW "CLIP-ON" UNLOADER COIL

- Loosen the screw securing the connector to the coil and then unplug the connector (A). Keep the screw and the connector rubber gasket for later use.
- 2. Unscrew the aluminum cap and discard.
- 3. Remove the plastic capture nut and discard.
- 4. Remove the coil and discard
- 5. **Keep the O-ring** on the stem.

- 6. Install the new clip-on coil on the stem.
- 7. Slide the coil over the stem assembly with the O-ring at the base of the stem.
