PREVOST

**SAFETY
RECALL**

SR19-42

DATE :	November 2019	SECTION :	06 ELECTRICAL
SUBJECT:	POTENTIOMETER INSTALLATION

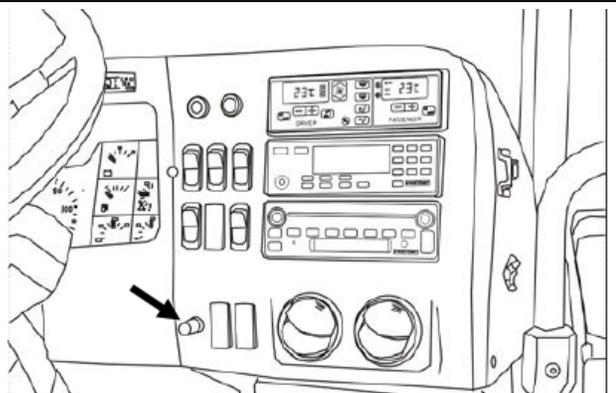
1. Remove the rubber cap installed over the potentiometer opening in the dashboard.

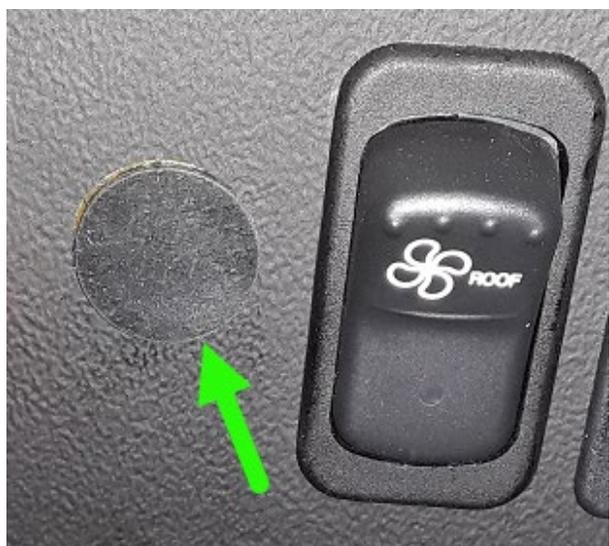
2. Remove the dashboard cover.

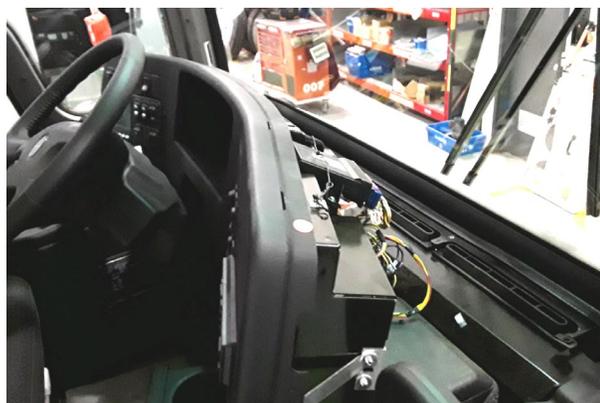
3. Under the dash, unscrew and move away (do not disconnect) the AE55 I/O-EA module installed over the potentiometer area.

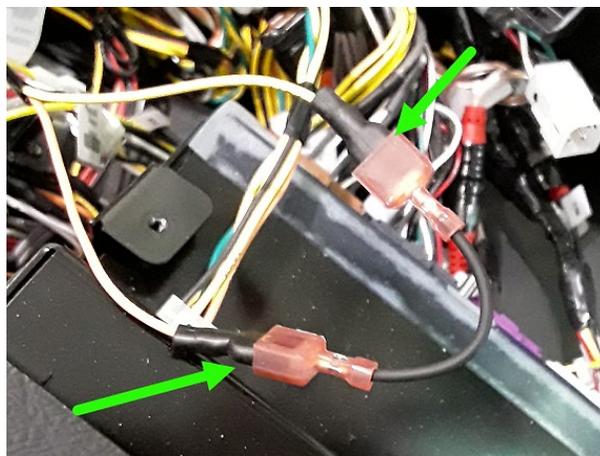
5. Replace the Pot1 terminal.

- Cut the Pot1 wire factory terminal and splice the wire end.
- Install (crimp) the supplied smaller **562291** terminal to the spliced end of the Pot1 wire.

- Install the supplied **562499** shrink tubing over the new connector (metal/spade part of the connector must be entirely covered).

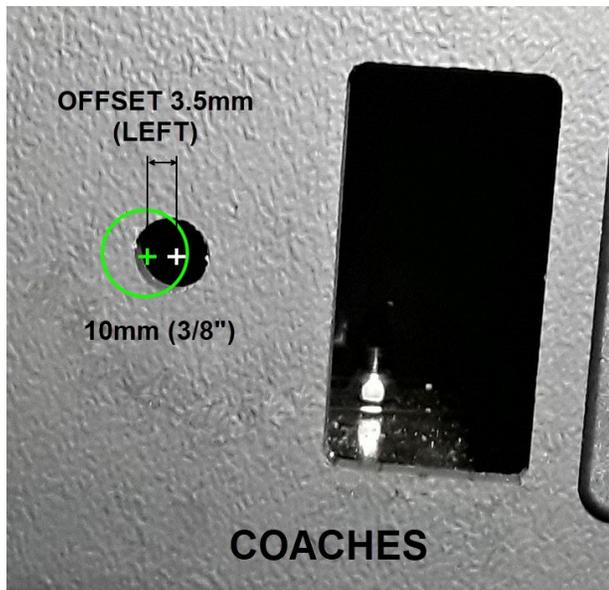
H3-45 & X3-45 vehicles: If present, remove the dash switch next to the potentiometer opening.

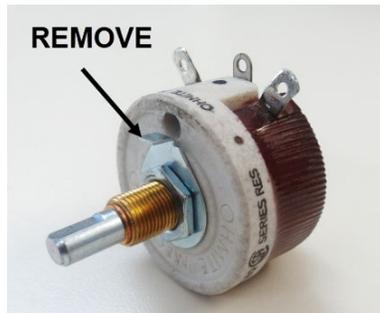
- Connect the Pot1 wire (smaller terminal) to the potentiometer center tab (carefully bent the center tab 45deg).

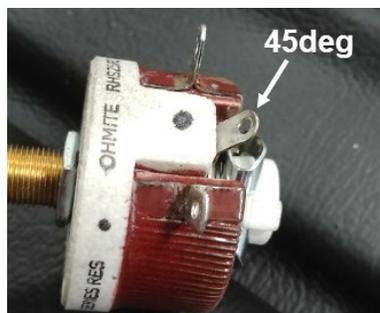
- Connect the A55J1.1 wire to the lower right tab (viewed from front, knob side as shown).

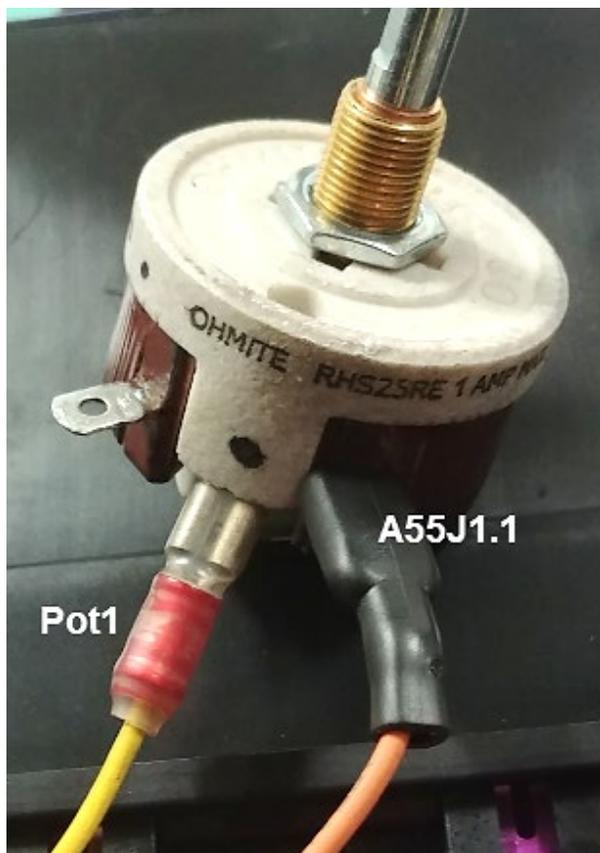
8. Install the potentiometer on the vehicle dashboard.

- Insert the potentiometer in the dash opening (connectors pointing down).
- Secure the potentiometer to the dash using the supplied locknut.
- H3-45 & X3-45 coaches: Reinsert & reconnect the rocker switch next to the potentiometer & check for correct clearance.

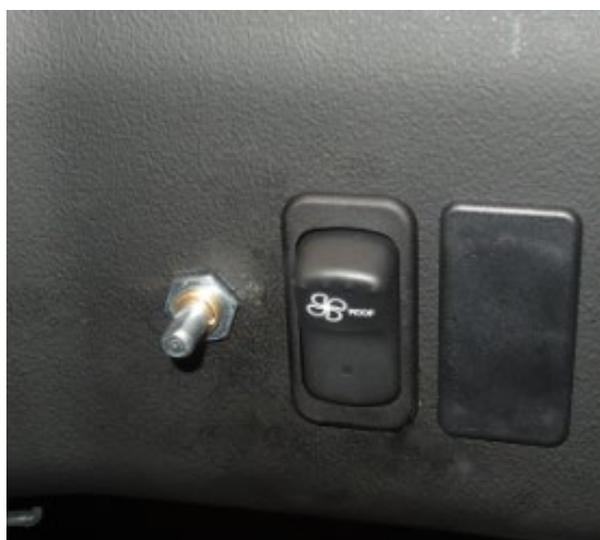
There must be at least a 1.5mm (1/16in) gap between the rocker switch and the potentiometer body.

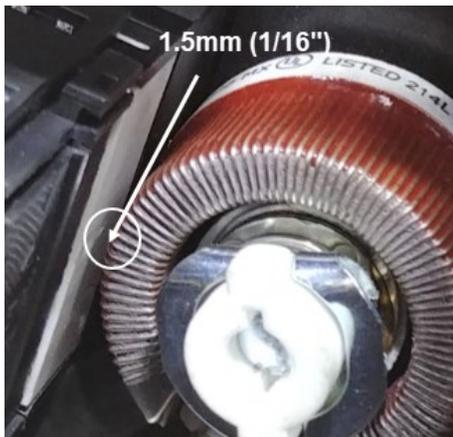
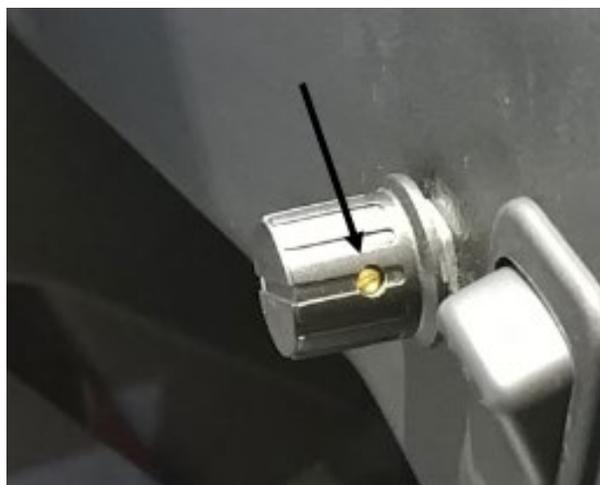
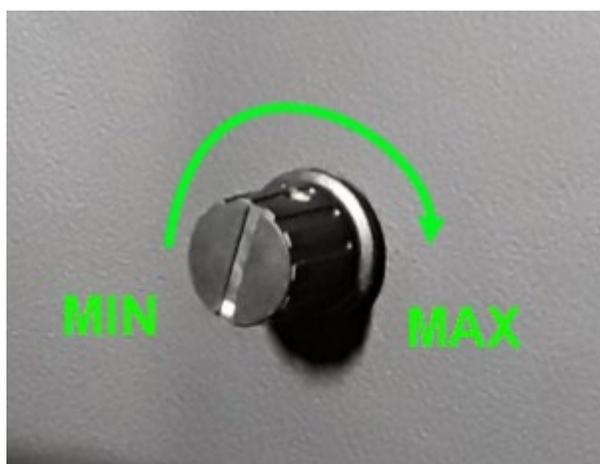
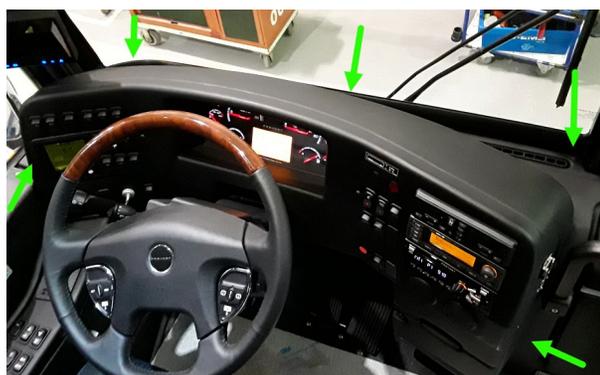
- Install the potentiometer knob (secure with the small locknut on the side of the knob).
- Connect the vehicle power & turn the lights on to validate that the potentiometer is working properly.
- Make sure that there is sufficient obscurity inside the driving area and watch for a dimming effect on the panel switches, radio & cluster display.
- Make sure that the knob pointer travel is correct (pointer is at the lower left at the low setting and lower right at the max setting).
- Reinstall the AE55 I/O-EA module and the dash cover.
