# SAFETY RECALL

## SR22-13

| SUBJECT: | DRIVER SEAT REPLACEMENT WITH<br>RECARO 3-POINT BELT DRIVER SEAT | |

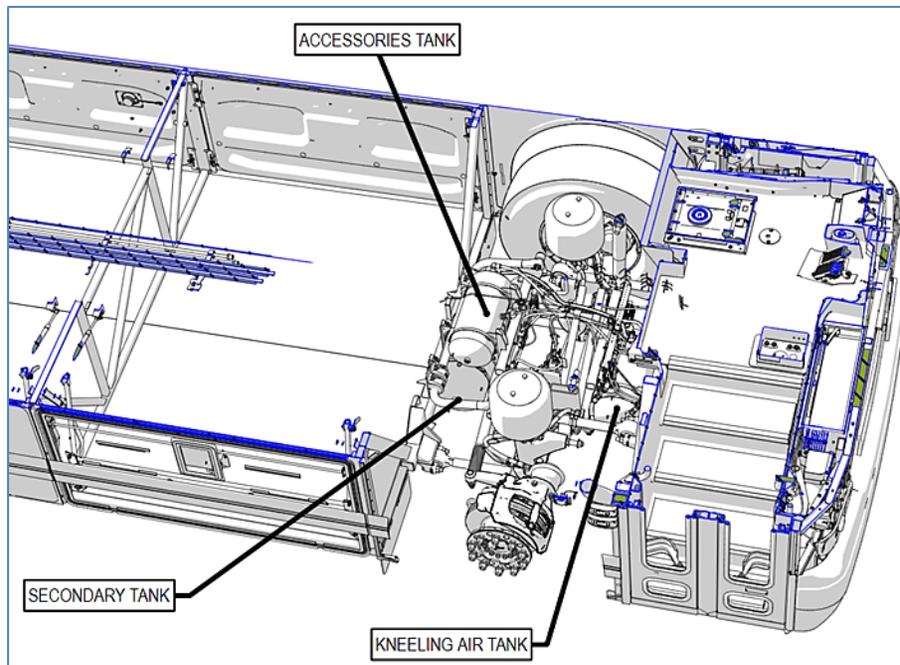
Figure 1

2. Drain the air from the Accessories tank. This tank is found above the secondary air tank. It is provided with a bottom drain valve.

3. Close the drain valve once done.

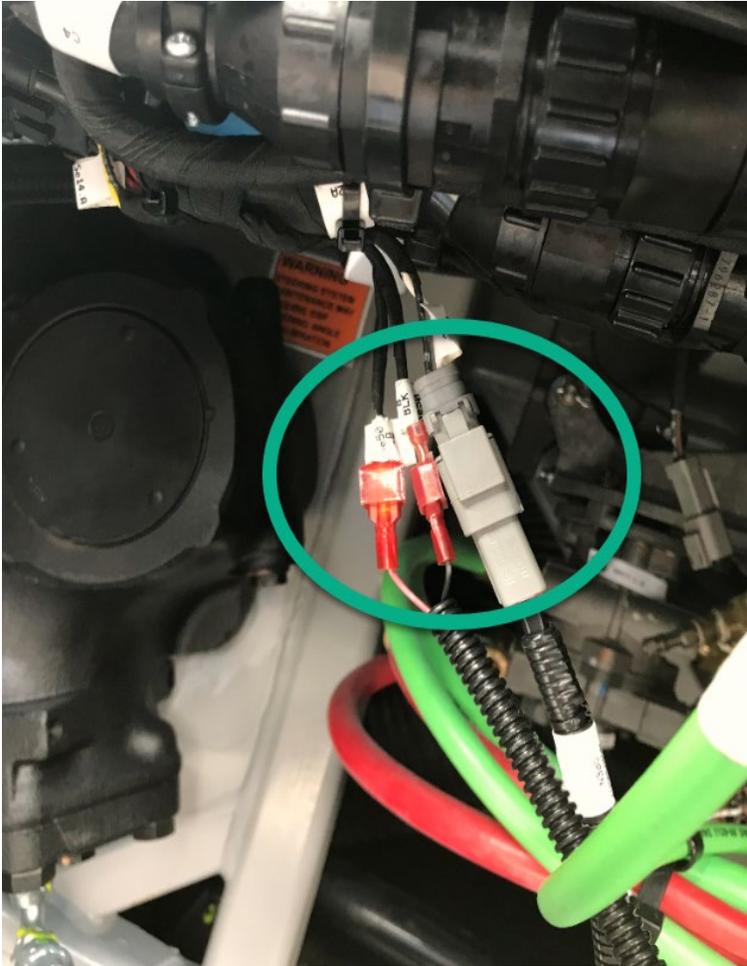
Figure 2

4. In the front service compartment, disconnect the driver seat harness.

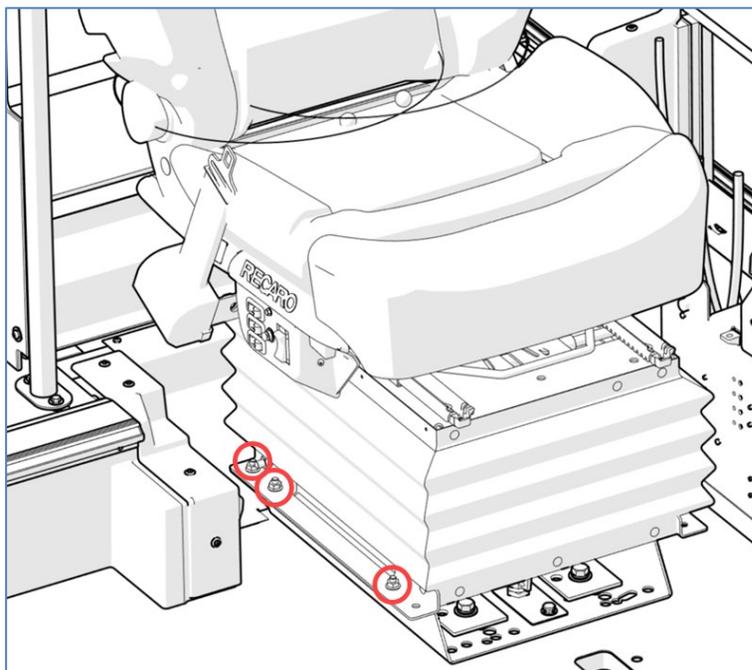
Figure 4

6. Unscrew and remove 6 screws attaching the seat to the riser (3 screws per side). Note if torque seal marks are present.

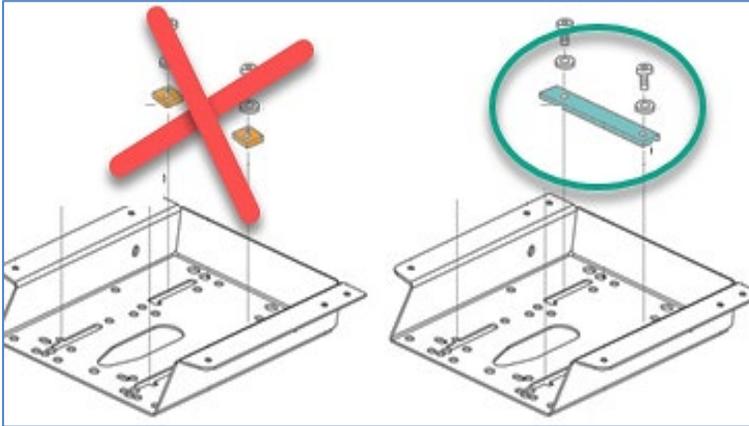
Figure 5

8. Replace the 2 backplates securing the riser with the long bar supplied with the new seat.

***Torque to 38 lb-ft***

***apply torque seal marks***

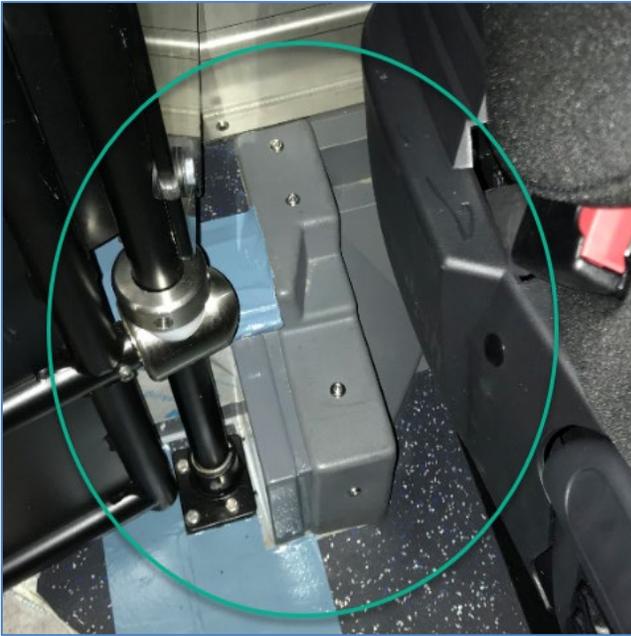
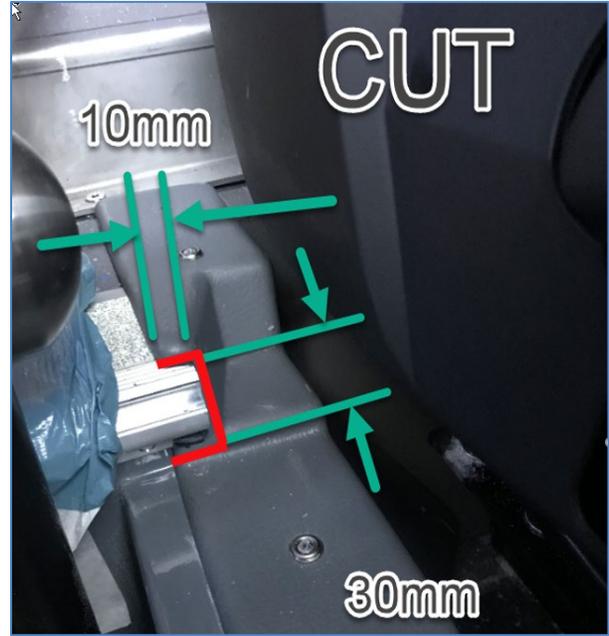
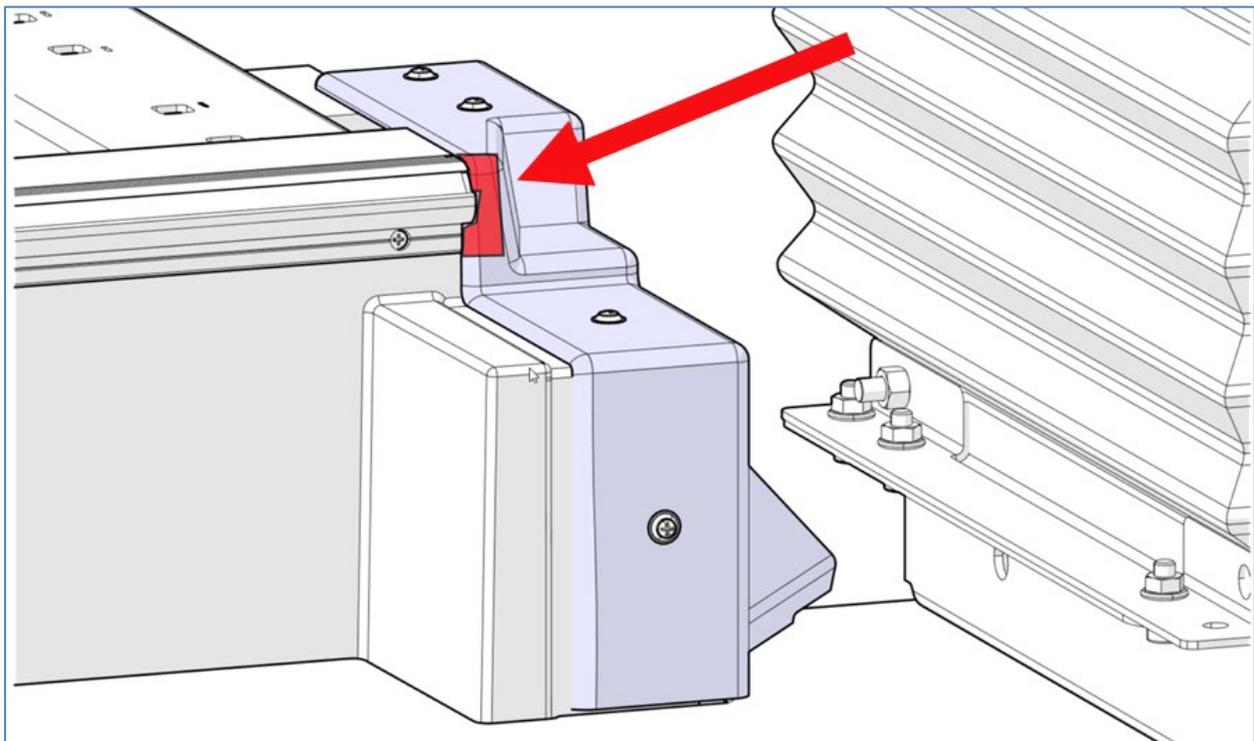
9. Remove the aisle stairs cover and cut a part of it as shown.

Dimensions to cut: about 10 mm X 30 mm

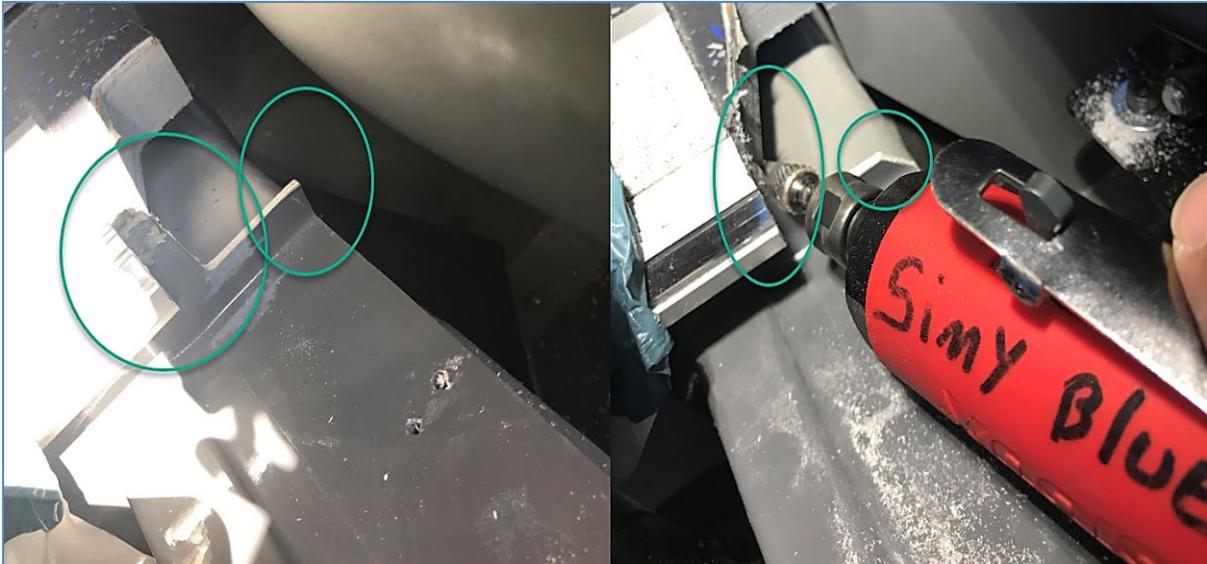
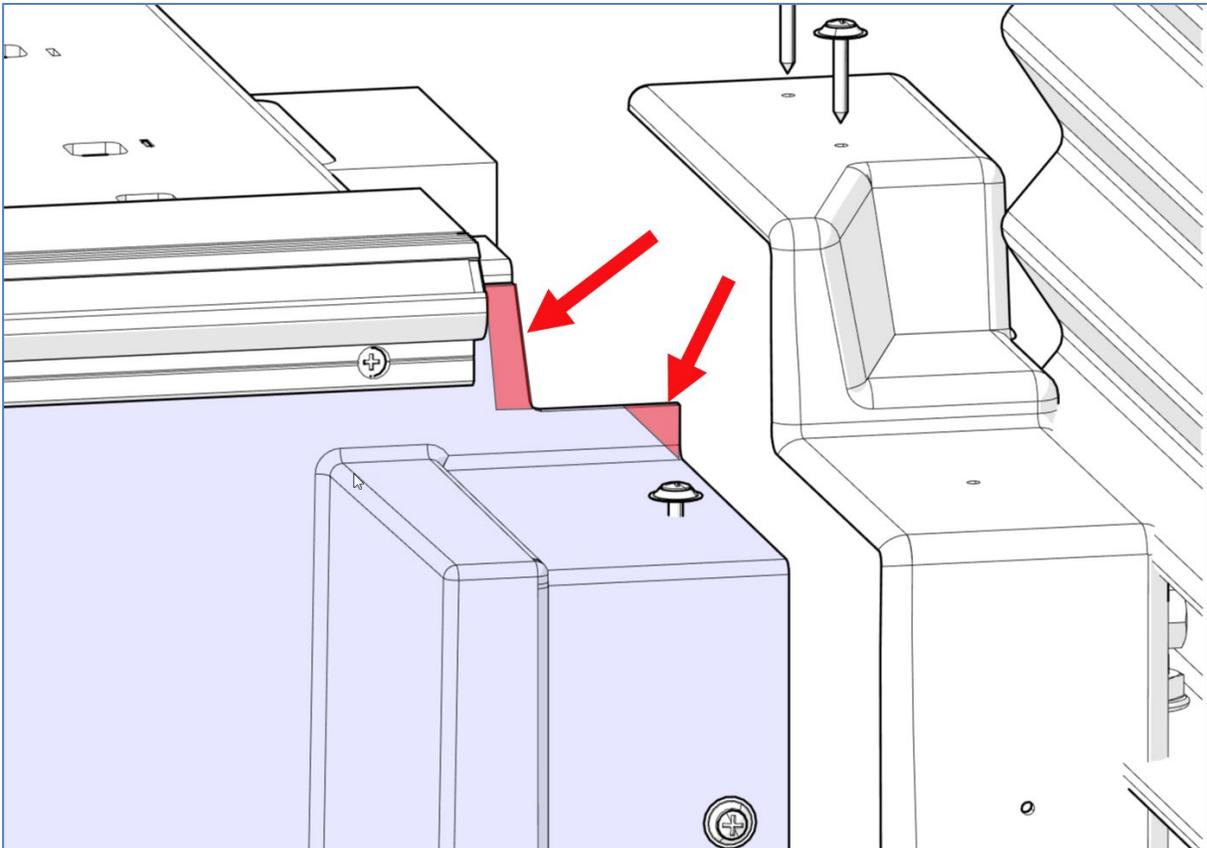
10. Cut fiberglass on the stairs as shown. The goal is to reinstall the cover as far as possible towards the entrance door so to leave a greater clearance between the seat and the cover.

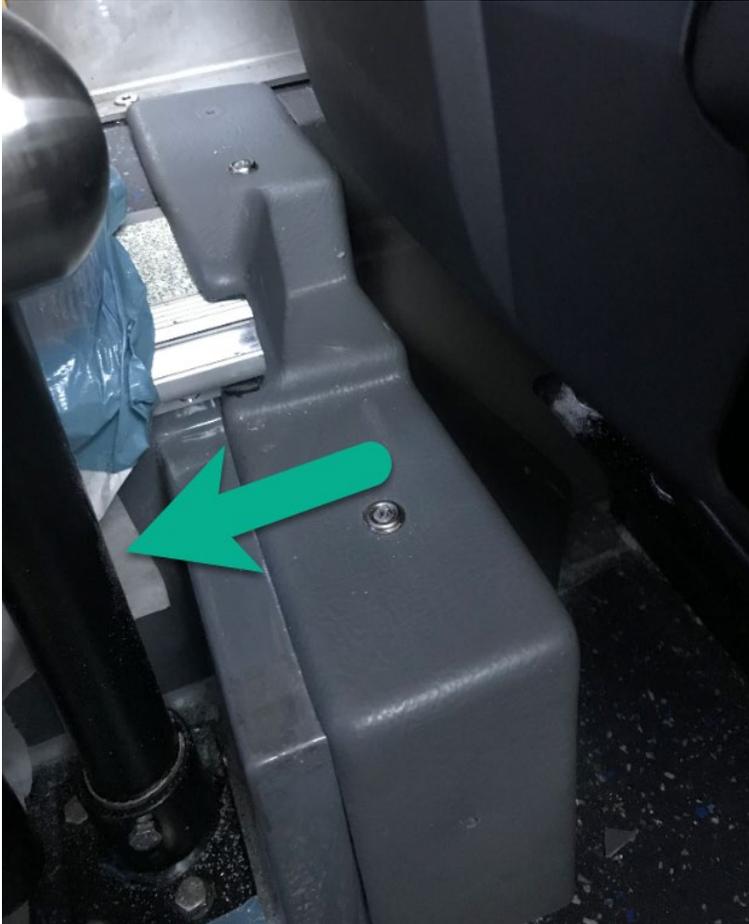
Figure 11

11. Reinstall the cover as far as possible towards the entrance door. Take note that the cover is now over the step and lean on the edge of the aluminum molding.

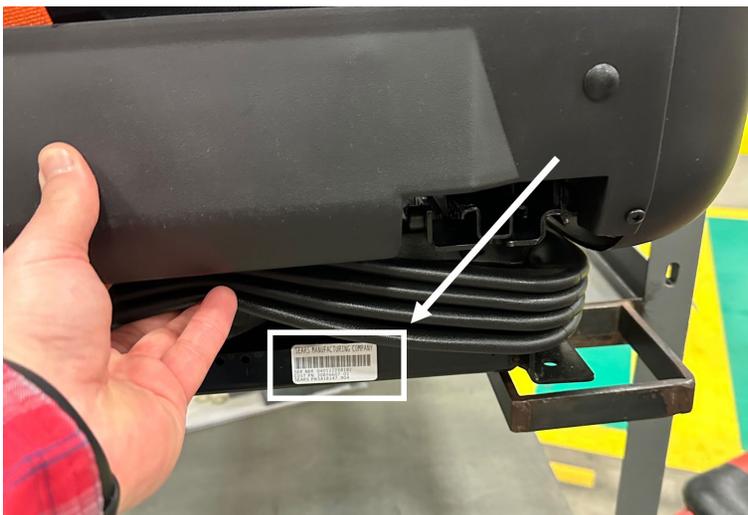
12. Record the serial number of the new seat and the VIN of the vehicle in which it is installed.

Figure 12: SERIAL NUMBER LOCATION

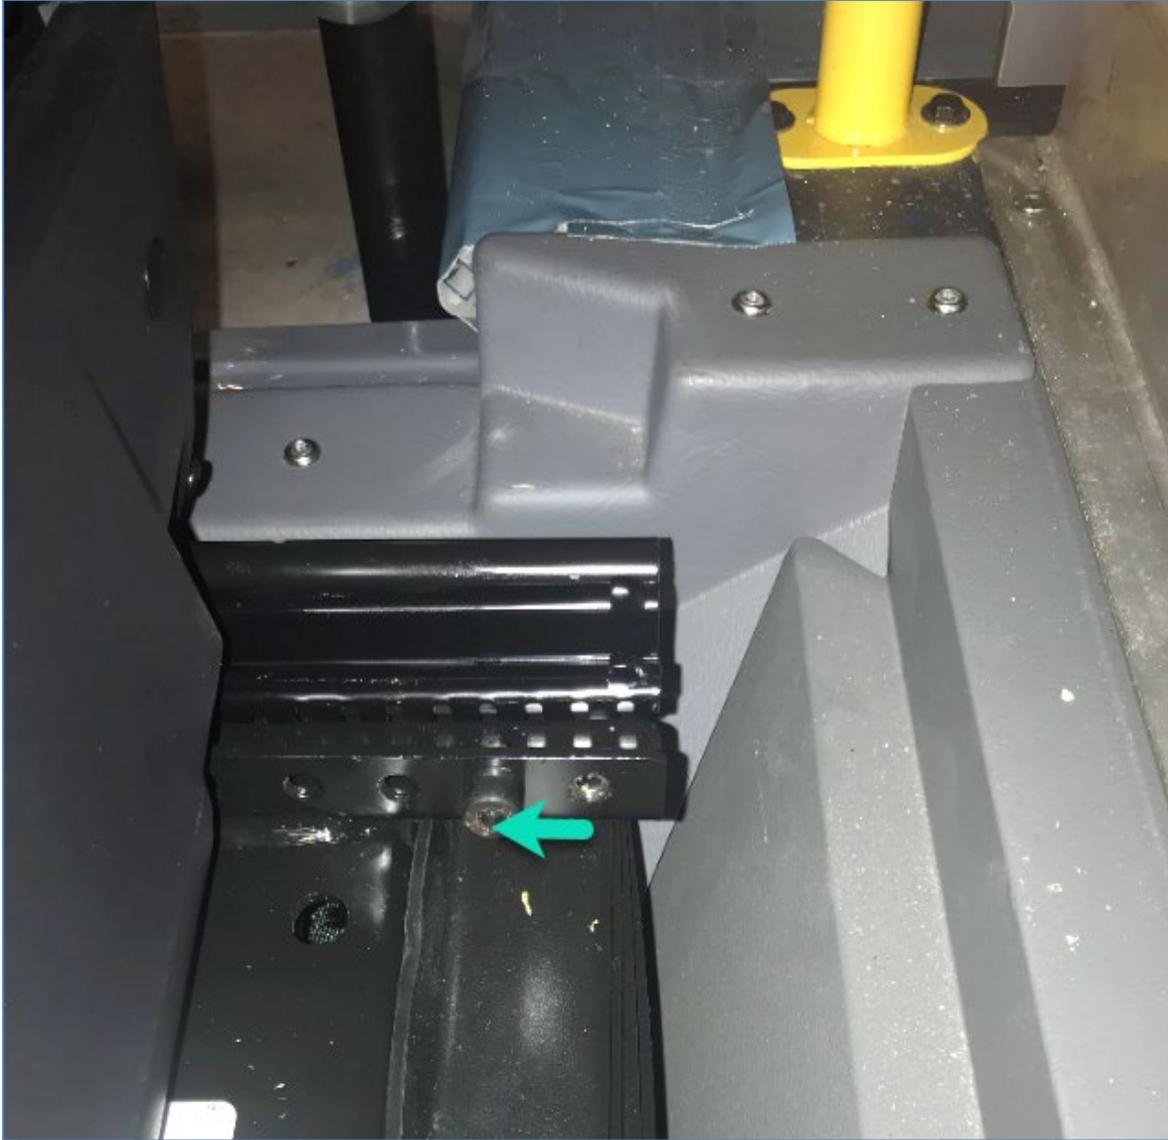
Figure 13

13. Before moving the new seat in the vehicle, relocate the stopper screw to the second hole (right rail, curb side, at the back of the seat).

***Torque to 8 lb-ft***

***Apply torque seal marks if applicable***

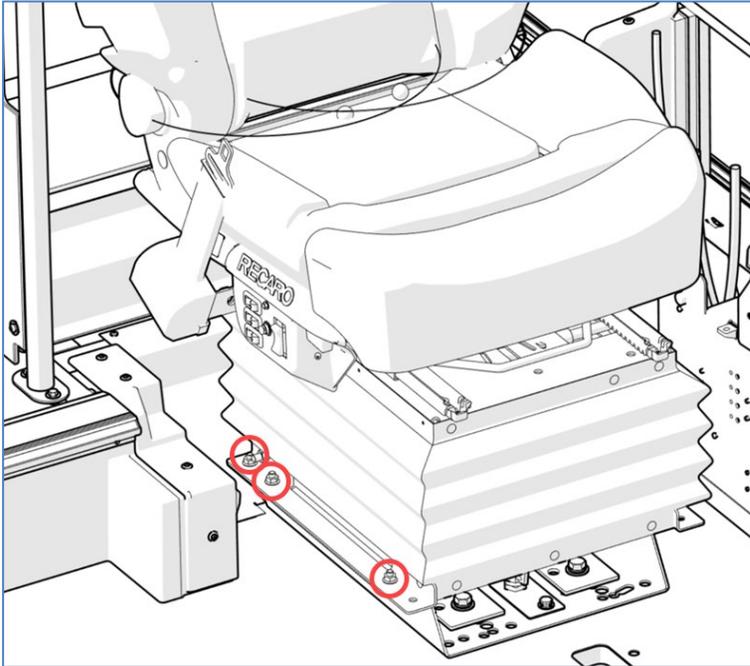
Figure 14

14. With the help of an assistant, install the new seat on the riser with the 6 screws previously removed. For aesthetic consideration, apply torque seal marks only if torque seal marks were present on the previous installation.

***Torque to 16.5 lb-ft***

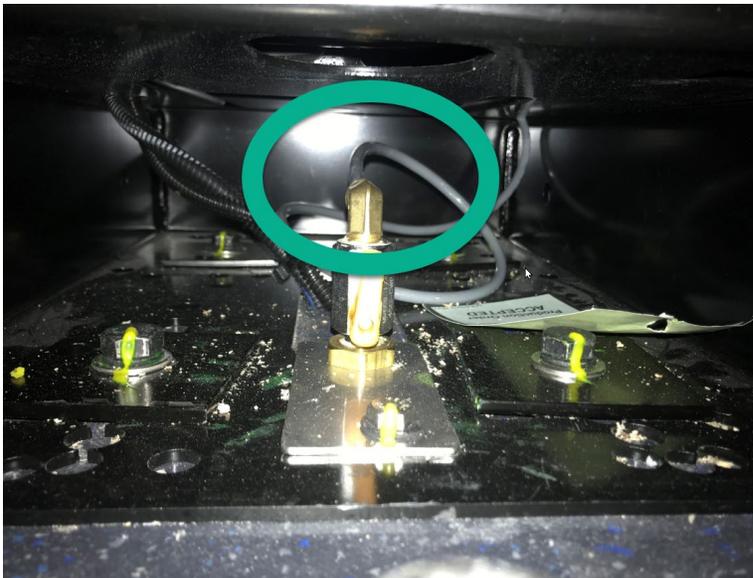
Figure 15

15. Under the seat, connect the seat air supply line from the push-in fitting.

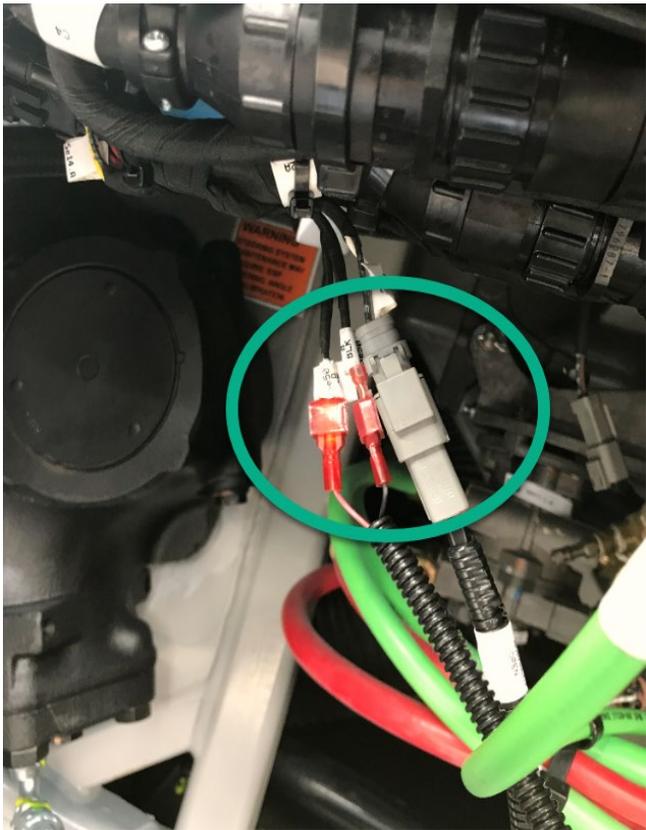
Figure 16

16. In the front service compartment, connect the driver seat harness, red, black and Open.
