WARRANTY BULLETIN

WB23-01

SUBJECT: IMPROPER VEC(F) POWER DISTRIBUTION

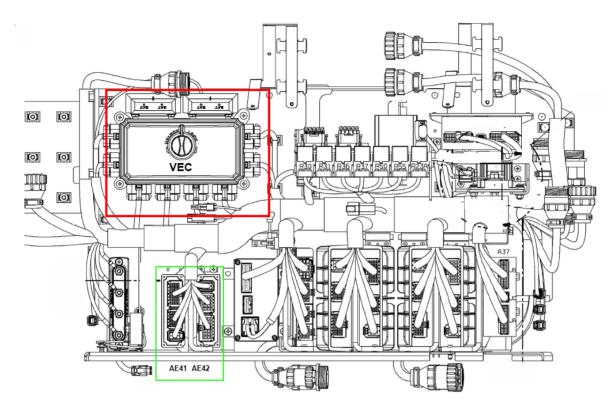
The vehicles affected by this bulletin may have been equipped with an improper front VEC unit, specifically, the multiplex modules AE41 & AE42 are possibly feed from the VEC with 12VD instead of 24V WUP.

Figure 1: VEC unit location in front junction box (also shown AE41 & AE42 affected modules).

- 1. Open the vehicle front electrical compartment (front junction box) and locate the VEC unit (figure 1).
- 2. Open the VEC cover and validate the **Prevost part number** located at the right of the unit (position 1 in figure 2) part number must be **560531**.
- 3. Power up the vehicle electrical system and check that:
 - F34 fuse is a 5A fuse (position 2 figure 2).
 - F34 fuse circuit is powered by 24V Wake-up (wake-up = must stay powered for 15 min after ignition shut-off).
- 4. If the VEC fails the tests at step 3, it must be replaced (order new VEC part # 560531).

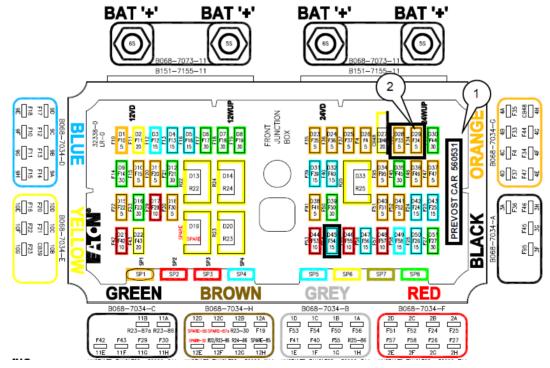
Figure 2: Prevost part number (1) and F34 fuse (2) position in VEC unit

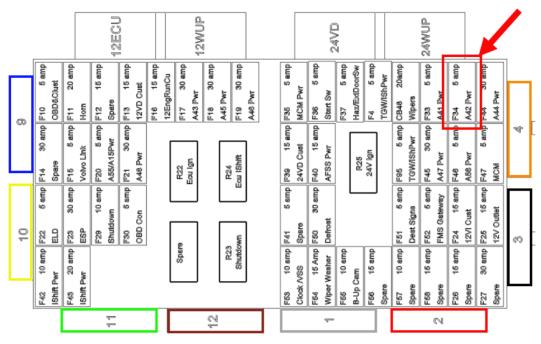
Figure 3: Other view of the F34 fuse position in VEC

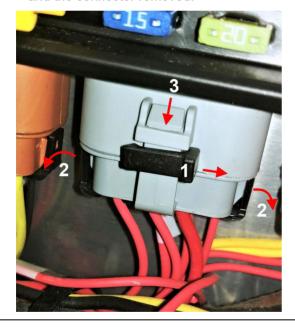
Each connector is secured using 3 different locking mechanisms

- 3. Disconnect the 8 connectors from the VEC
 - Remove the 4 lower connectors (from left to right: green, brown, gray & red).
 - Remove the 2 left connectors (blue top & yellow bottom).
 - Remove the 2 right connectors (orange top & black bottom).

- Lock 1 must be removed first (slide to right & do not lose).
- Lock 2 must then be disengaged on both sides of the connector.
- Finally the center lock 3 can be disengaged and the connector removed.

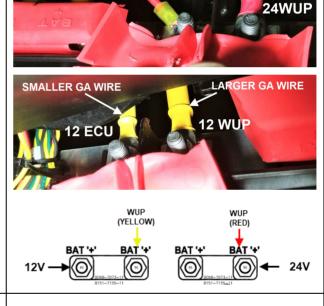
LARGER GA WIRE

SMALLER GA WIRE

24VD

- Reverse this procedure to install a new VEC module.
 - Make sure that the new module part number is 560531.
 - Make sure that the new module F34 fuse is 5A.
 - Make sure that the power cables are reconnected at their original location (VEC studs)
 - Yellows = 12V (left connection)
 - Reds = 24V (right connection)
 - WUP = larger GA wire (12 & 24V)
 - VEC screw connections torque

216 lb-in (24 Nm)

6. Once reinstalled, reset the power and check to make sure that there is 24V WUP at the F34 fuse.
