# PREVOST

## WARRANTY BULLETIN

**WB24-17**

DATE :	May 2024	SECTION :	18 BODY
EXPIRATION:	May 2026		
SUBJECT :	<b>REINFORCEMENT OF PVC PIPES FASTENING INSIDE BAGGAGE COMPARTMENTS</b>

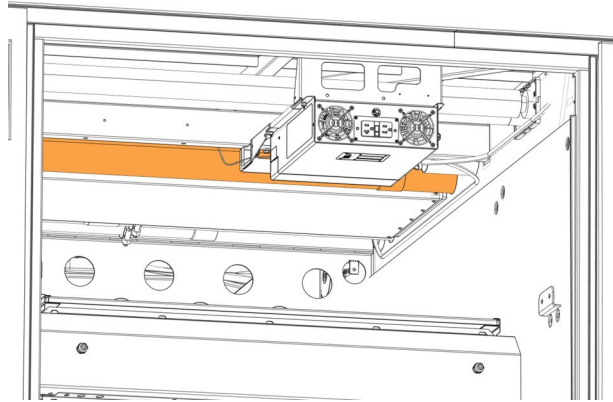
4. Locate the PVC pipe to be fastened at the top of the fifth baggage compartment.
