Service Bulletin A1-M1N-1729EN - Flywheel Ring Gear Wear / Damage

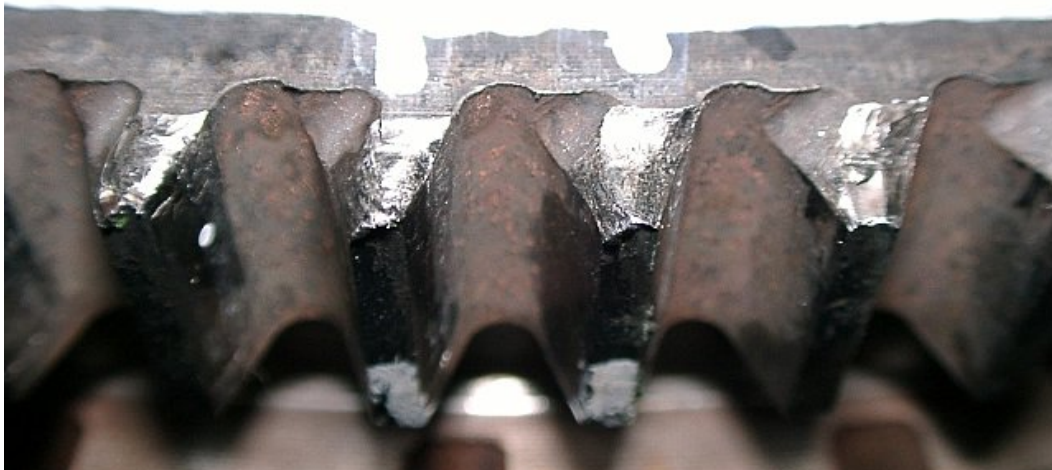
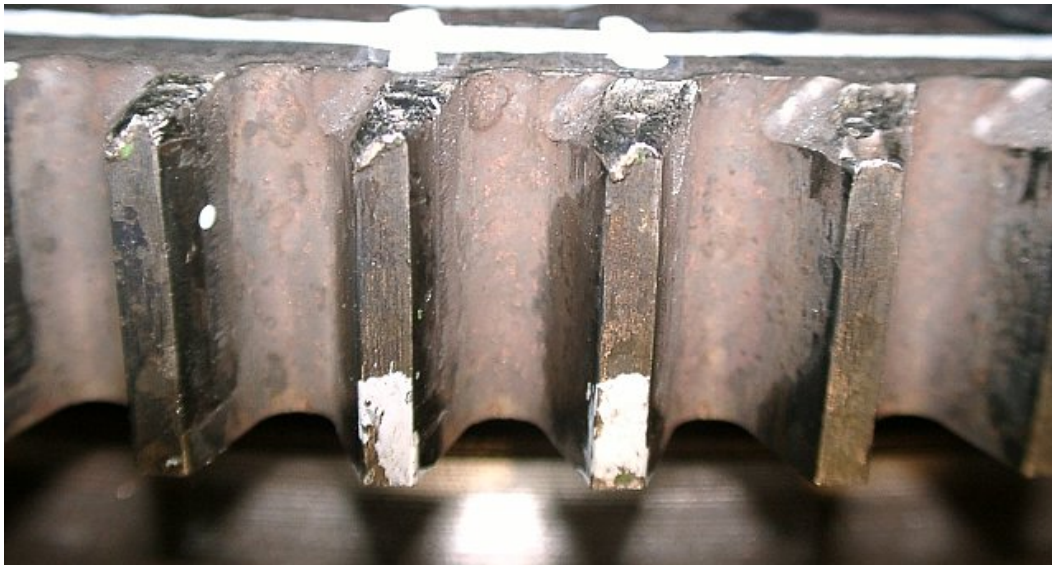
(Sample of Maximum Ring Gear Wear / Damaged)

Please refer to the above photos and please replace the ring gear which has similar level of damage as these. See the next page for the method to measure the depth of the damage.
