# PREVOST

## WARRANTY BULLETIN

**WB15-19I**

DATE :	OCTOBER 2015	SECTION :	22 - HVAC
EXPIRATION:	OCTOBER 2017		
SUBJECT :	<b>BITZER A/C COMPRESSOR VIBRATION – ADDITION OF A REINFORCEMENT BRACKET TO THE MOUNTING</b>

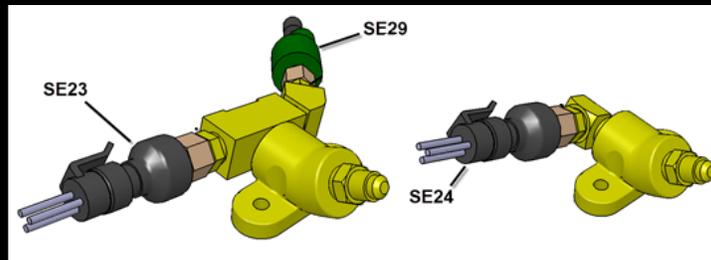
If bulletin WB14-06 has been completed, you should see on the engine curbside harness support two *fitting arrangements for pressure sensors and switches SE23; SE29 SE24.*

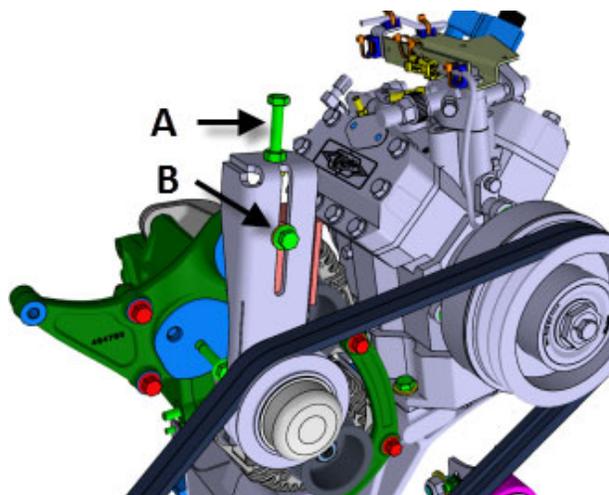
1. Loosen bolt (A).
2. Unscrew and remove bolt (B).
3. Remove the drive belt tensioner.
4. Remove the drive belts.

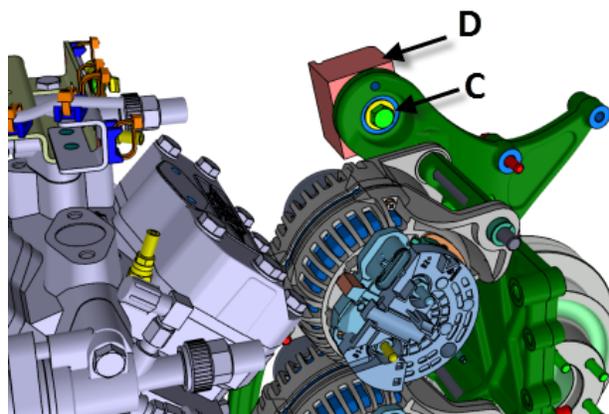
5. Unscrew and remove bolt (C).
6. Discard block (D).

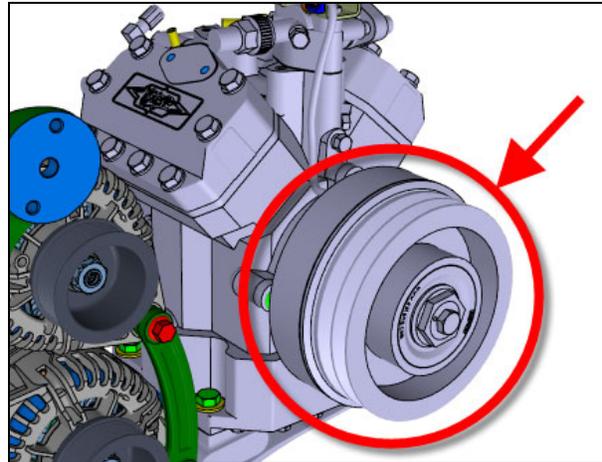
10. Remove the LANG electromagnetic clutch assembly.

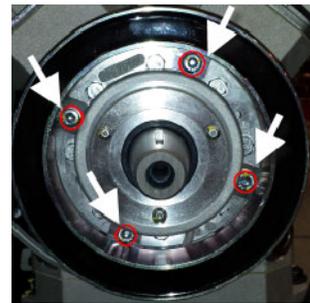
10.4. Loosen the fastening screws (4x) of the coil and pull the coil off the retainer.

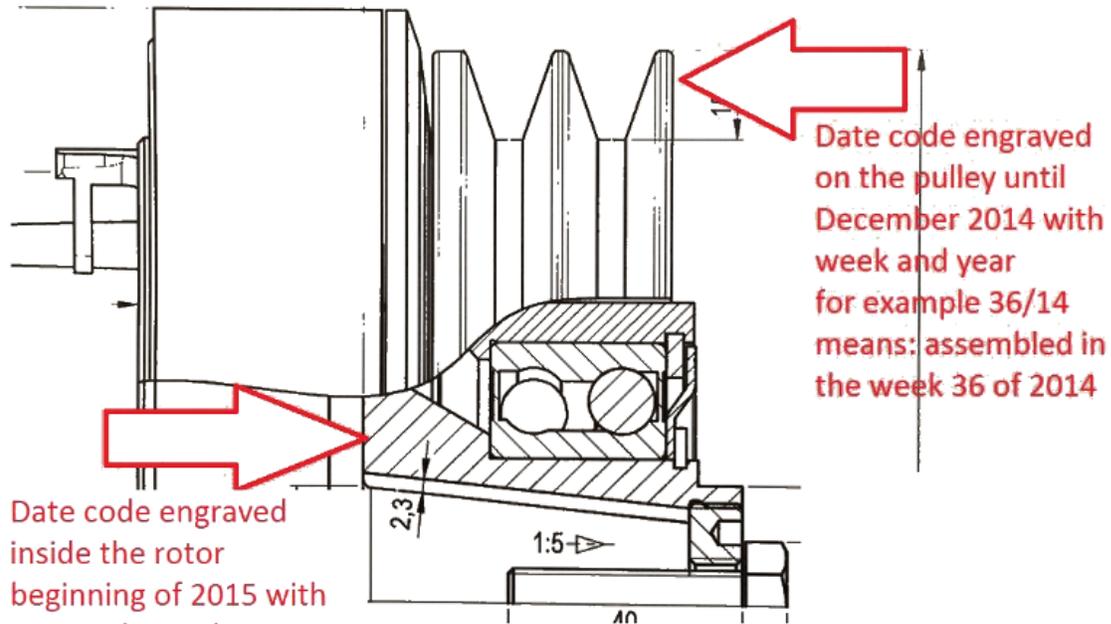
10.5. Check the date code on the clutch pulley. If it is before S05 (May 2015), install a new coil #950533 in replacement of this one.

Date code engraved inside the rotor beginning of 2015 with year and month for example S02  
S= 2015  
02= February

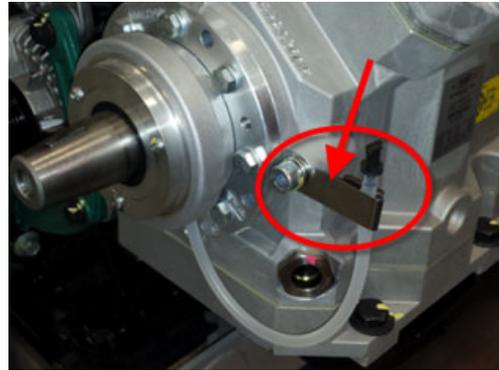
13. Install new reinforcement bracket #457675 as shown using previously removed hardware (bolt (C) and flat washer). DO NOT tighten at this moment.

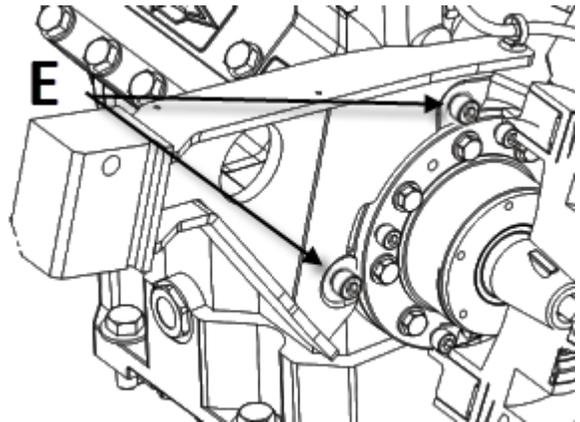
- 13.1. Carry on with the installation of new reinforcement bracket #457675 as shown. Use two "cylindrical head" socket cap screws #5001616 (E).

*Tighten to 40 lbf-ft (43 N-m)*

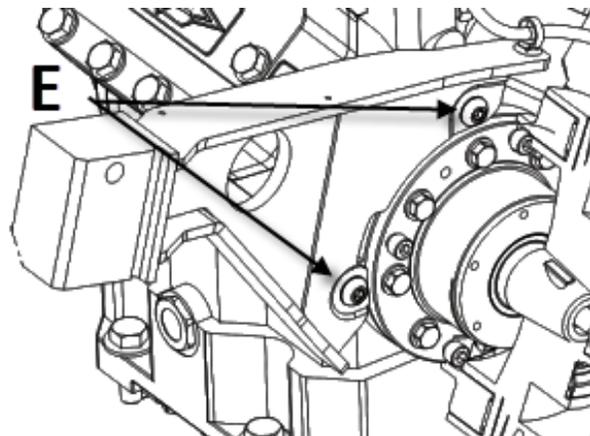
- 13.2. Carry on with the installation of new reinforcement bracket #457675 as shown.

- 13.3. Any standard bolt head would interfere with the coil body, therefore use two button head cap screws #502949 provided in the kit (E).

*Tighten to 32 lbf-ft (43 N-m)*

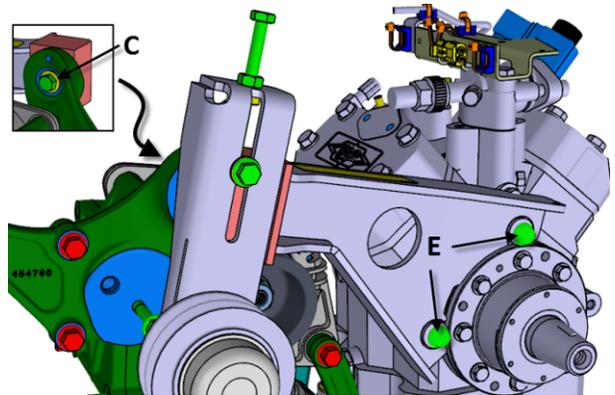
14. Tighten bolt in location (C).

**C = 74 lbf-ft (100 N-m)**

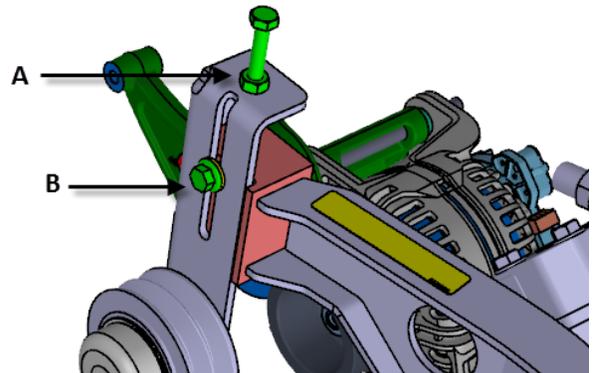
15. Reinstall tensioner, bolt and washer (B) and bolt and nut (A). You don't have to tighten these bolts as the belt tension adjustment will be done later in this procedure.

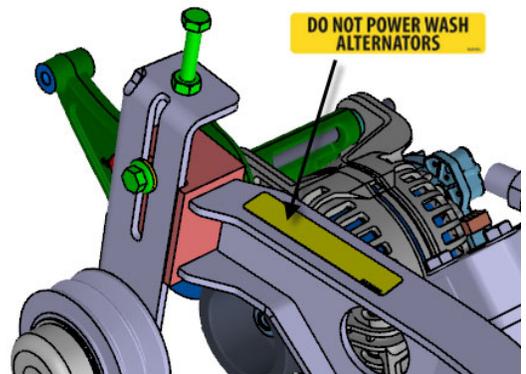
16. Apply decal #0610176 where indicated on the image.

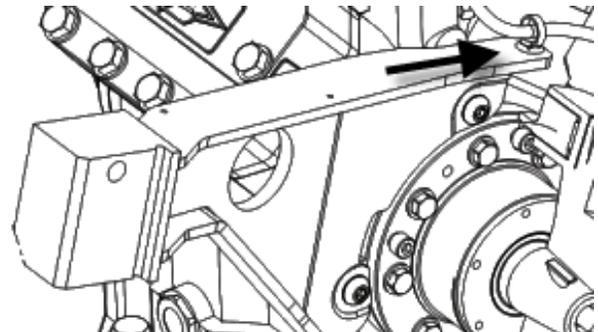
17. Install nylon tie mount #509815 where indicated on the image.

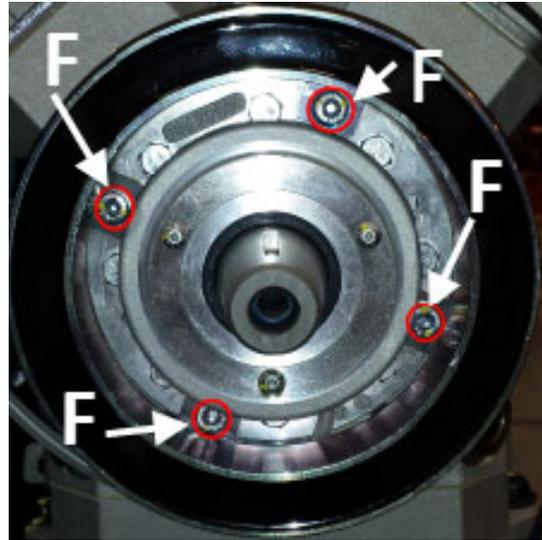
18. Reinstall the electromagnetic clutch coil. Position cable lead on the right side. Slip the coil on the retainer on the compressor flange. Fasten the coil with 4 screws to the compressor.

Coil mounting screws (F): **22 lbf-ft** (30 N-m).  
Use blue Loctite 243.

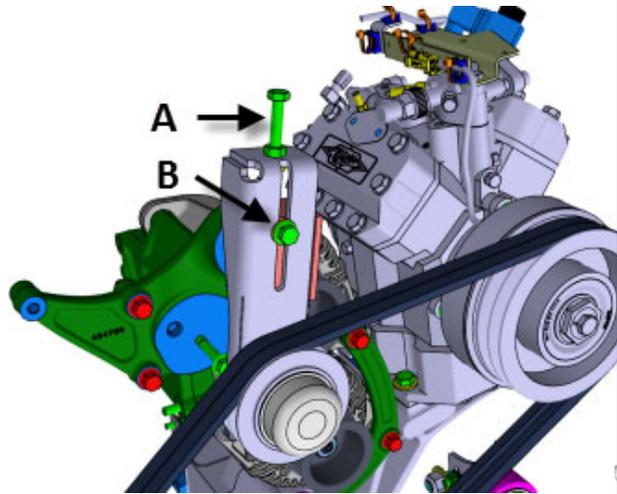
Hand-tighten bolt (B) Apply loctite on bolt (B)  
Adjust belt tension using bolt (A). Use the jam nut to prevent rotation of bolt (A). When proper tension is achieved, tighten bolt (B) to **43 lbf-ft.** (58 N-m)

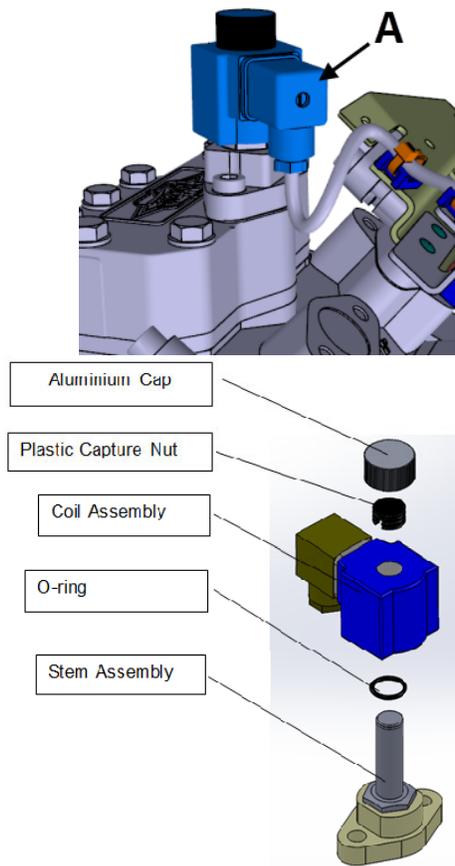
1. Loosen the screw securing the connector to the coil and then unplug the connector (A). Keep the screw and the connector rubber gasket for later use.
2. Unscrew the aluminum cap and discard.
3. Remove the plastic capture nut and discard.
4. Remove the coil and discard
5. **Keep the O-ring** on the stem.

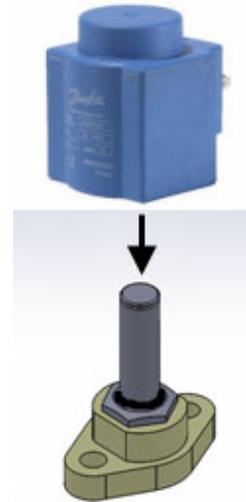
6. Install the new clip-on coil on the stem.
7. Slide the coil over the stem assembly with the O-ring at the base of the stem.

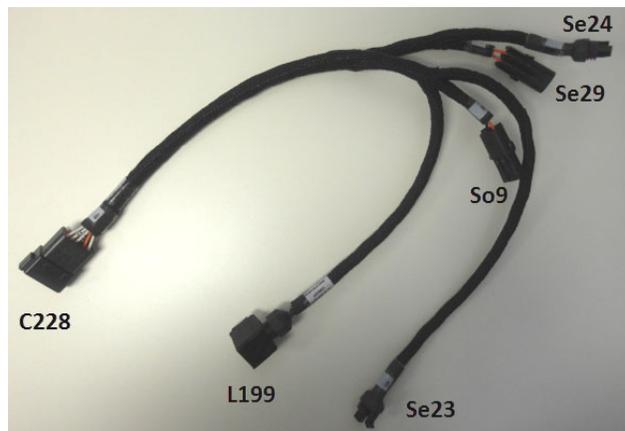
1. While proceeding with one connector at a time, remove the existing A/C compressor harness simultaneously as you install the new harness. The new harness should be installed and routed like the one being removed.

*So9: A/C electromagnetic clutch*

*Se29: A/C pressure switch*

*L199: the R.H. side cylinder unloader coil*

*Se23: high side pressure transducer*

*Se24: low side pressure transducer*

*C228: other C228 connector half*

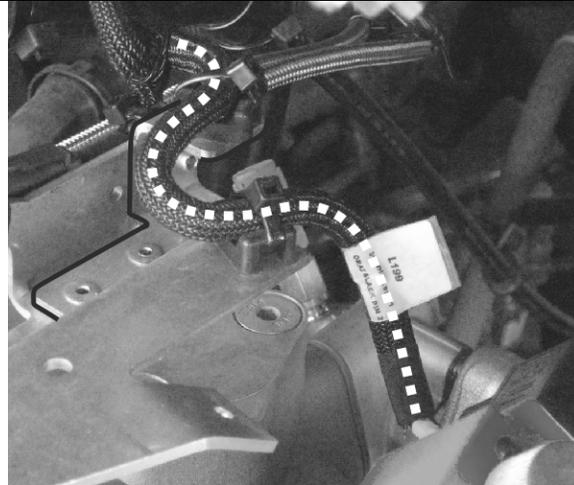
2. Install new harness **069206**. Connect **L199** to the unloader coil. Tighten the screw securing connector L199 to the coil.
3. Secure the cable on the cable tie mounts.

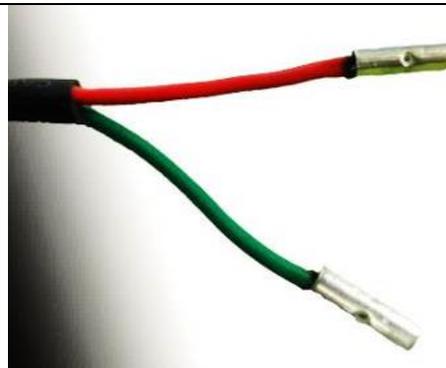
**Electromagnetic clutch connector So9. The clutch should be connected directly (hard wired) to the harness without using So9.**

4. Write down wire color matching then cut the clutch connectors **So9** on harness and compressor.
5. Slip shrink tube #062490 over each wire. Slip an additional shrink tube over cable insulation.
6. Refer to table below if required to match wire colours. (According to VIN of vehicle).

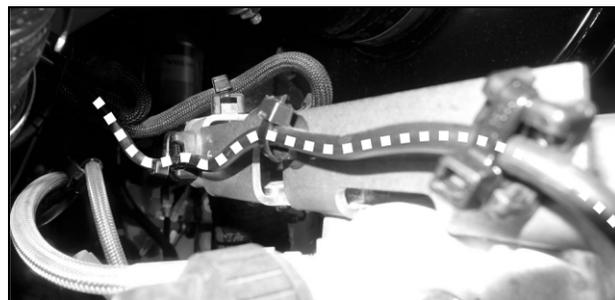
7. According to table, splice wires with butt slice #562228. Crimp and solder. Inspect to make sure you have a good crimp and solder.
8. Seal each wire with shrink tube. Seal over the two wires and cable isolation with shrink tube.
9. Attach clutch cable along bracket as shown.

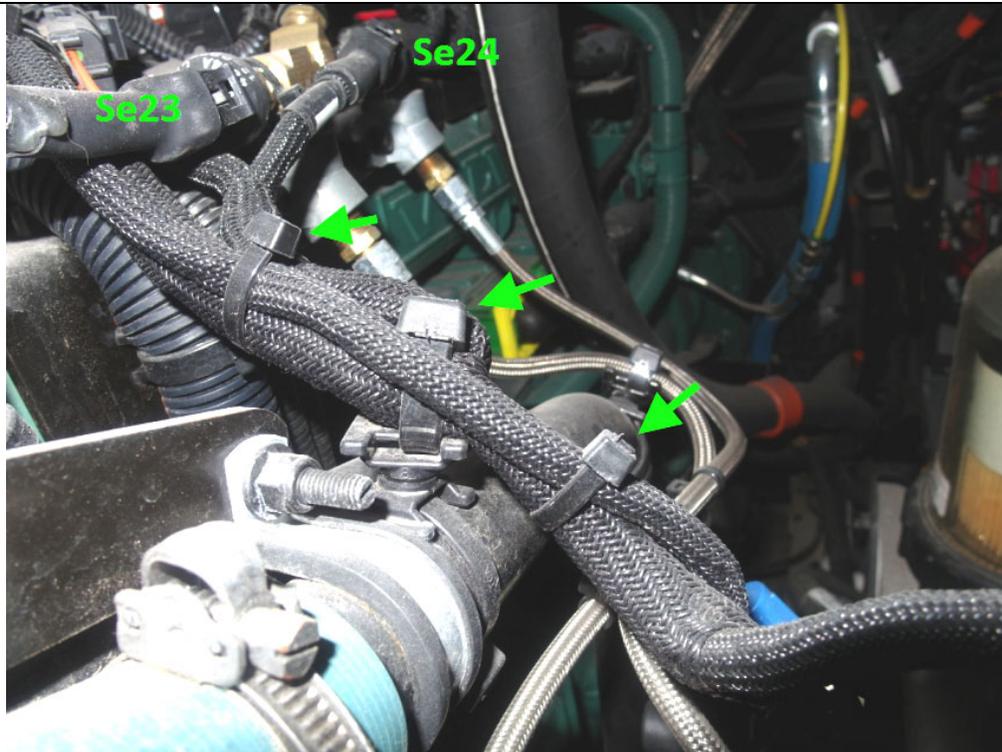
ATTACH THE EXCESS LENGTH OF CABLE ALONG MAIN STRAND OF HARNESS AS SHOWN- NYLON TIES LOCATION SHOWN BY ARROWS

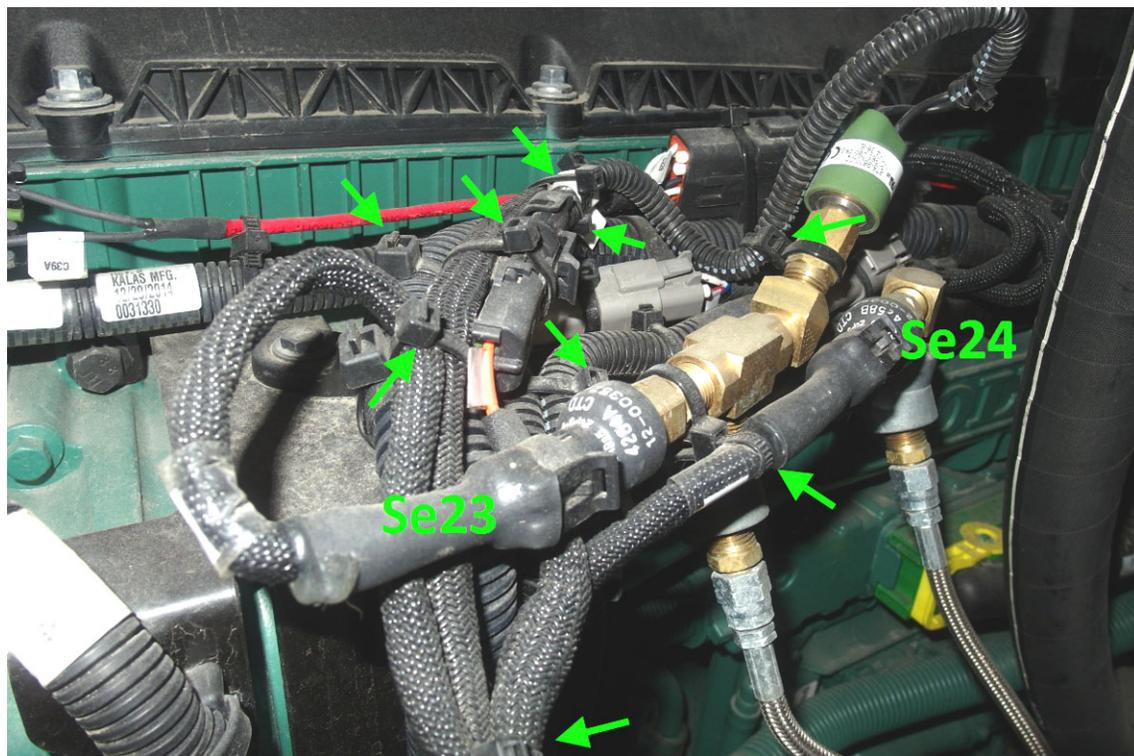
ATTACH THE EXCESS LENGTH OF CABLE ALONG MAIN STRAND OF HARNESS AS SHOWN- NYLON TIES LOCATION SHOWN BY ARROWS

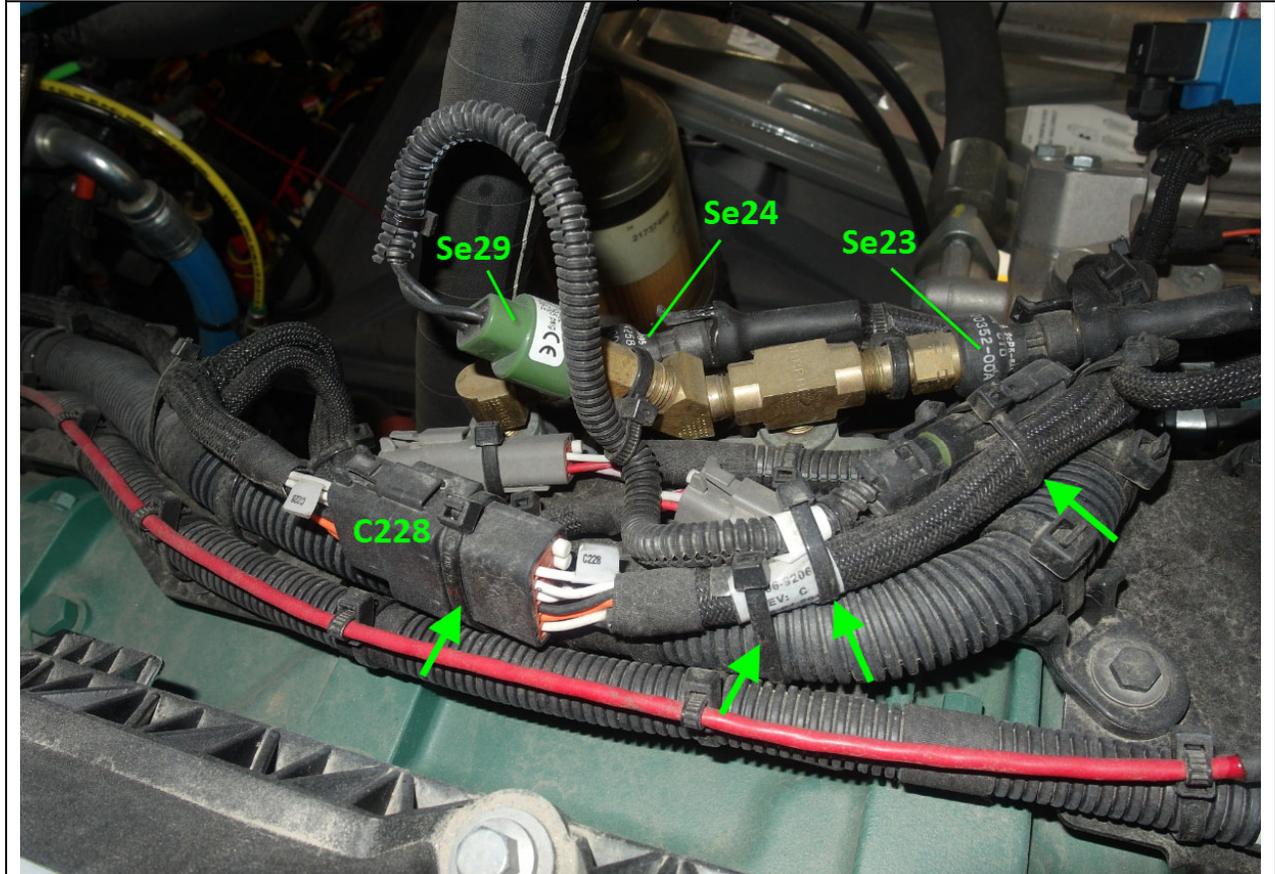
ATTACH THE EXCESS LENGTH OF CABLE ALONG MAIN STRAND OF HARNESS AS SHOWN- NYLON TIES LOCATION SHOWN BY ARROWS

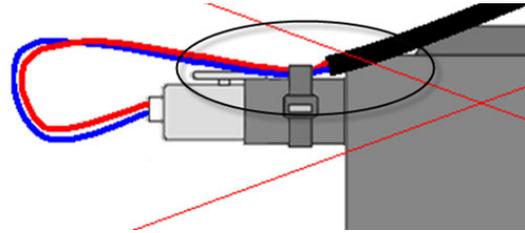
- Prefer larger cable ties over smaller cable ties in your assembly to limit local pinch effect.
- Avoid sharp edges to prevent chaffing and abrasion.
- Always attach over harness loom or corrugated tubes, not on the bare cables themselves.

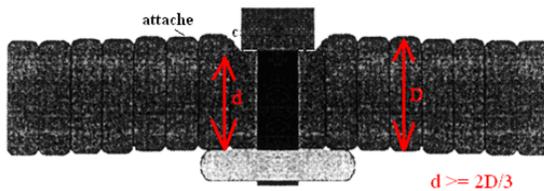
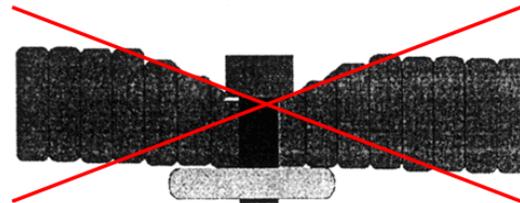
- No over-tightening of cable ties. (Must only prevent harness movement)

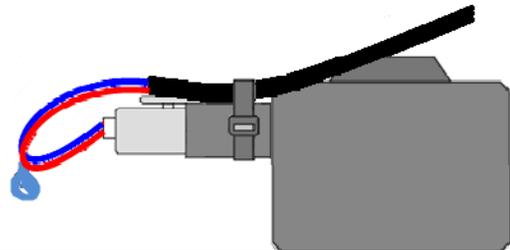
- Perform smart harness routing to prevent water intrusion in the connectors. (nearest low point: below connector)

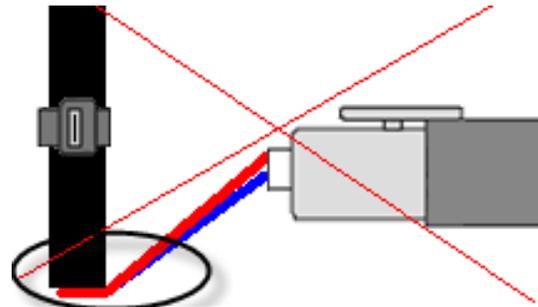
- Also avoid sharp edges of plastic corrugated tubes.

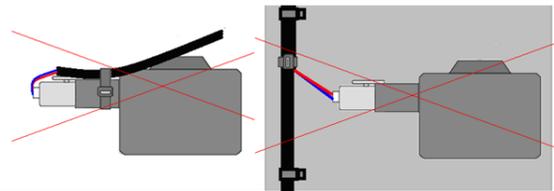
- No pulling or tension on connections.

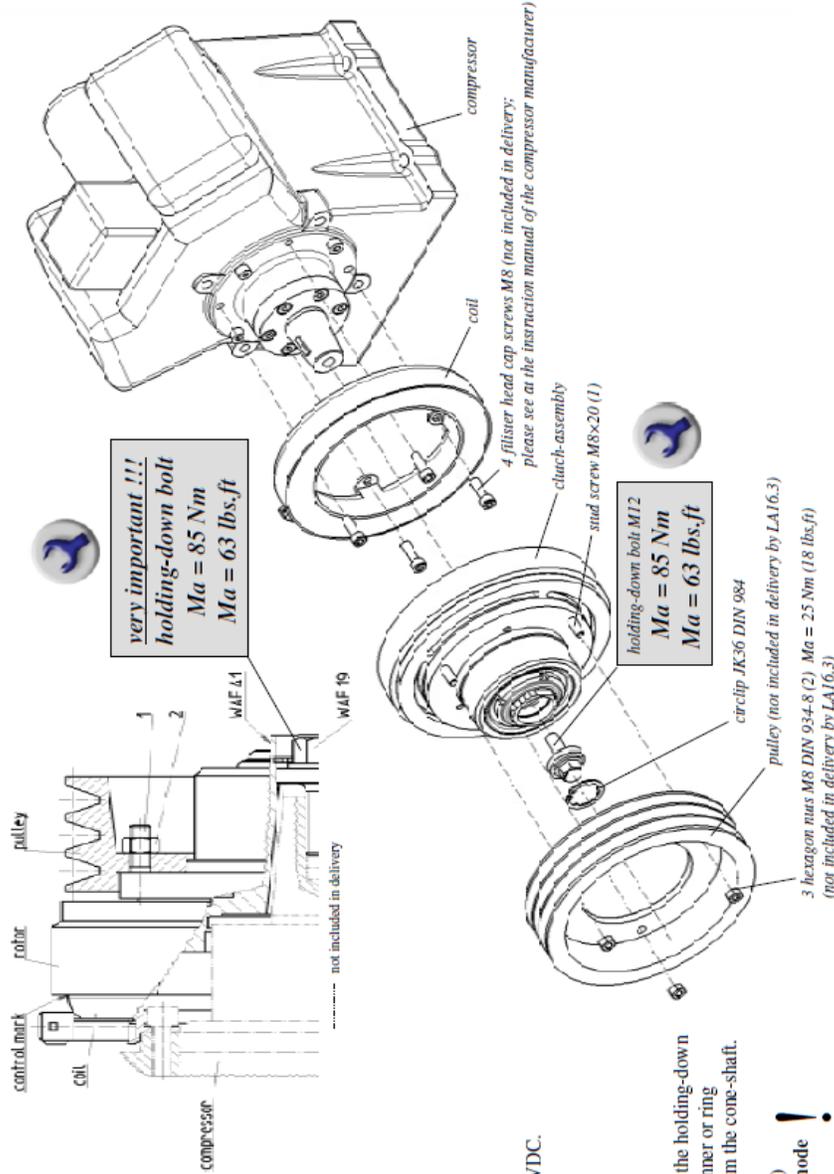
1. Attach coil according to instruction manual of the compressor manufacturer. Connect cable in a way that avoids contact with hot components (only if coil contains a cable).  $t_{max} = 105^{\circ}\text{C}$

2. Remove circlip and holding-down bolt from clutch-assembly. Slide clutch-assembly onto compressor shaft. Look through the center-hole for a correct position of the compressor shaft key in the rotor-keyway. Rotor should turn freely without touching the coil. Consider the control mark! Insert and tighten holding-down bolt M12 (tightening torque  $Ma = 85\text{ Nm}$ ,  $Ma = 63\text{ lbs.ft}$ ). Hold down the rotor with an open-ended spanner or ring spanner WAF41. Insert circlip.

3. Slide pulley over the stud screws (1) and bolt on with nuts M8 DIN 934-8 (2) (only for LA16.3; for other LA16 is pulley integrated part of the clutch).
