SAFETY RECALL

SR21-85D

FRONT HEADLAMPS REPLACEMENT 9700 USCAN (B13R)

On the vehicles affected by this recall, replace both headlamp assemblies and then perform the software or parameters update.

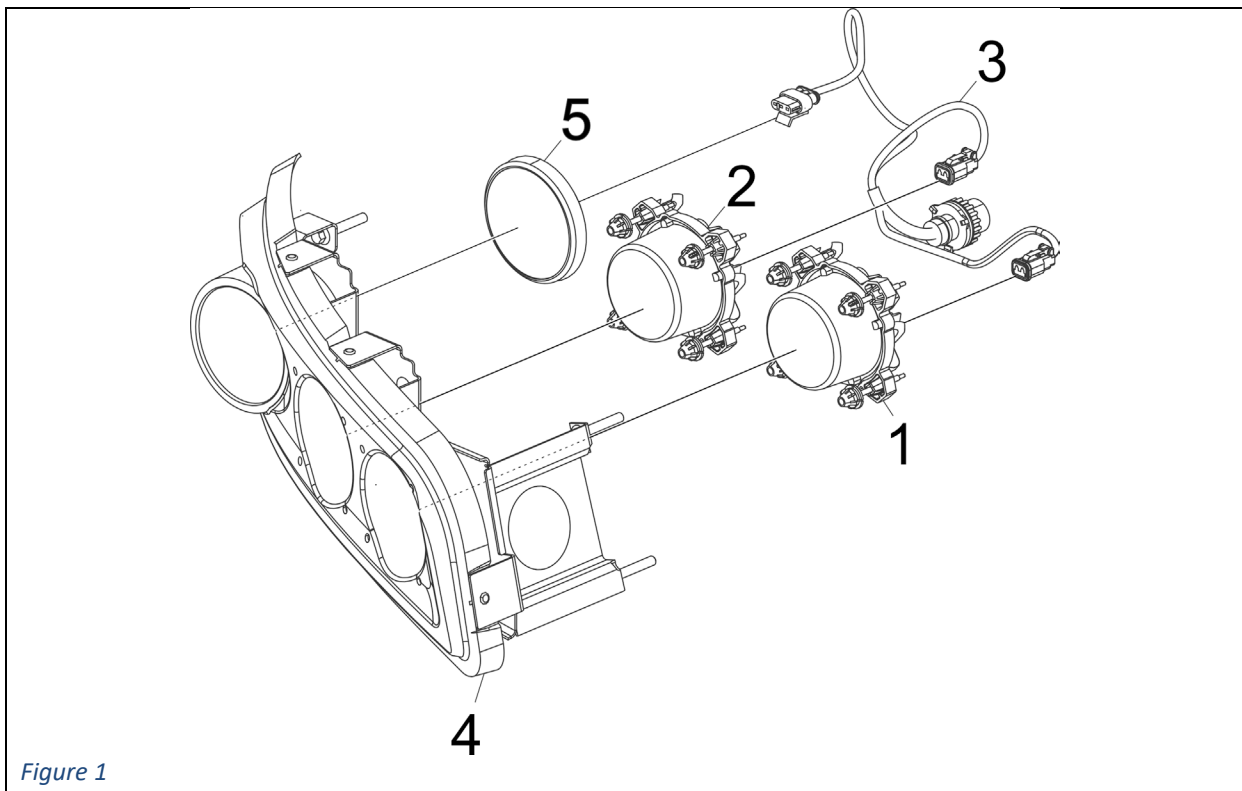
Figure 1

Item	Part number	Description
1	24224437-NS	HIGH BEAM LED 90 mm (<i>stamped with "8458"</i>)
2	24224438-NS	LOW BEAM LED 90 mm (<i>stamped with "8459"</i>)
3	-	WIRING HARNESS, FRONT LIGHT
4	7775331	HEADLAMP BEZEL RH
4	7775332	HEADLAMP BEZEL LH

5	24219713-NS	LAMP,4" TURN/PARK SIGNAL
---	-------------	--------------------------

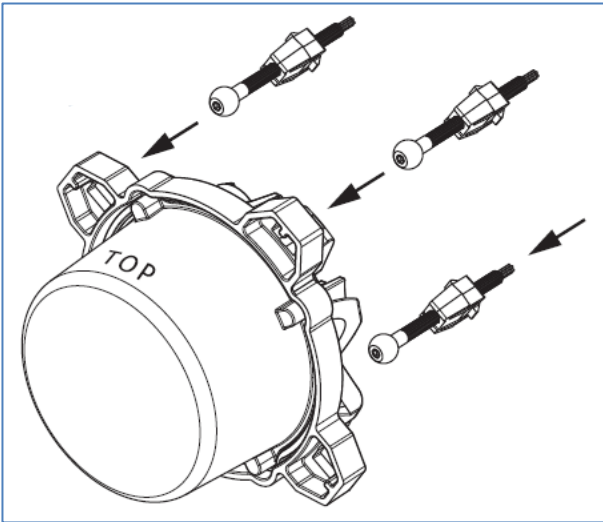
Figure 2

- 1) LOW BEAM LED p/n 24224438-NS stamped with "8459" (item 2, Figure 1). Insert adjuster screws in mounting bracket from back with ball facing front and side labeled "top" facing up. Press in by hand until adjuster snaps into housing.

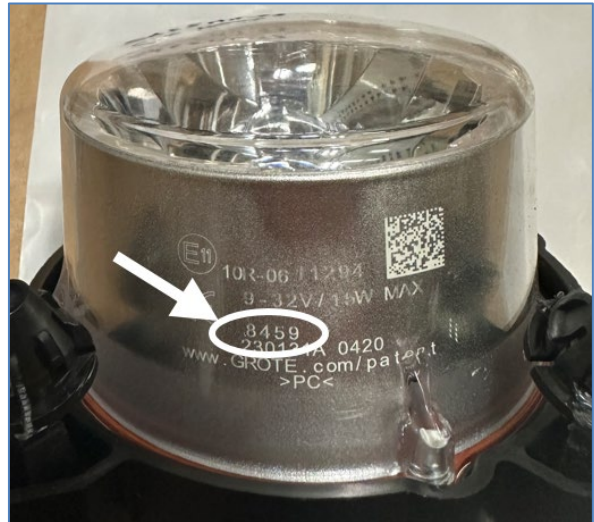
Figure 3: stamped with "8459"

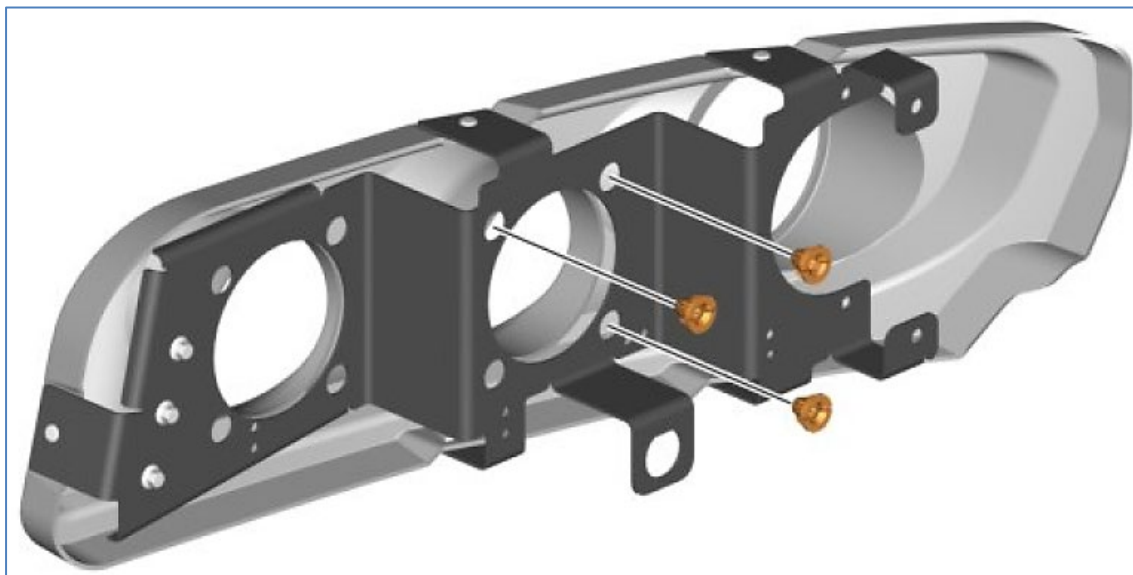
- 2) Snap low beam clips into mounting holes on RH & LH headlamp bezel (item 4, Figure 1)

Figure 4: RH headlamp shown

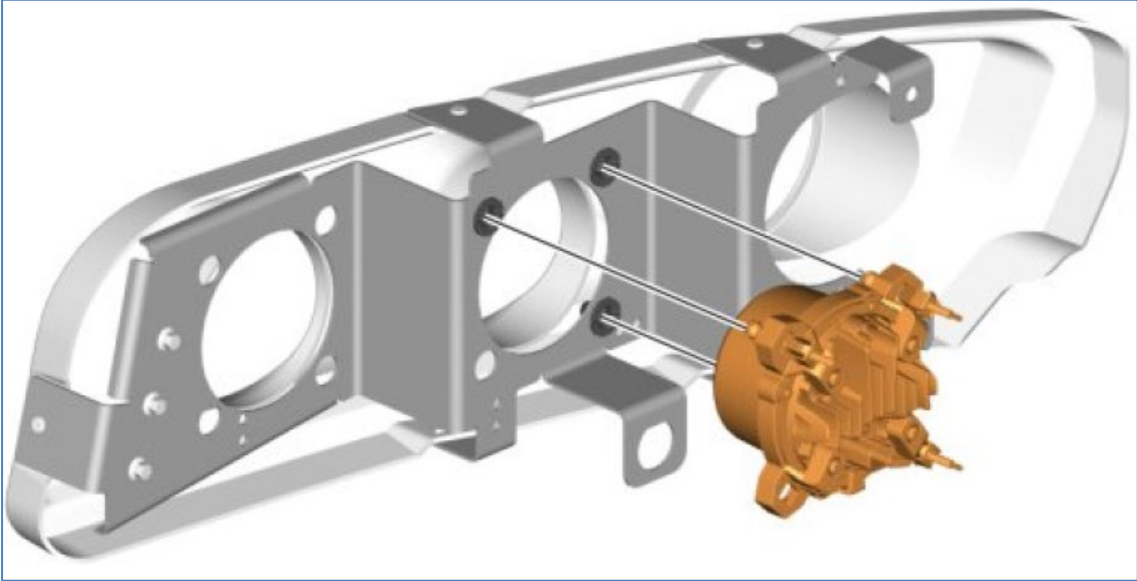
- 3) Press adjuster balls into clips. The TOP inscription on the lens should be placed at the top, so the connector is at the bottom.

Figure 5: RH headlamp shown

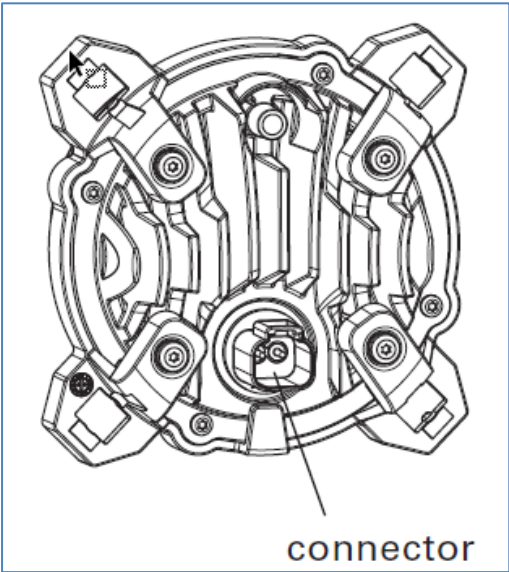
Figure 6: CONNECTOR AT THE BOTTOM

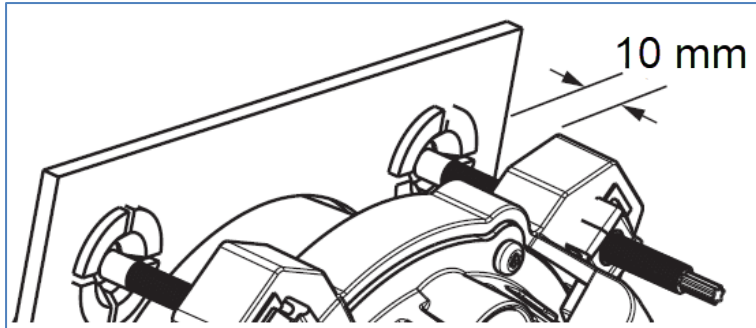
Figure 7

- 4) Adjust the four (4) screws until the beam mounting bracket is **10 mm** from panel.

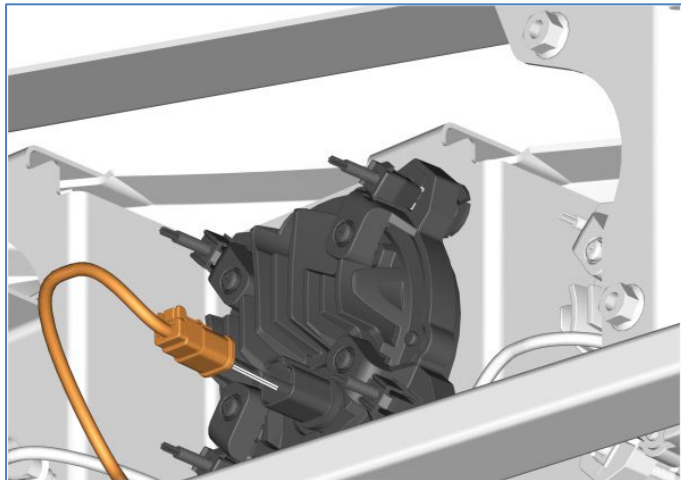
Figure 8

- 5) Plug the low beam connector labelled **E02**.

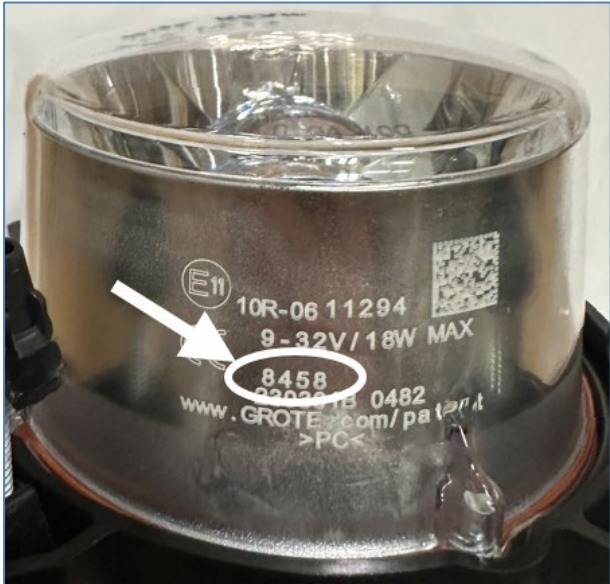
- 1) Proceed similarly with the high beam p/n 24224437-NS stamped with "8458" (item 1, Figure 1).

Figure 9: stamped with "8458"

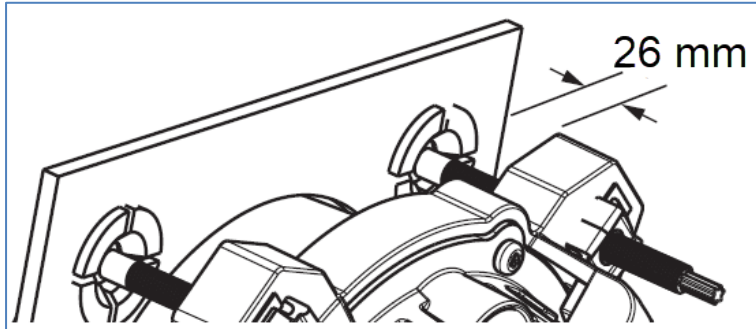
Figure 11

- 2) Adjust the four (4) screws until the beam mounting bracket is **26 mm** from panel.

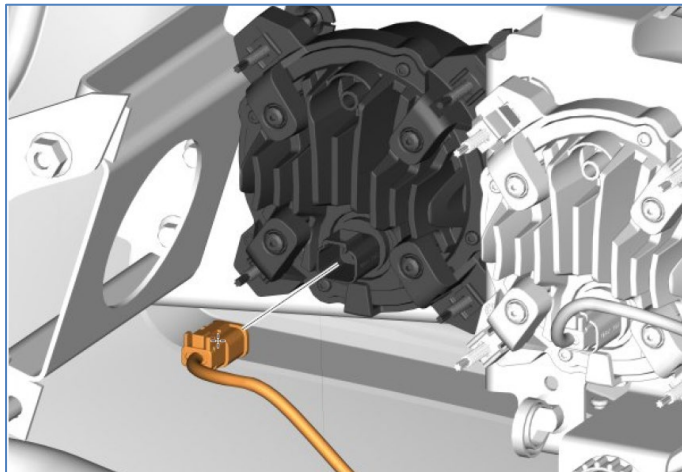
Figure 12

- 3) Plug the high beam connector labelled **E01**.

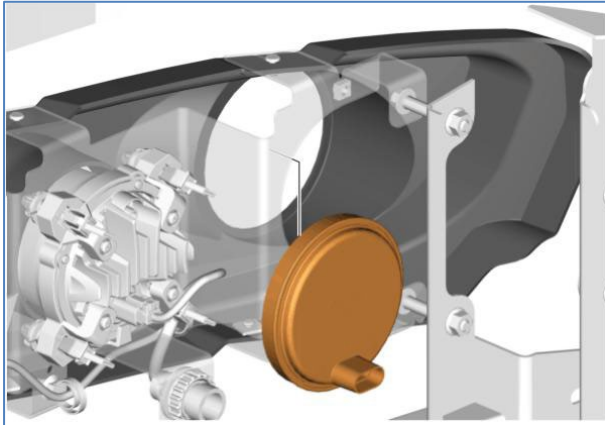
- 1) Position the turn signal module in place.

Figure 13: RH headlamp shown

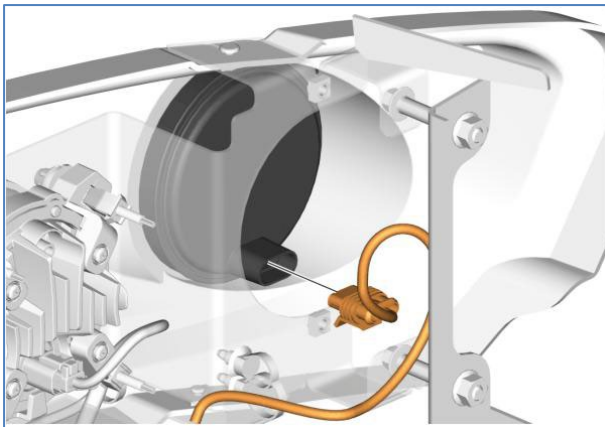
- 2) Plug the turn signal module with labelled **E13**.

Figure 14: RH headlamp shown

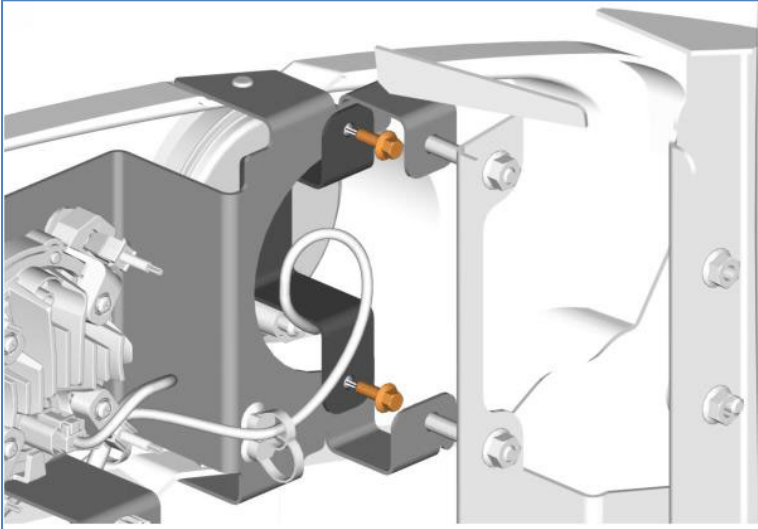
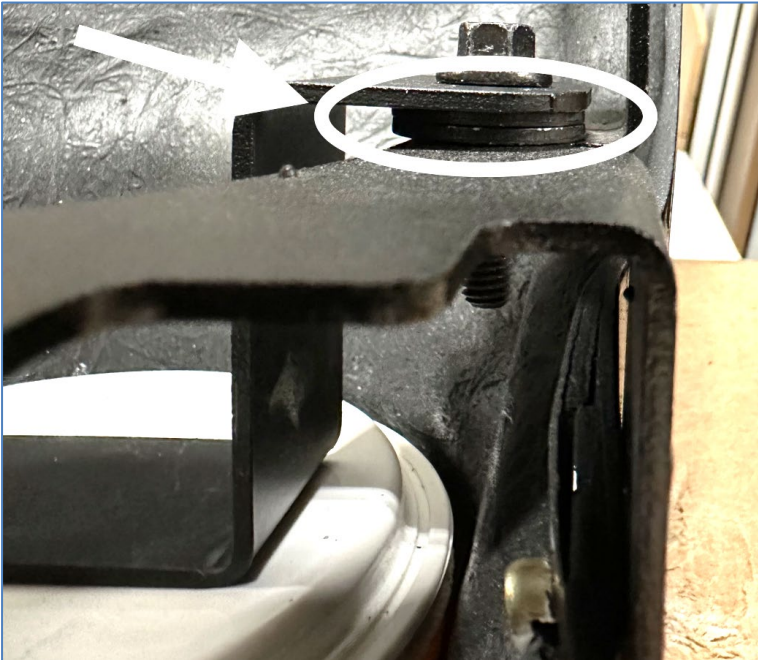
- 3) Install the bracket, the two (2) screws (2 washers per screw) and then tighten.

Figure 15: : RH headlamp shown

Figure 16: Two washers per screw

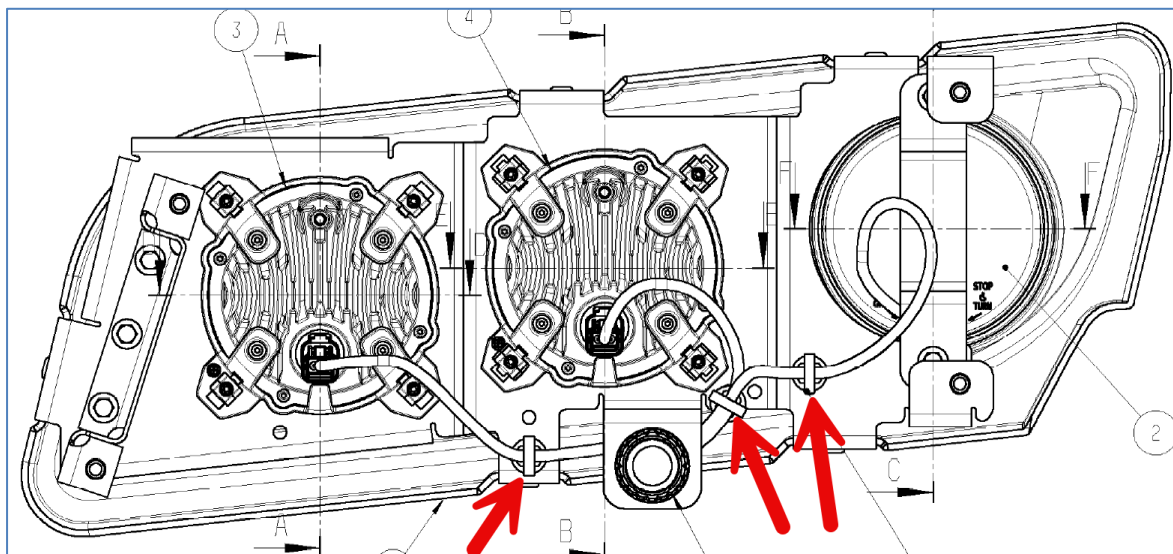
- 1) If not already done, secure the harness using three (3) cable ties as shown the following images.

Figure 18: : RH headlamp shown

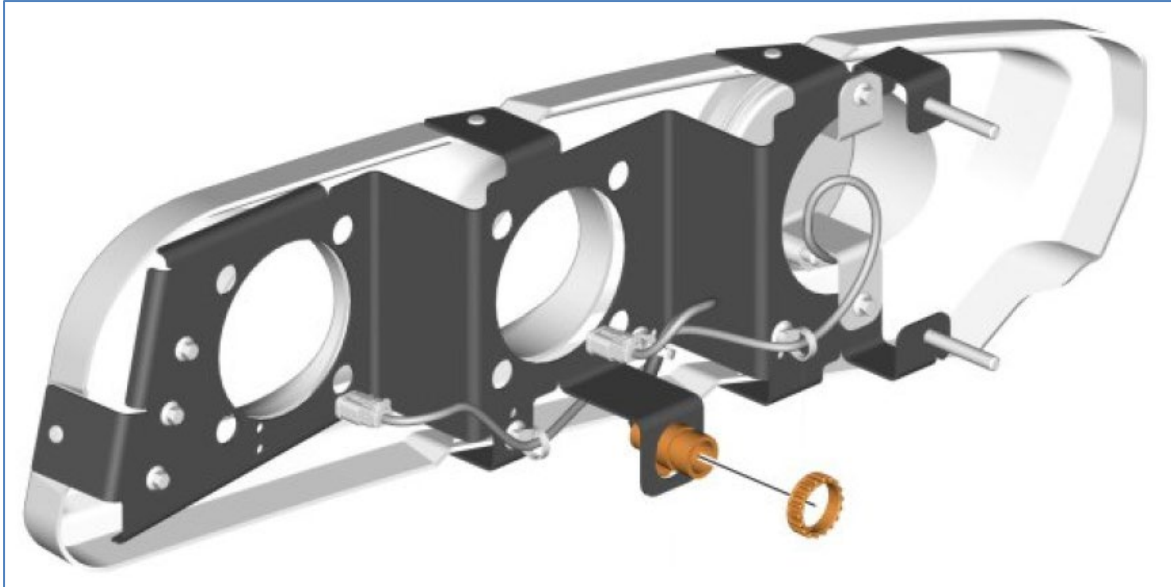
2) If not already done, secure the connector with the locking ring 3963413.

Figure 19: RH headlamp shown

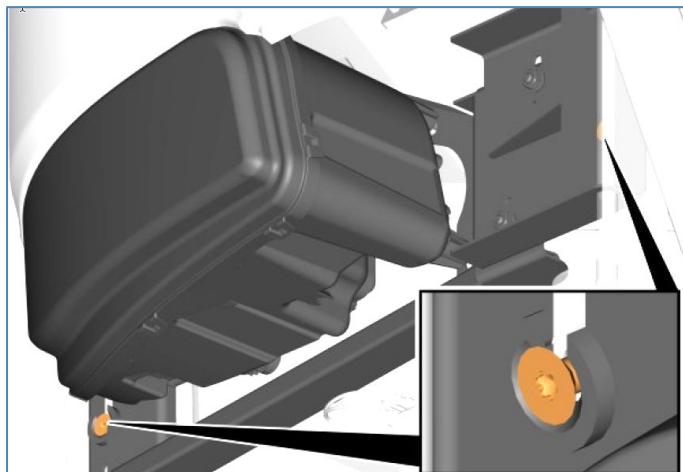
Figure 21

- 2) Loosen the two (2) screws identified in the image below.

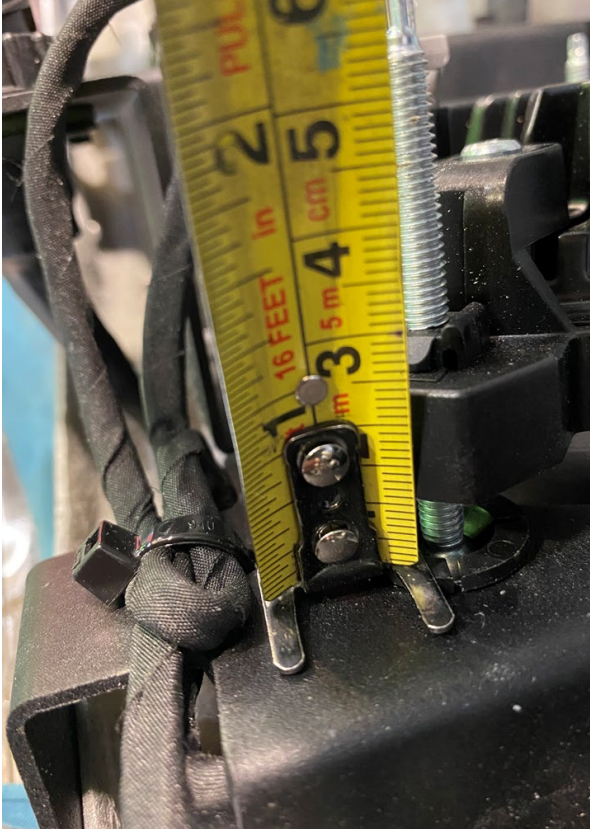
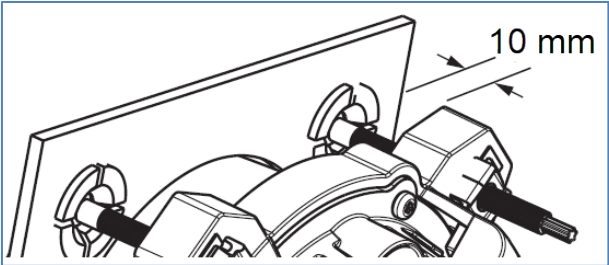
Figure 26

- 7) Check the pre-adjusted **low beam** module height in relation to the mounting plate. The measurement should be **10 mm**. If necessary, adjust using the corresponding adjustment screw.

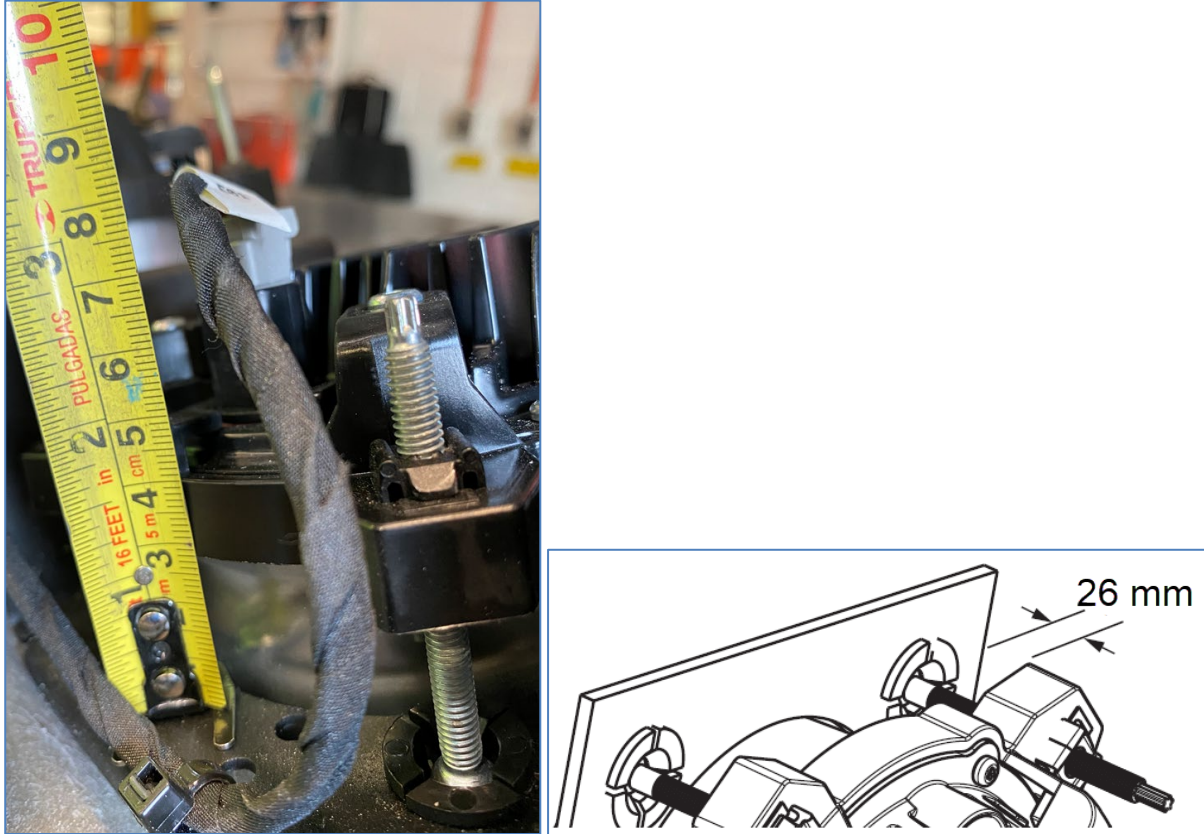
Figure 27

- 8) Check the pre-adjusted **high beam** module height in relation to the mounting plate. The distance should be **26 mm**. If necessary, adjust using the corresponding adjustment screw.

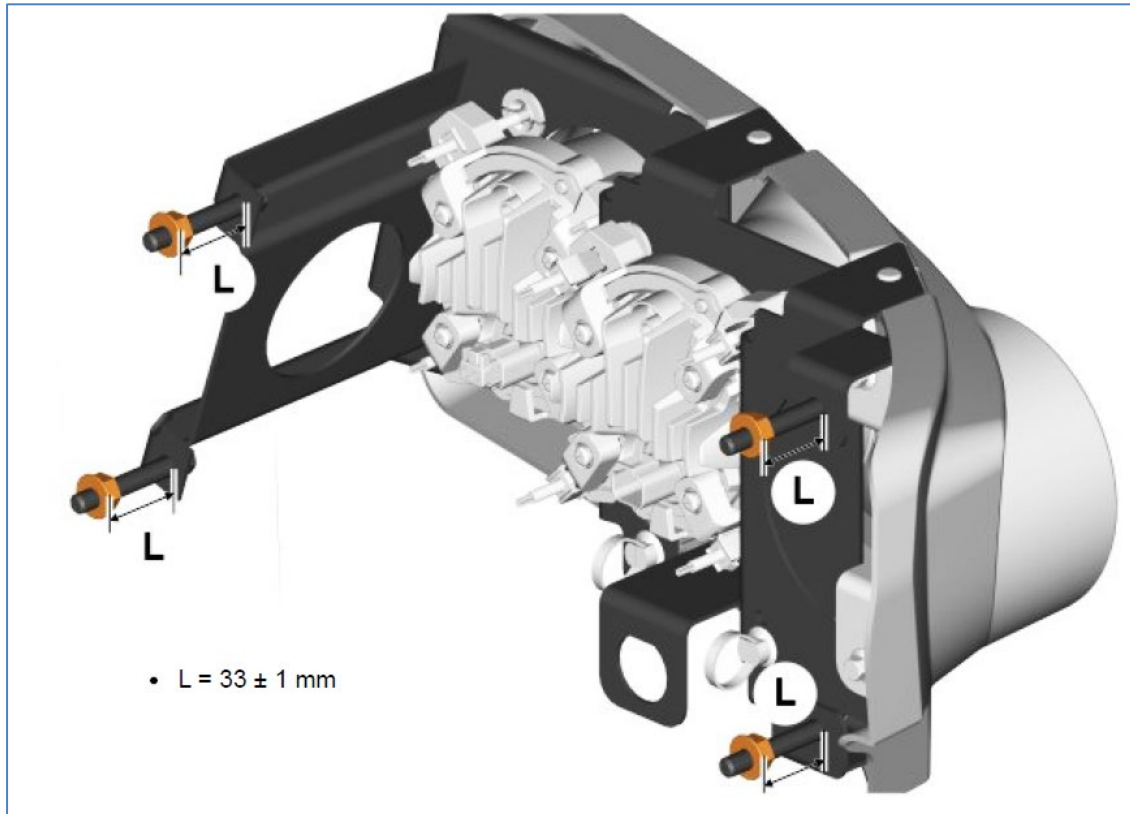
Figure 28

- 9) Check the pre-adjusted measurements of the headlamp unit at the lock nuts. The distance from the bracket base at each fixing screw should be 33 +/- 1 mm.

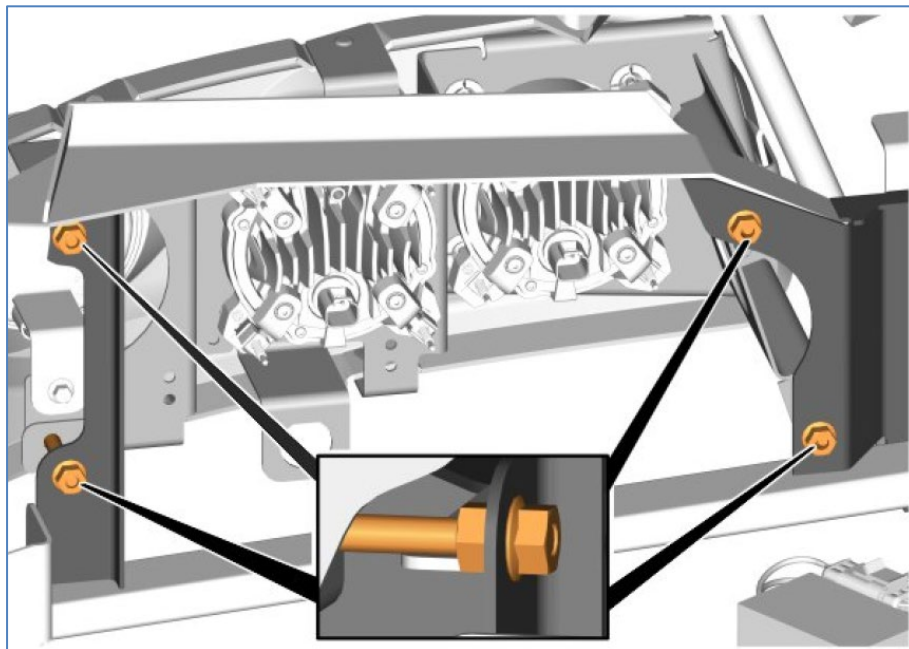
Figure 29

- 10) Install the new front headlamp assembly on the vehicle by screwing the four fixation screws to the body installation bracket. Tighten the headlamp fixation screws to a torque of **28 N-m**.

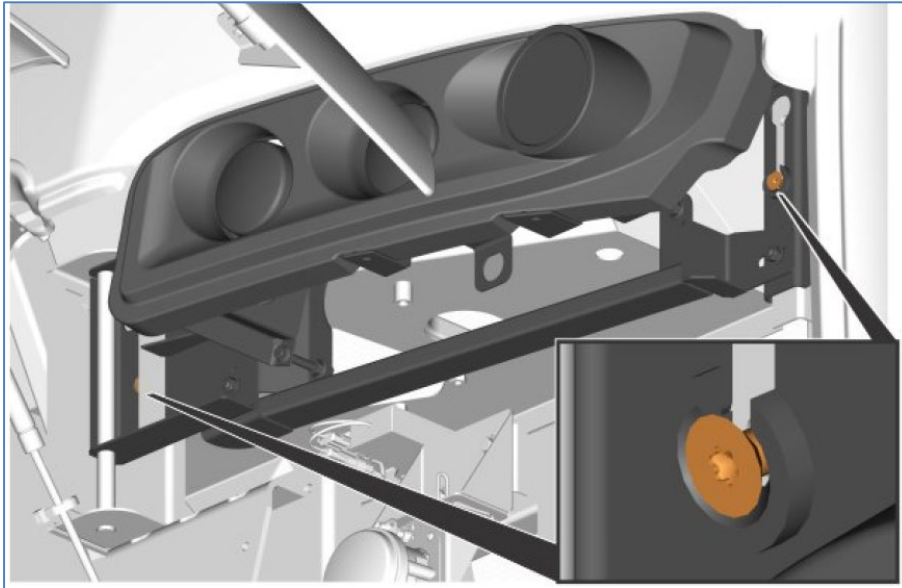
Figure 33

- 14) Fix the headlamp assembly bracket to the coach body structure by screwing its fixing screws. Tighten the headlamp assembly bracket fixing screws to a torque of **54 +/- 4 N-m**.

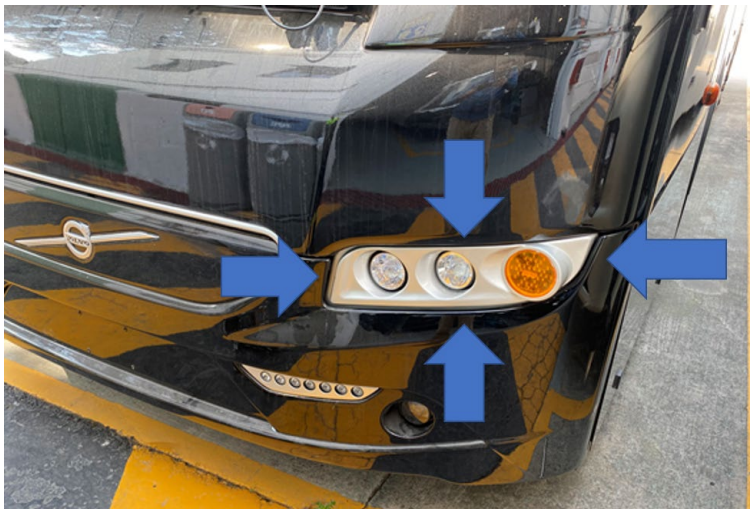
Figure 34

- 15) Close the front hatch and if necessary, adjust the headlamp bezel with the surrounding surfaces of the coach front panel and the bumper. To do so, screw or unscrew the bracket fixing screws locknut, modifying the pre-adjusted measurement of **33 +/- 1 mm** as required.

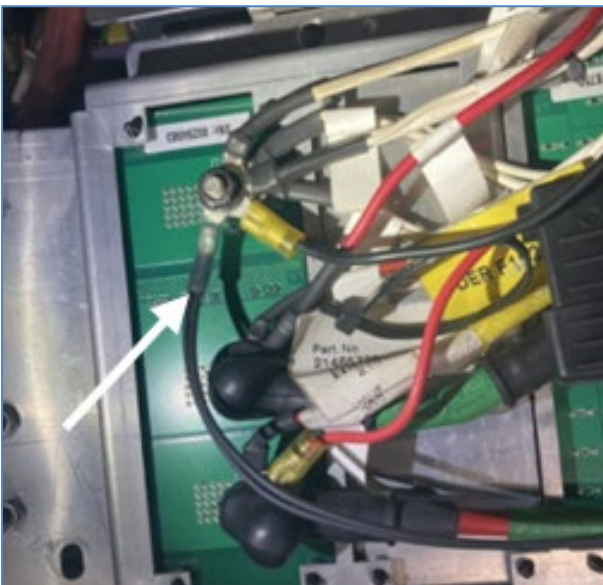
Figure 37

- 4) Locate LCM A27.A connector.

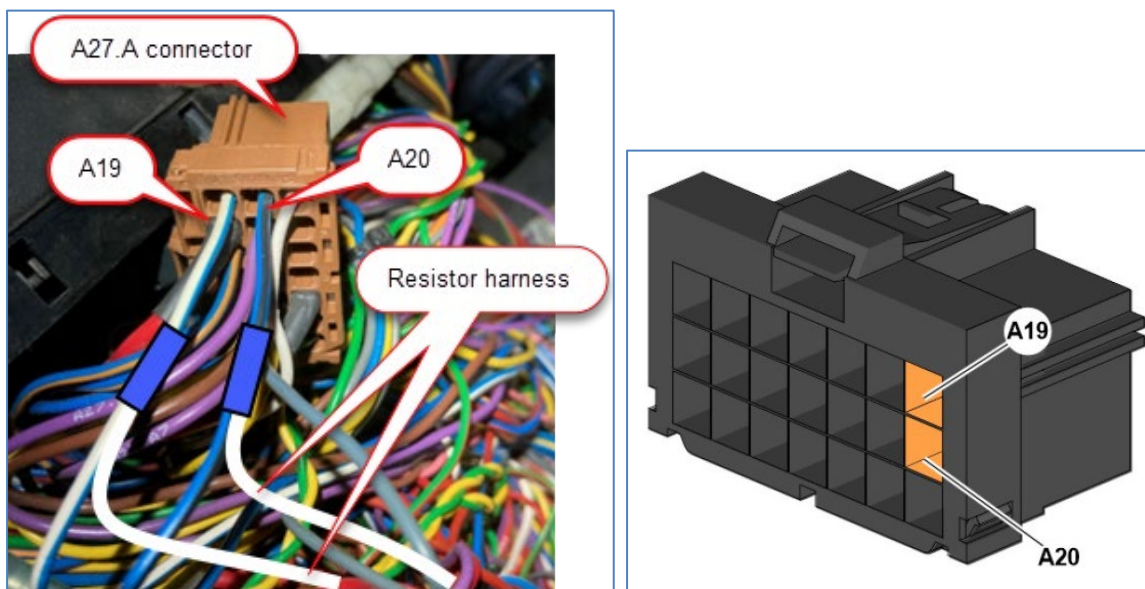
Figure 39

- 5) On this connector, identify circuits A19 & A20.

- 6) Splice one of the white wire of resistor harness with **blue/white** wire (circuit A19) connected at A27.A19.
- 7) Splice the second white wire of resistor harness with **blue/black** wire (circuit A20) connected at A27.A20.

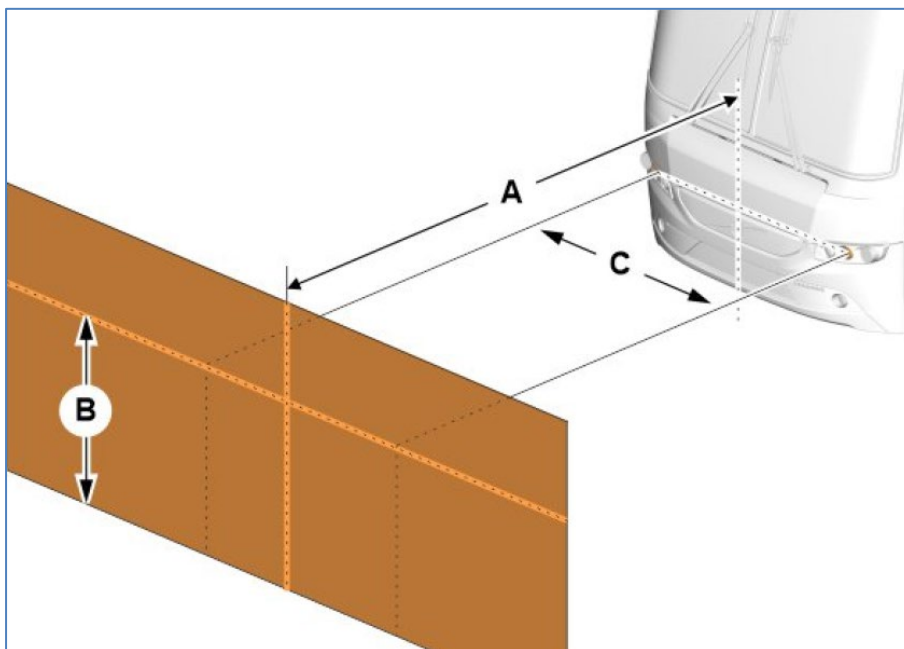
Figure 40

The distance between the front of the coach (at the center) and the screen or wall must be 7.6 meter (25 ft) (see A in Figure 40).

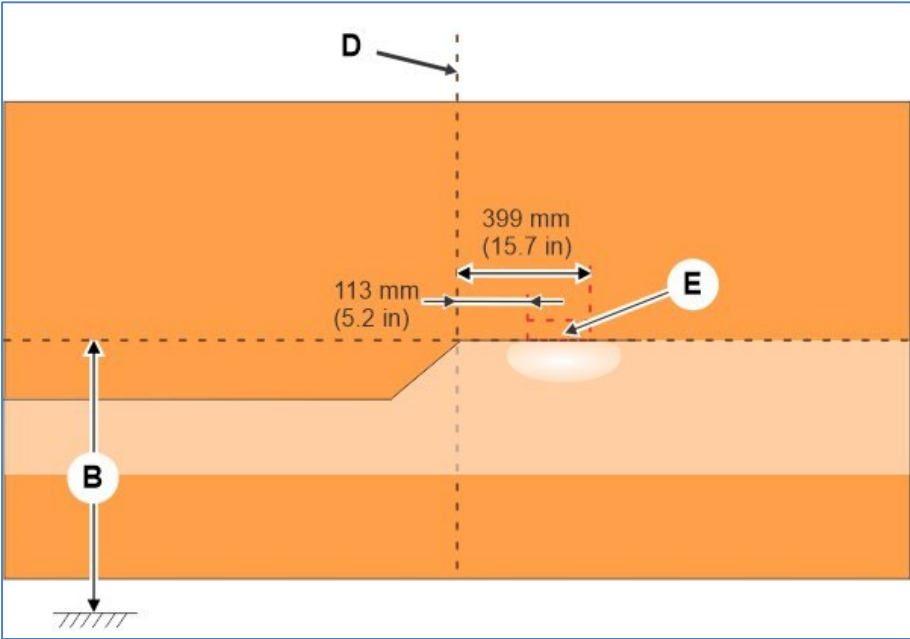
Figure 41

- 11) Draw a horizontal line (B) at 940 mm (36.5 in) above the floor level and mark the distance between low beams C: 1875 mm (73.8 in).
- 12) Turn the low beams headlamps on.
- 13) The lens is aimed using the horizontal cutoff line B matching the top edge of the high-intensity zone, to the right of the headlamp's vertical centerline D, use region E to set aim.

The highest zone of the light beam must be aligned (and touching) with the 940 mm line.

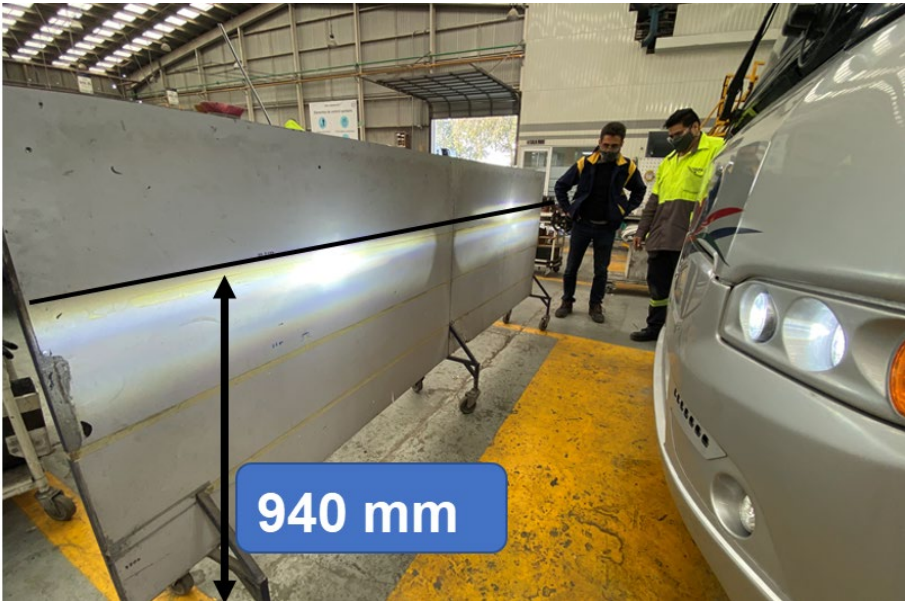
Figure 42: proper low beam height

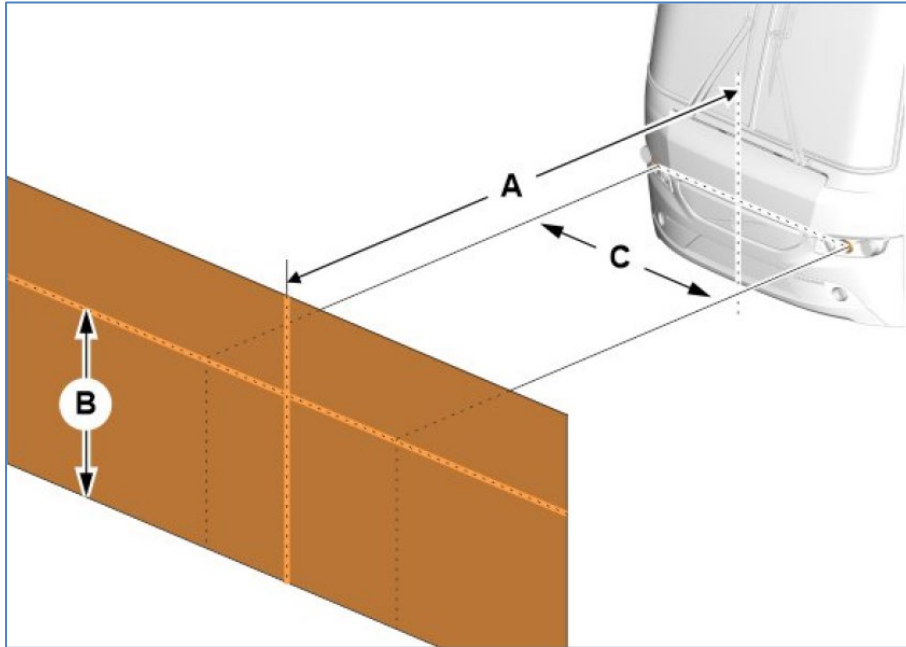
Figure 44

- 15) Draw a horizontal line **(B)** at 928 mm (above the floor level) and mark the distance between high beams **C**: 1616 mm (73.7 in).

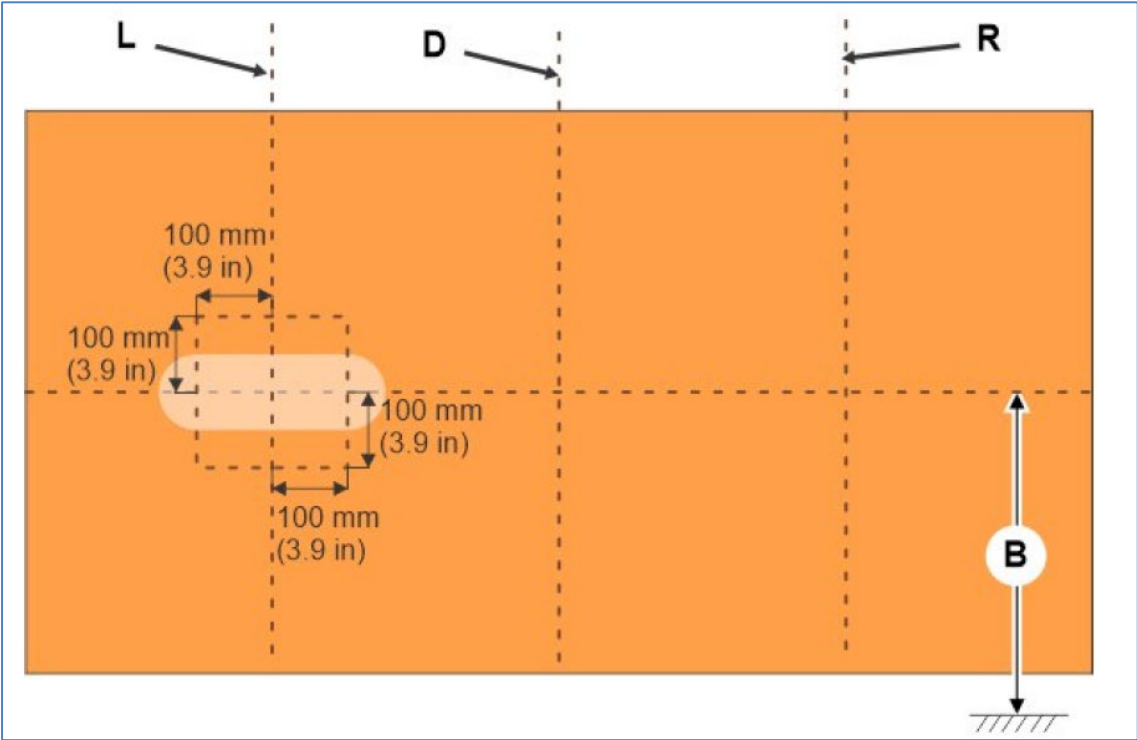
Figure 45

- 16) The lens is aimed using the intersection between the horizontal B cutoff and straight-ahead vertical line of the lens position (L or R) that matching at the center of the high-intensity zone, use the 100 mm area around the intersection to set aim.

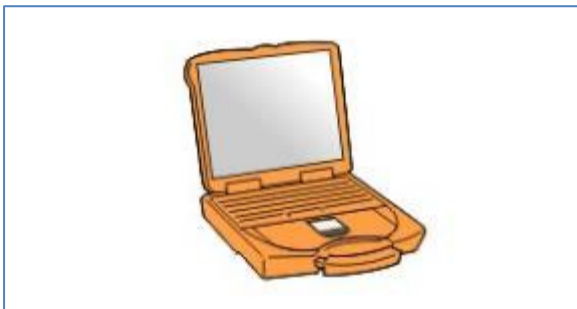
Figure 48

- 2) Run the accessory KIT: **N/P: 24252354**; CONVERSION KIT, SLCM PARAMETERS.
- 3) Order LCM MID 216 software to manage software new.
- 4) Program LCM using storage software.

- 5) Go back to manage new software and return software package.

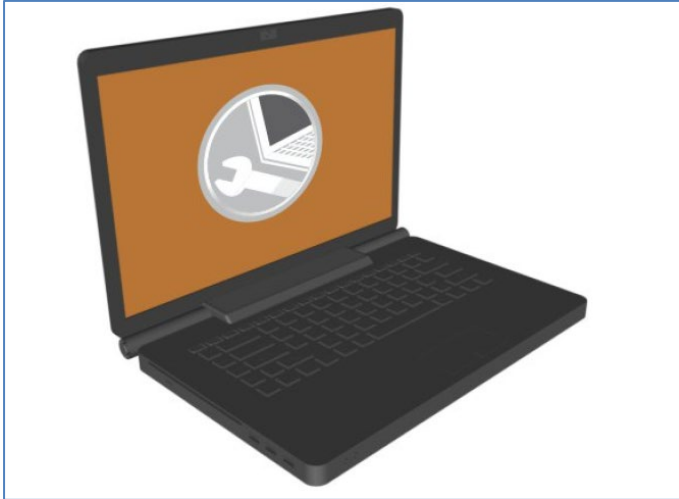
Figure 49

Connect Premium TechTool. Go to operation Parameter programming. Select / control unit / MID 216. Confirm all parameters below are set to the proper values and change values if needed:
