# PREVOST

## WARRANTY BULLETIN

**WB24-40**

DATE :	November 2024	SECTION :	22 HVAC
EXPIRATION:	November 2026		
SUBJECT :	DRIVER'S FOOTWELL AIR DUCT INSPECTION

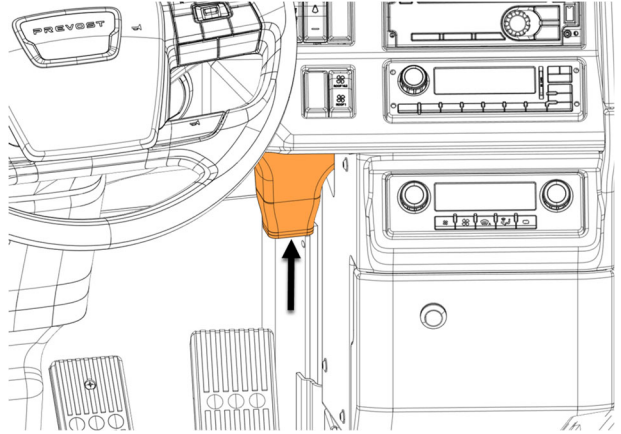
1. Locate the driver's footwell air duct in the center console of the dashboard.

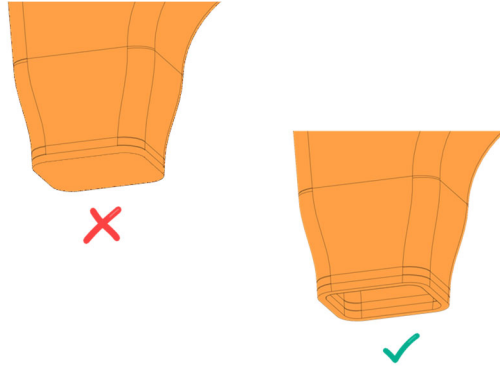
2. Inspect the end of the air duct.
  - If an opening is present, the bulletin is complete.
  - If no opening is found, proceed with the following steps.
