Warranty Bulletin

WB24-88

DVD PLAYER SOUND QUALITY ISSUE – ADDITION OF A PREAMPLIFIER
9700 (B13R)

On the vehicles affected by this bulletin, the sound quality from the DVD player may be poor. Install a HDMI converter and preamplifier to improve audio performance.

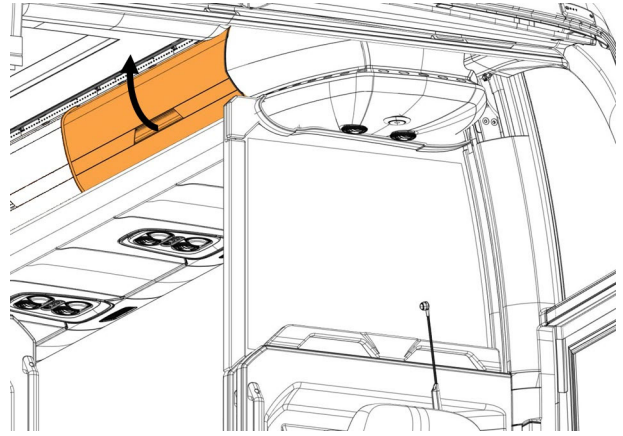
1. Open the first parcel rack on the driver-side.

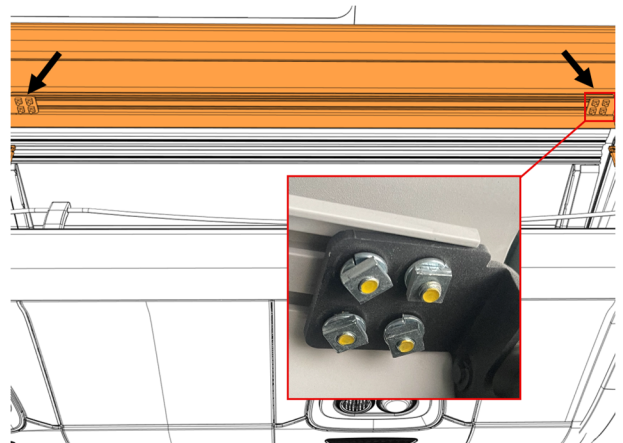
2. Unscrew and remove the parcel rack door.
3. Keep the nuts and washers for reinstall.

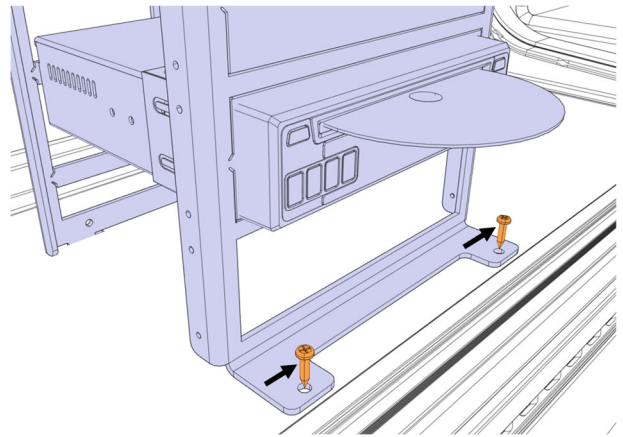
6. Remove and discard the screws (2x) retaining the support front to the parcel rack.

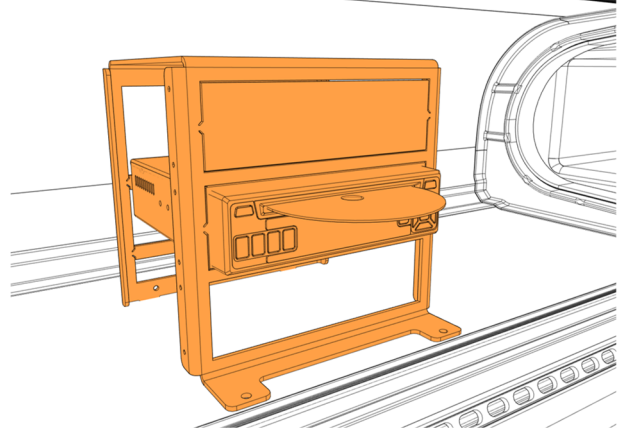
12. Take the support with the DVD player out of the parcel rack.

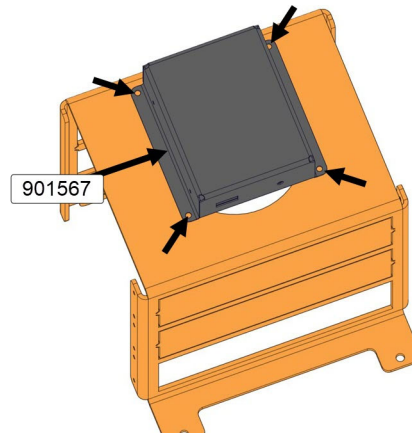
17. Drill four (4) holes of 9/64-inch diameter at the top of the support for the HDMI converter 901567.

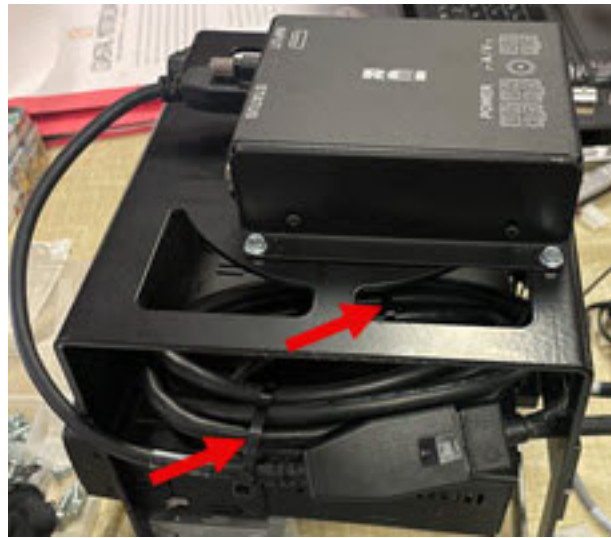
23. Secure the cables with cable-ties (2x) 504637.

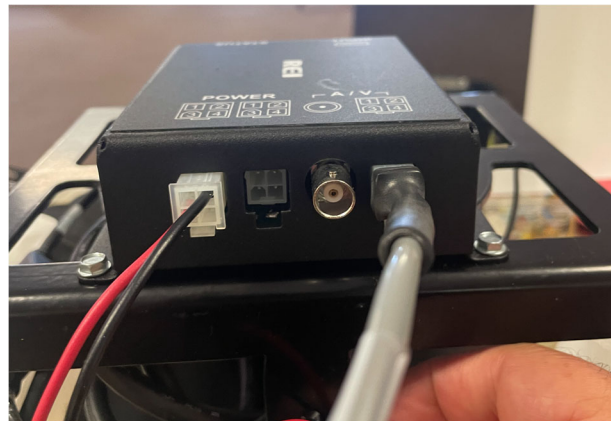
- Plug connector **A** of the pre-amplifier 7775435 into one of the power ports of the HDMI converter.
- Plug connector **D** "AUDIO" of the pre-amplifier 7775435 into the audio output of the HDMI converter.

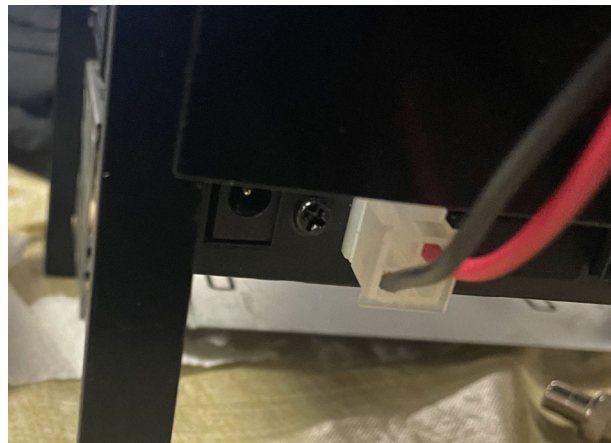
- Plug connector **B** of the pre-amplifier 7775435 into the power input at the rear of the DVD player.

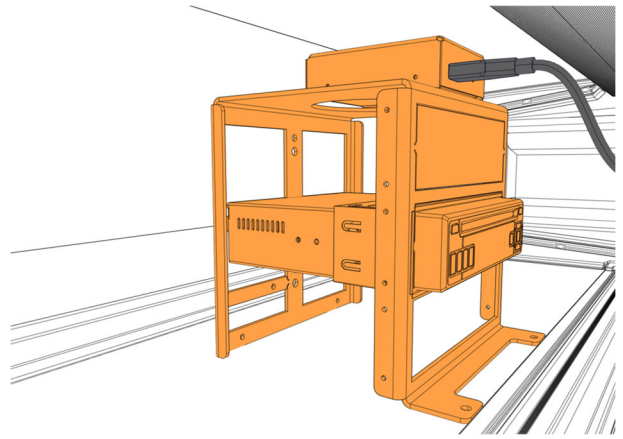
32. Place the support in the first parcel rack on the driver side.

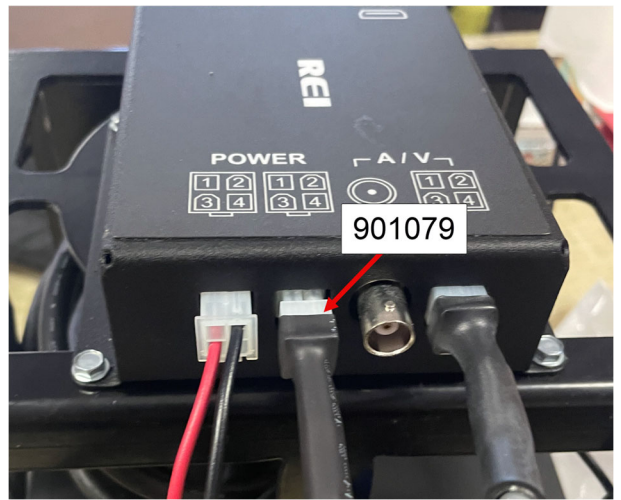
35. Plug the power cable 901079 into the second power port of the HDMI converter.

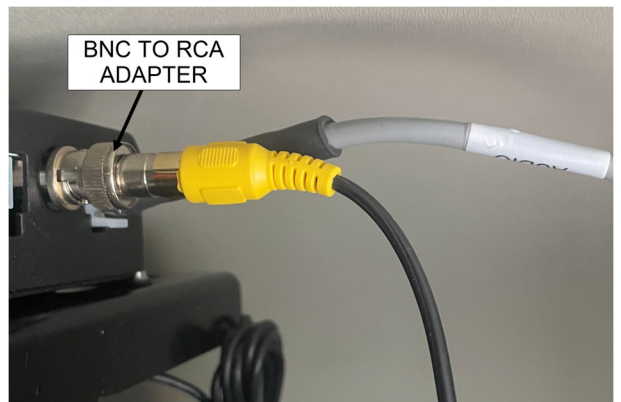
38. Connect the yellow connector of the RCA cable to the A/V port of HDMI converter. Use the BNC to RCA adapter removed previously.

39. Secure the connection with electrical tape.

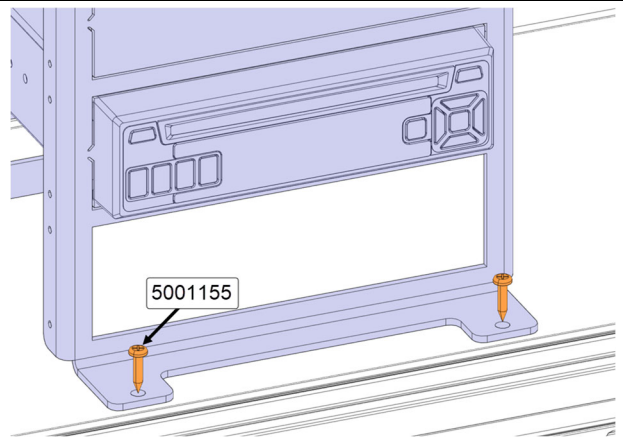
40. Secure cables in the parcel rack with cable ties 504637.

41. Fasten the support in the parcel rack with new tapping screws 5001155 (2x).

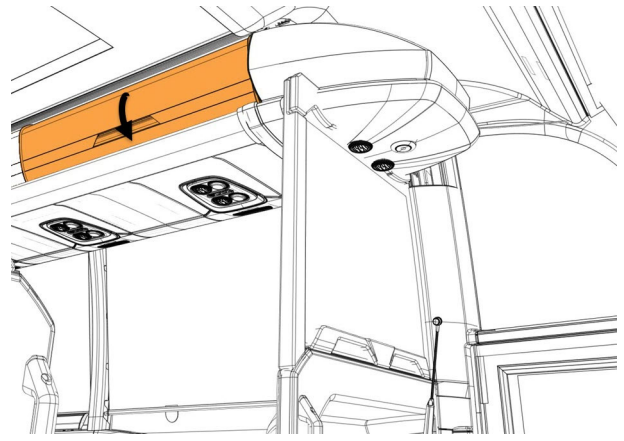
44. Close the parcel rack door.
