**MAINTENANCE  
INFORMATION**

**MI25-06**

DATE :	March 2025	SECTION :	18 BODY
SUBJECT :	<b>MODIFICATION OF THE FRONT SERVICE DOOR LOCK LEVER</b>

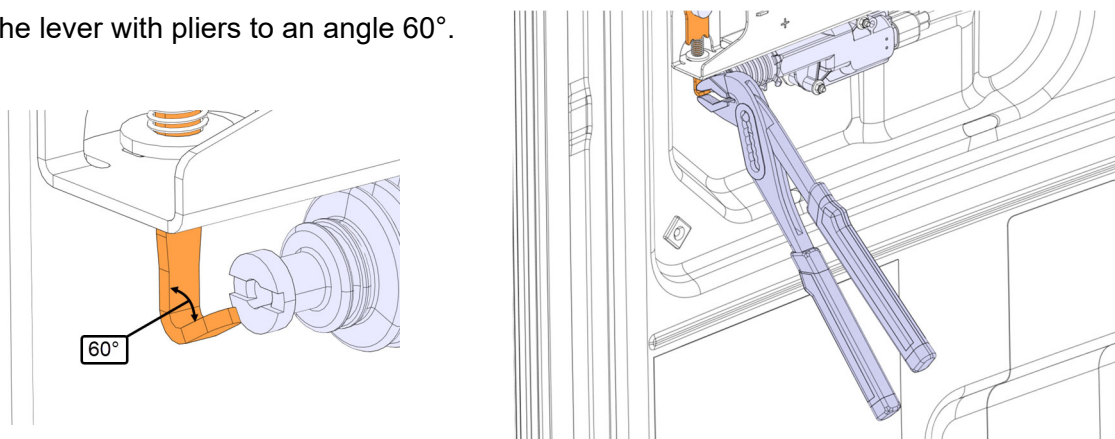
On the vehicles affected by this bulletin modify the actuator lock lever actuator to avoid the lever disconnection from the actuator.

6. Bend the lever with pliers to an angle 60°.
