PREVOST

SAFETY RECALL

SR25-13A

DATE:	June 2025	SECTION:	16 SUSPENSION
SUBJECT:	RETORQUE IFS LOWER CONTROL ARM BOLTS

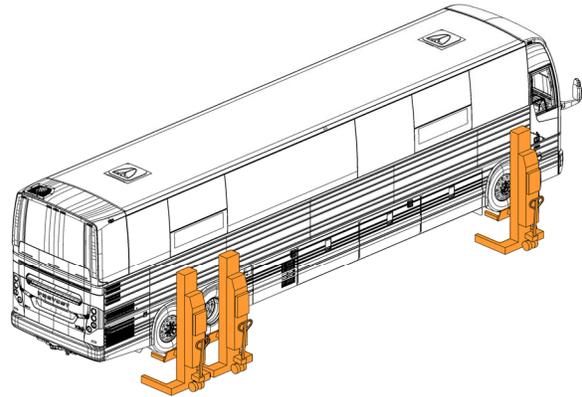
1. Insert the lifting equipment (always use six (6) lifting equipment; two (2) per axle with VIP).
2. When columns have been inserted under the wheels, we recommend releasing the parking brake to allow the wheels to turn freely during the lift, to avoid stressing the wheel seals on the drive axle.
3. Lift the vehicle.

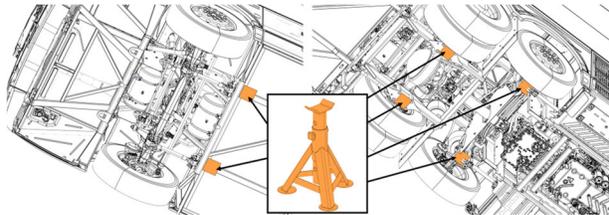
4. Secure the vehicle with six (6) jack stands.
Refer to maintenance information MI18-18 for the jack stand capacity and location on the vehicle.

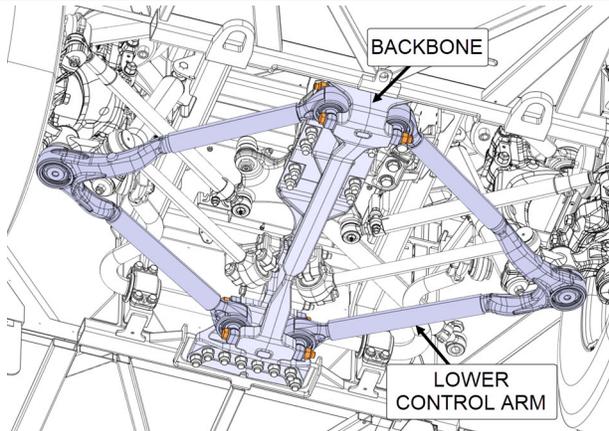
On vehicles affected by this recall, the bolts securing the front lower control arms may not have been properly tightened, potentially resulting in the separation of the control arms.

5. Locate the four bolts securing the lower control arms of the front suspension to the backbone.

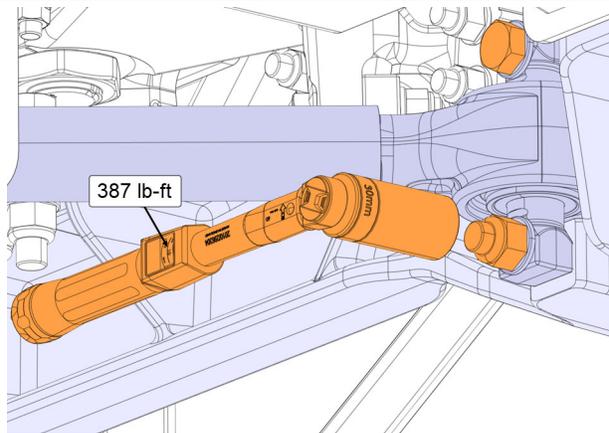
6. Torque each bolt to **387 lb-ft**.
7. Apply red torque seal mark.

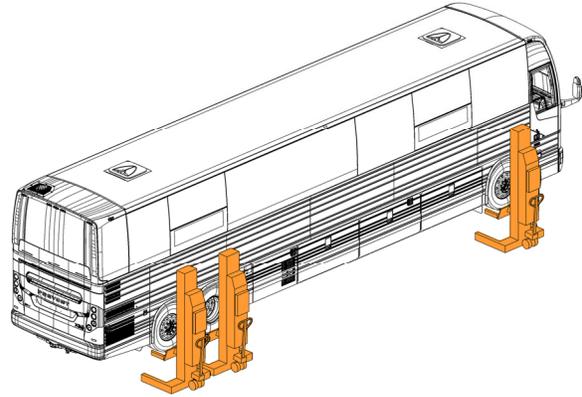
8. Remove the six (6) jack stands.
9. Lower the vehicle.
10. Apply parking brake.
11. Remove the lifting equipment.
