PREVOST

WARRANTY BULLETIN

WB17-06

DATE :	March 2017	SECTION :	23 ACCESSORIES
EXPIRATION:	March 2017		
SUBJECT :	WCL PENDANT SUPPORT IMPROVEMENT

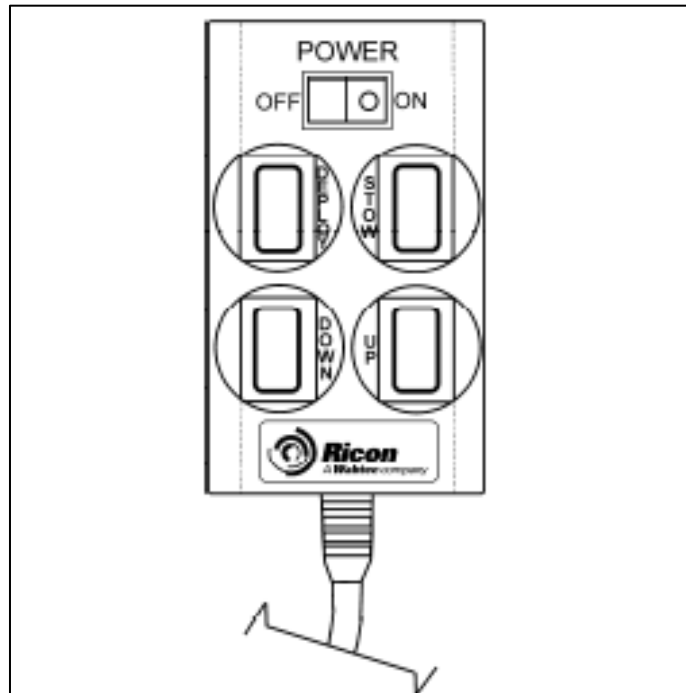
Figure 1 : Wheelchair lift control pendant

The yellow control pendant is larger than the black model and in certain conditions is harder to hook on the existing bracket.

Open the wheelchair lift access door and verify the control pendant body color.

If control pendant body is BLACK, no action required, END OF BULLETIN.

If control pendant body is YELLOW, PROCEED with bulletin.

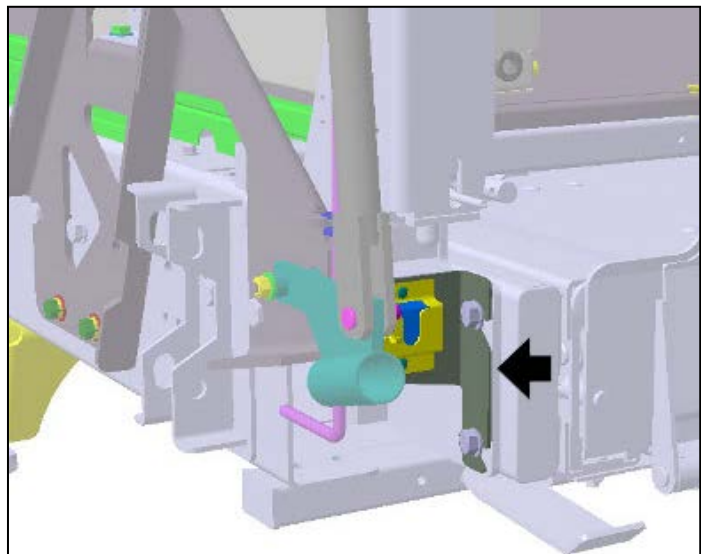
Figure 2

2. Remove the small bracket assembly on the left side of the platform. (Arrow, Figure 2.)

1. Stow out the platform a few inches to gain access to the pendant storage bracket.

3. Leave mounting bolts on the platform.

Tighten to: **96 lb-in**
