# SAFETY RECALL

# SR17-80A

## I-START DUAL BATTERY SYSTEM - WRONG CONNECTION OF GROUND CABLES GND11 & GND11A 9700 US/CAN (B13R)

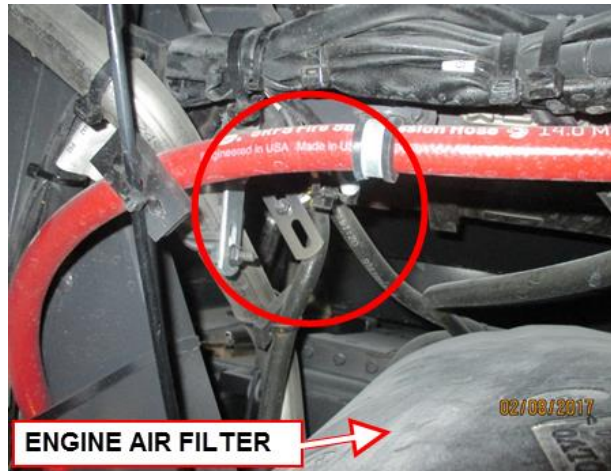
FIGURE 2

- 2) Locate the ground connection point above the engine air filter (FIGURE 2).

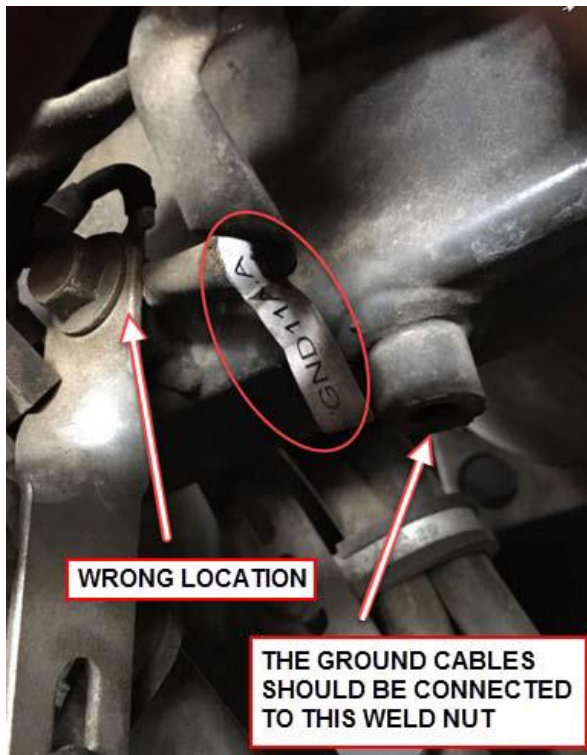
On the vehicles equipped with I-Start dual battery system, it is necessary to check if ground cables **GND11** & **GND11A** are connected to the proper ground connection point which is a weld nut on a structural member.

- 3) Make sure that both ground cables (GND11 & GND11A) are connected together on the proper ground connection point (FIGURE 3). If not, perform steps 4 & 5.

**WELD NUT DESCRIPTION: part number #1136923 M8x18mm.**

FIGURE 3: WRONG CONNECTION OF GROUND CABLES

- 4) Thoroughly clean the weld nut and the cable ring terminals to ensure good electrical conductivity.

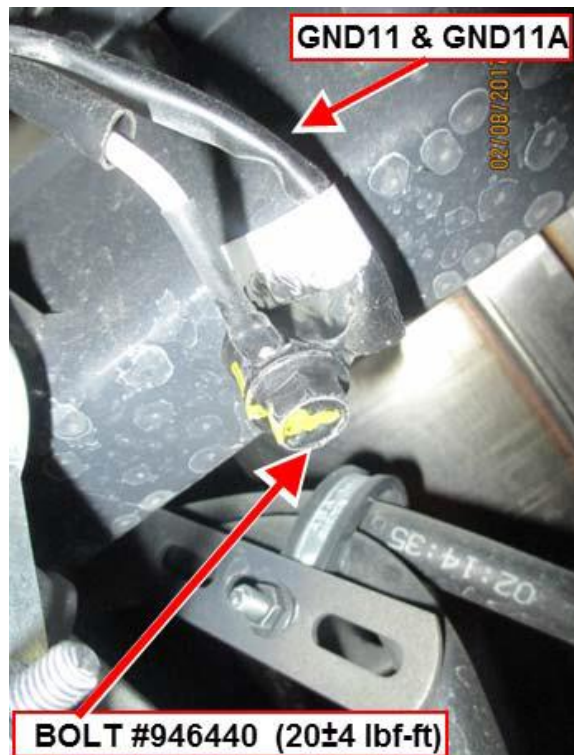
FIGURE 4: PROPER CONNECTION OF GROUND CABLES (it is possible some vehicles require M10 flange screw 5001729 Torque 48 lbf-ft)

5) Fasten the ground cable terminals to the connection point using flange screw #946440, torque  $20\pm 4$  lbf-ft (FIGURE 4). **If you need to install the M10 flange screw 5001729, torque 48 lbf-ft.**

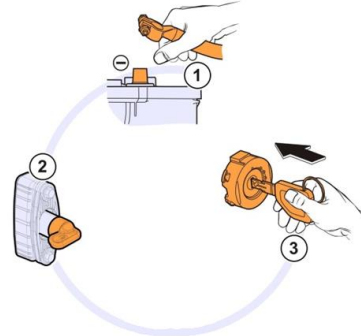
FIGURE 5

6) Turn on the vehicle electrical system. Follow these steps:

- Connect NEGATIVE cable to the vehicle battery;
- Turn on battery switch;
- Insert vehicle key.
