PREVOST

Instruction Sheet

IS-08080B

Sound Selector replacement, VSS04 to VSS05

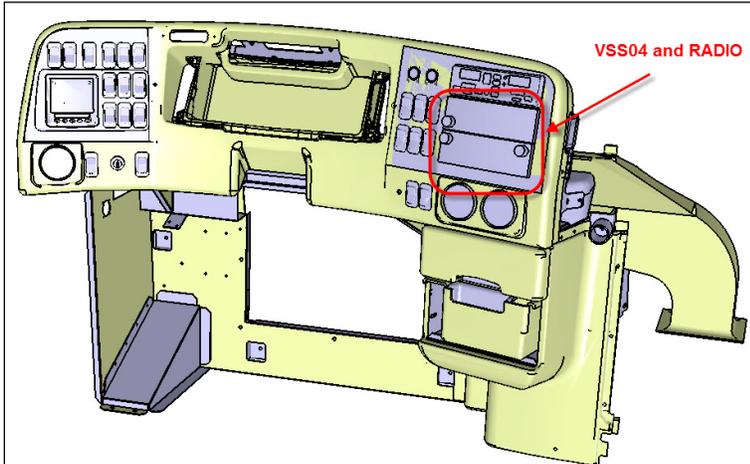
FIGURE 1: POSITION OF VSS04 AND RADIO IN A TYPICAL DASHBOARD

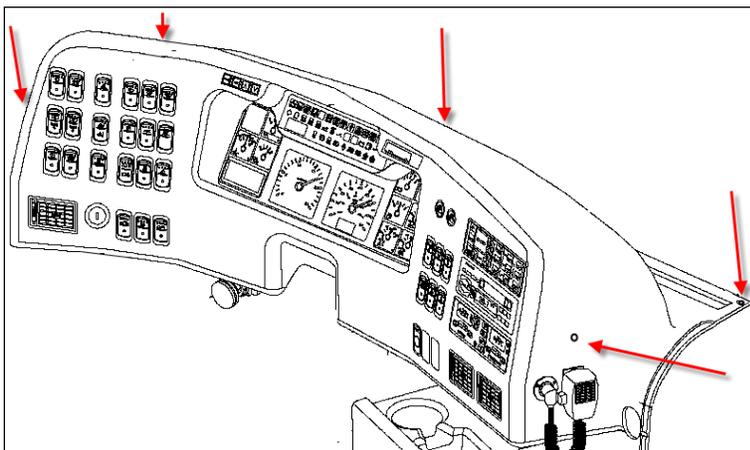
FIGURE 2: COVER RETAINING SCREWS POSITION

1. To gain access to the radio and sound selector (VSS) connections, remove the dashboard cover by unscrewing the five (5) M4 – 0.7x 20 screws that secure it to the dashboard (Figure 2).

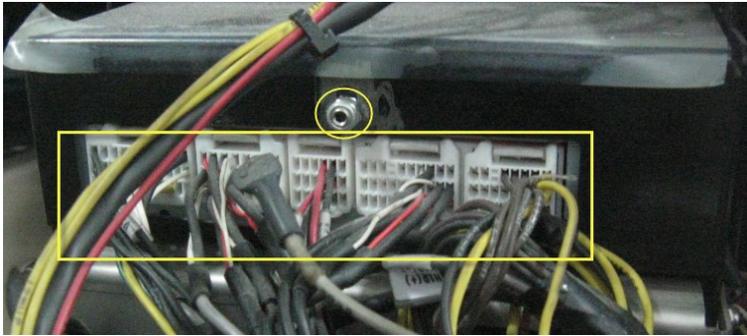
FIGURE 3: CONNECTORS AND RETAINING HEX NUT

2. Using a small flat head screwdriver, disconnect the five (5) connectors at the back of the sound selector (VSS) (Figure 3).

3. Remove the hex nut that holds the sound selector to the dashboard support (Figure 3).
4. Repeat operations 2 and 3 for the radio; remove the hex nut, disconnect the harness and the antenna cable.
5. Insert 2 flat radio removing tools in the vertical openings located on both sides of the sound selector front panel and pull out the sound selector (Figure 4 & Figure 5).

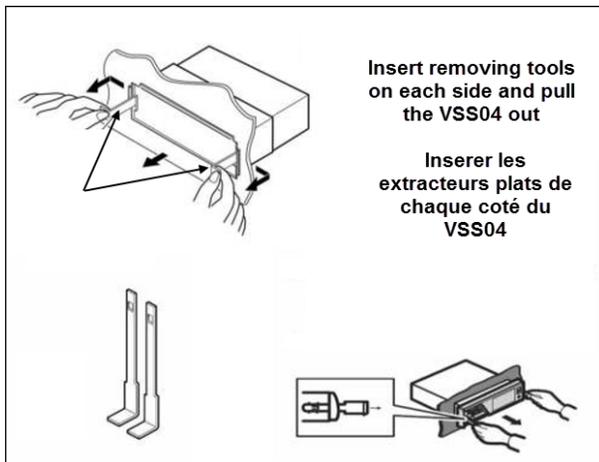
FIGURE 4: VSS REMOVAL WITH FLAT REMOVING TOOLS

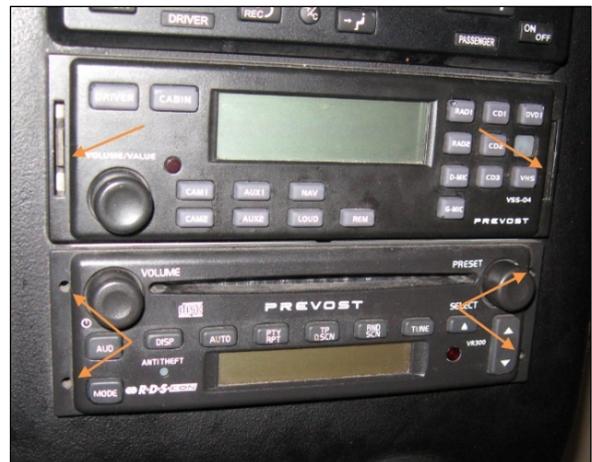
FIGURE 5: VERTICAL OPENINGS AND HOLES POSITION ON THE VSS AND RADIO UNIT FACES

6. Insert two (2) U-shaped radio removing tools in the four (4) holes located on both sides of the radio front panel and pull it out (Figure 5 & Figure 6).

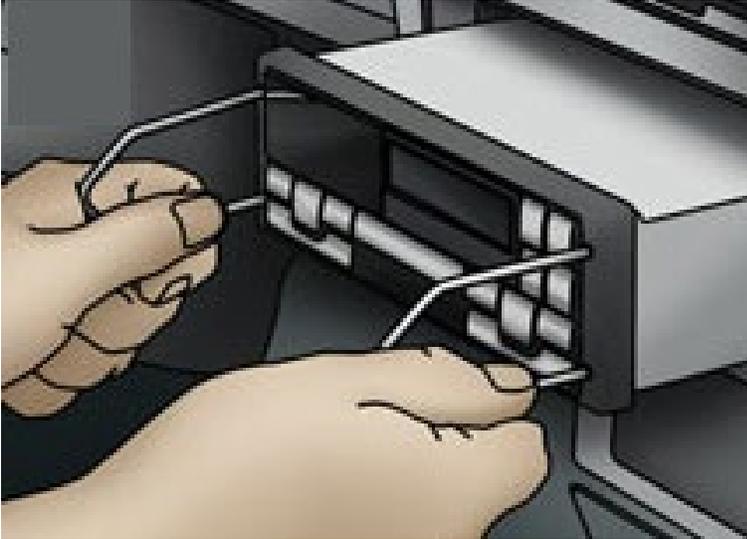
FIGURE 6: TYPICAL RADIO REMOVAL USING U-SHAPED TOOLS

NOTE: Some radio models may require flat radio removing tools.

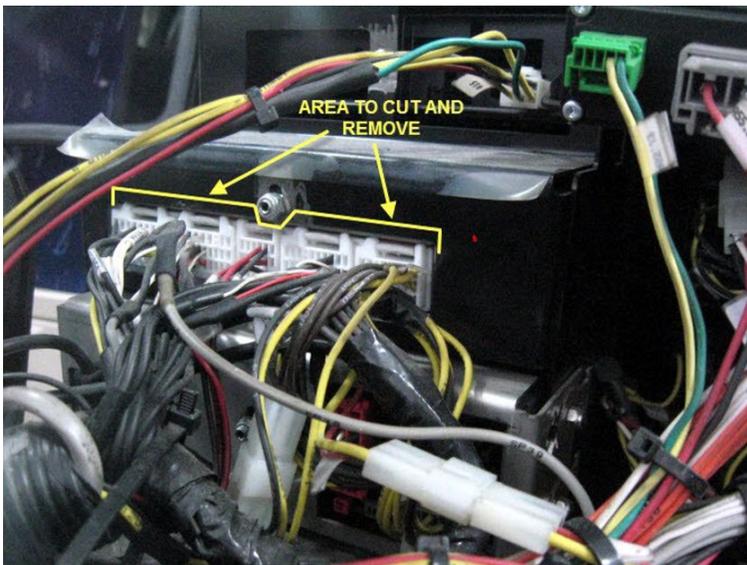
FIGURE 7: AREA ON THE SOUND SELECTOR SUPPORT TO BE ENLARGED

7. Before installing the new VSS05 sound selector in place, the back-support opening will need to be enlarged to allow sufficient clearance for the bigger VSS05 connectors.
8. Use a die grinder and a small cutting wheel or a suitable carbide bit and follow Figure 7 & Figure 8 below. Protect the area against metal particles.

NOTE: Do not cut through the central hex nut area of the support.

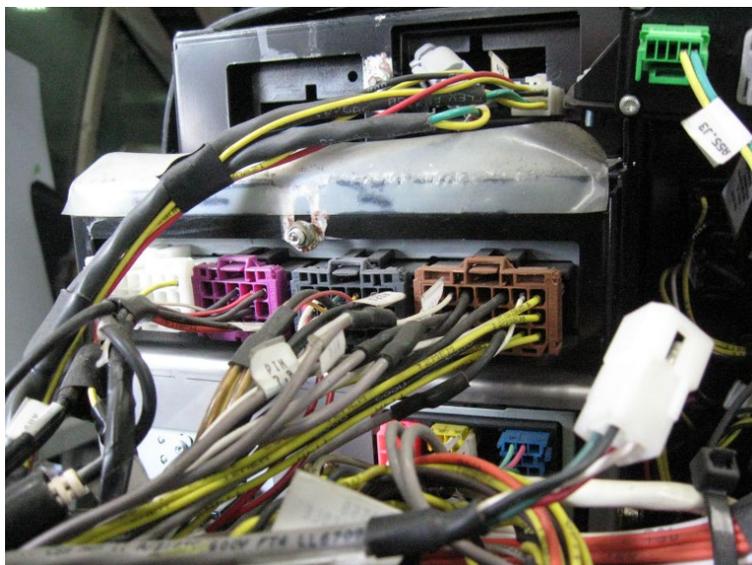
FIGURE 8: INSTALLED VSS05 SHOWING ENLARGED SUPPORT OPENING AND BIGGER HARNESS CONNECTORS

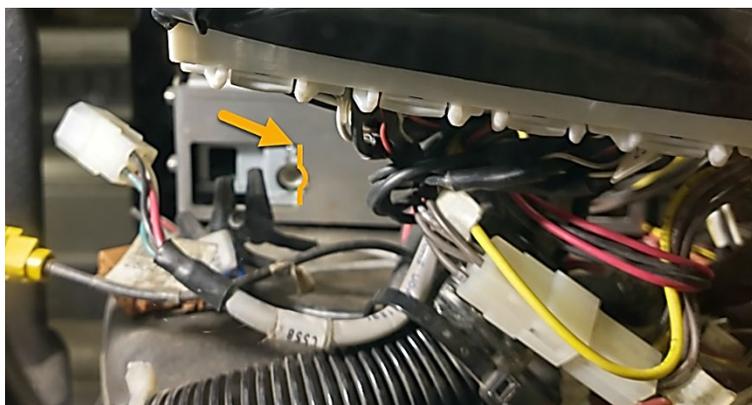
FIGURE 9: ENLARGED ANTENNA CONNECTOR OPENING

9. Before installing the new radio in place, the antenna connector opening will need to be enlarged to allow sufficient clearance (Figure 9).

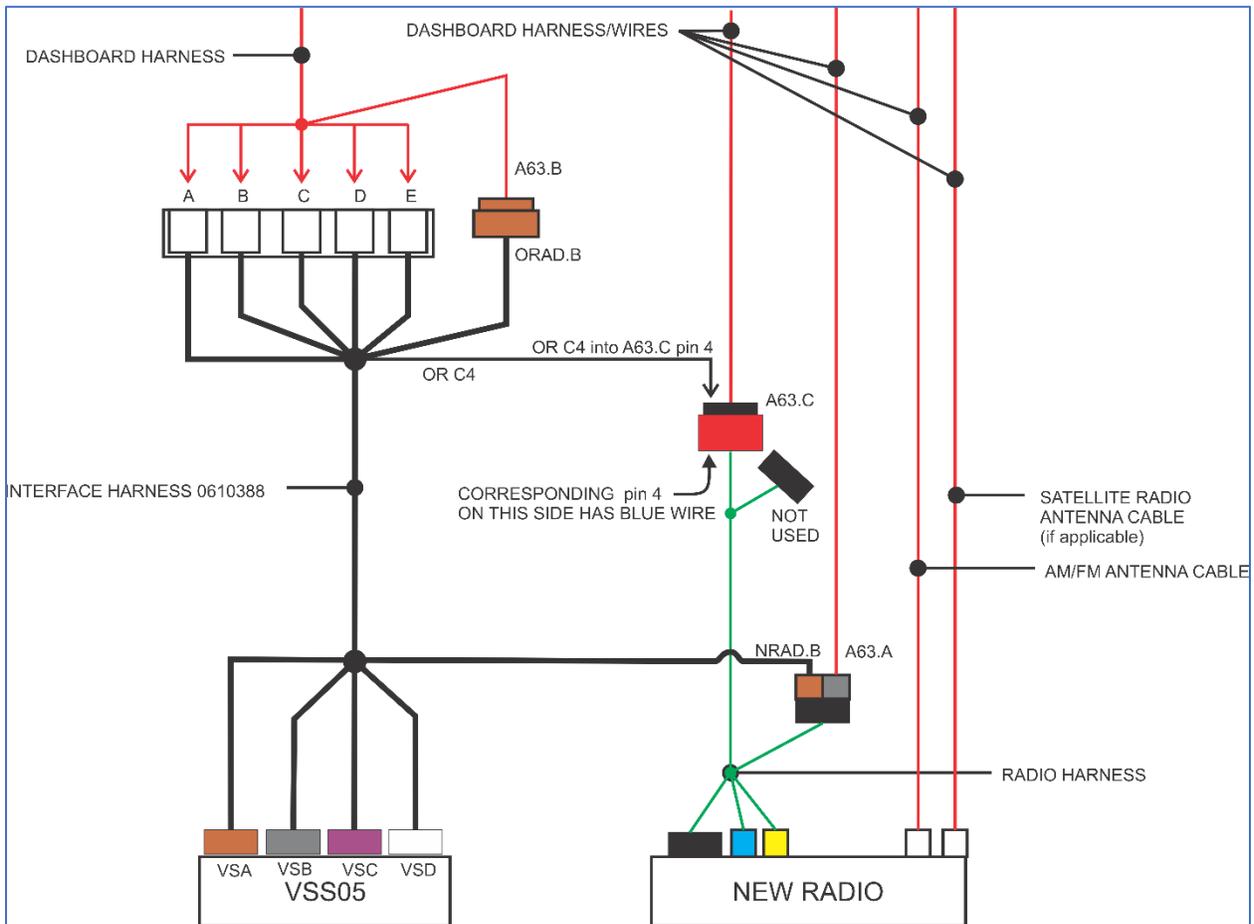
FIGURE 10: CONNECTIONS SCHEMATIC

13. Use the connections schematic (Figure 10) below to connect the dashboard harness to the VSS05 interface harness and the radio harness.

NOTE: To avoid improper connection, the interface harness connectors are all shaped differently.

15. Insert **OR C4** circuit terminal into black connector A63.C cavity no. 4 as shown in Figure 10 & Figure 11.

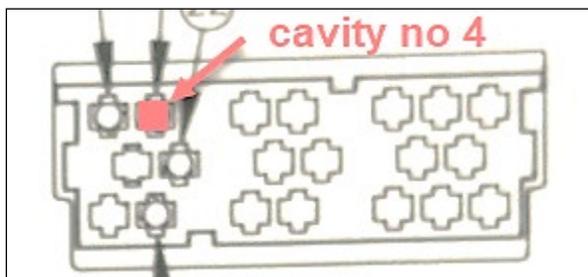
FIGURE 11: CAVITY NO. 4, SEEN FROM THE BACK (WIRE SIDE) OF THE BLACK CONNECTOR

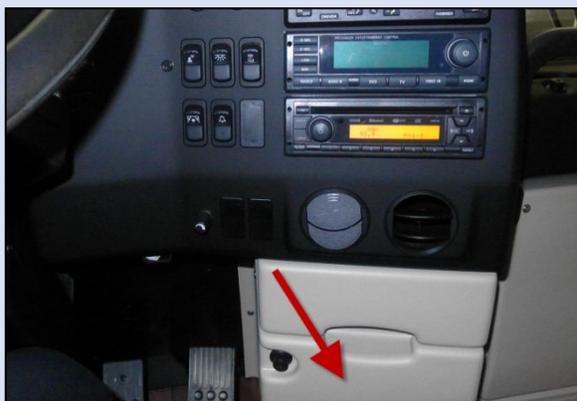
FIGURE 12

IMPORTANT NOTE: Radio external audio inputs i.e. USB and auxiliary ports are now located on the front panel of the new radio. Therefore, radio external audio inputs, USB and auxiliary port located inside the dashboard lower drawer is no longer supported.

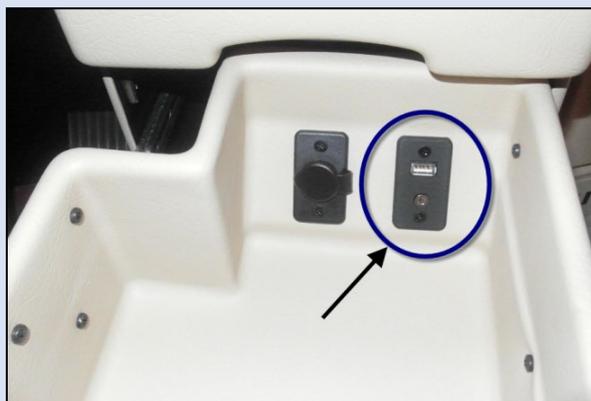
FIGURE 13: EXTERNAL AUDIO INPUTS - USB AND 3.5 mm AUXILIARY PORTS
