SAFETY RECALL

SR21-85C

FRONT HEADLAMPS REPLACEMENT 9700 USCAN (B13R)

On the vehicles affected by this recall, replace both headlamp assemblies and then perform the software or parameters update.

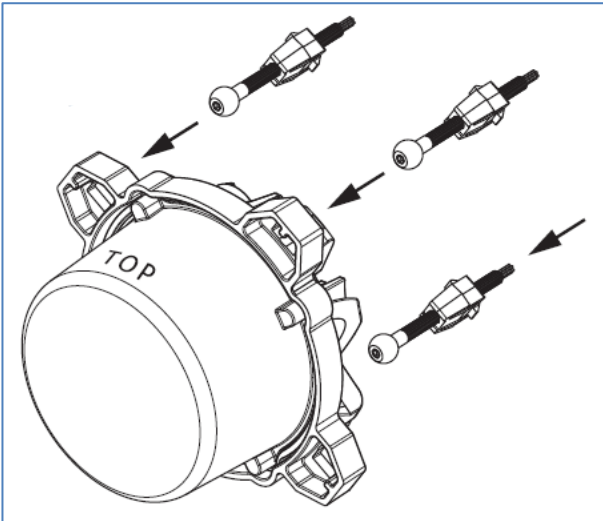
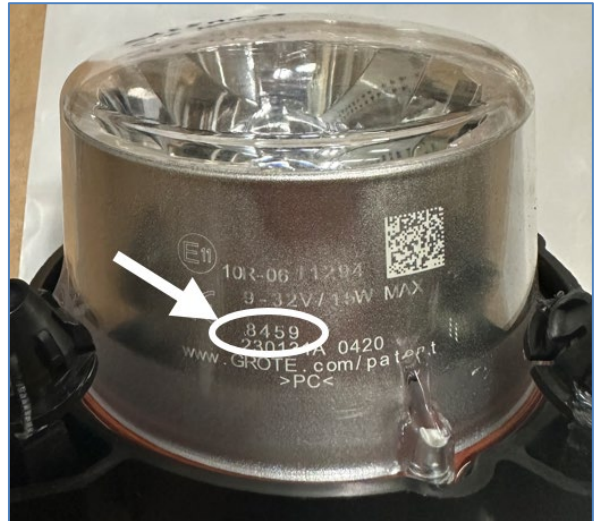
Figure 2

- 1) LOW BEAM LED p/n 24224438-NS stamped with "8459" (item 2, Figure 1). Insert adjuster screws in mounting bracket from back with ball facing front and side labeled "top" facing up. Press in by hand until adjuster snaps into housing.

Figure 3: stamped with "8459"

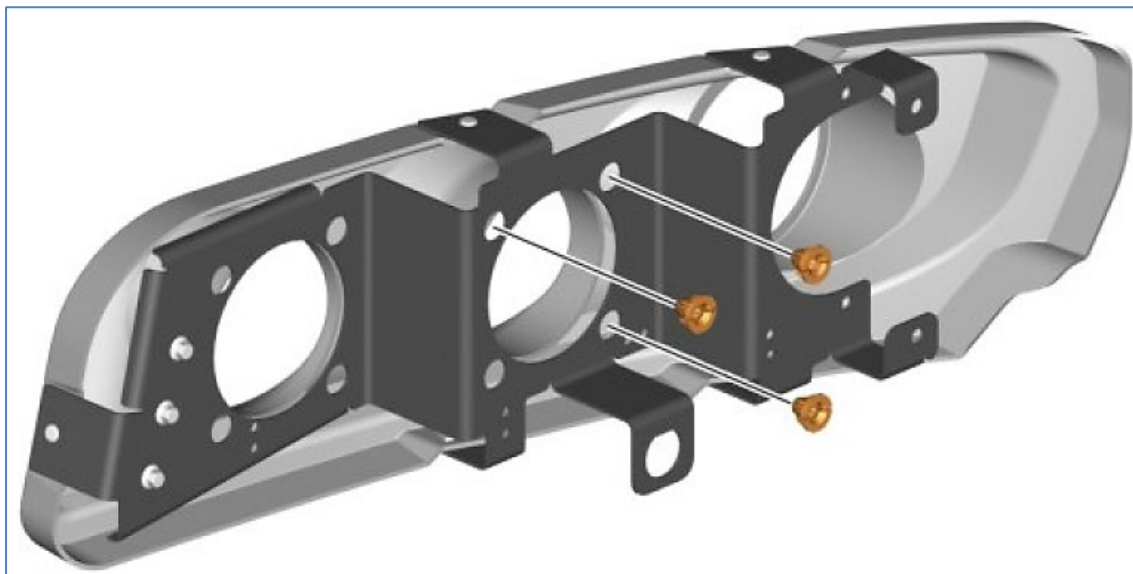
Figure 4: RH headlamp shown

- 2) Snap low beam clips into mounting holes on RH & LH headlamp bezel (item 4, Figure 1)

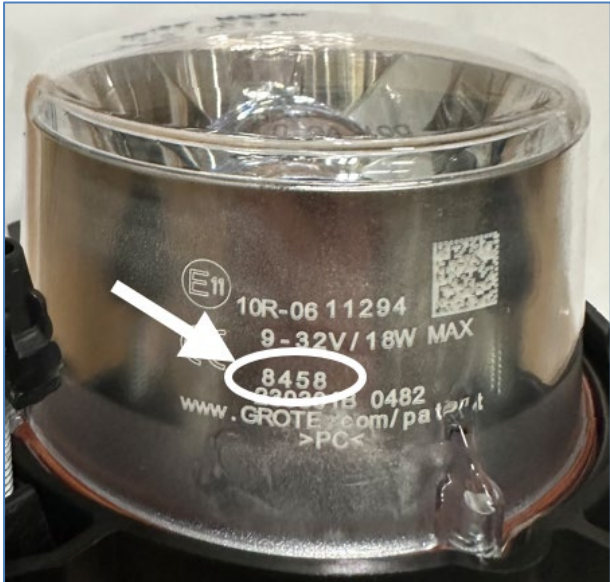
Figure 9: stamped with "8458"

- 1) Proceed similarly with the high beam p/n 24224437-NS stamped with "8458" (item 1, Figure 1).

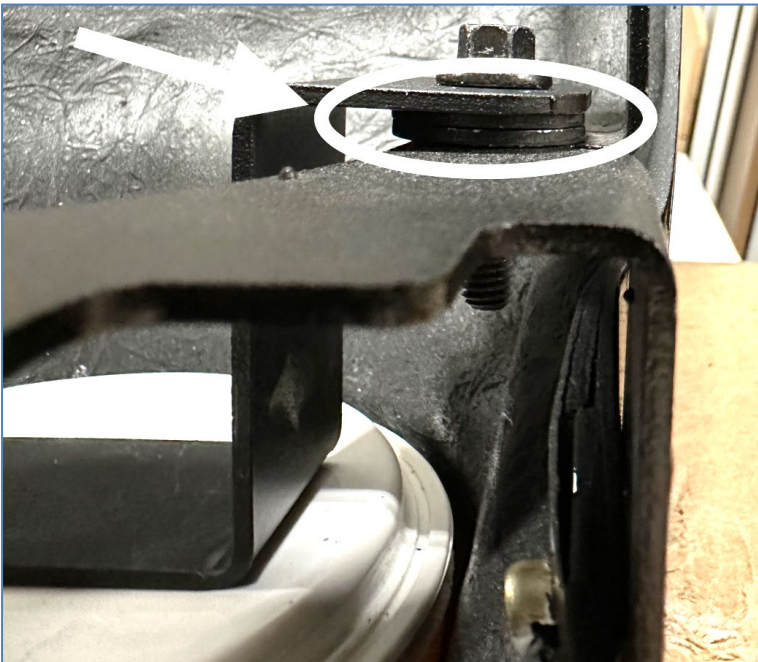
Figure 15: : RH headlamp shown

- 3) Install the bracket, the two (2) screws (2 washers per screw) and then tighten.

Figure 16: Two washers per screw

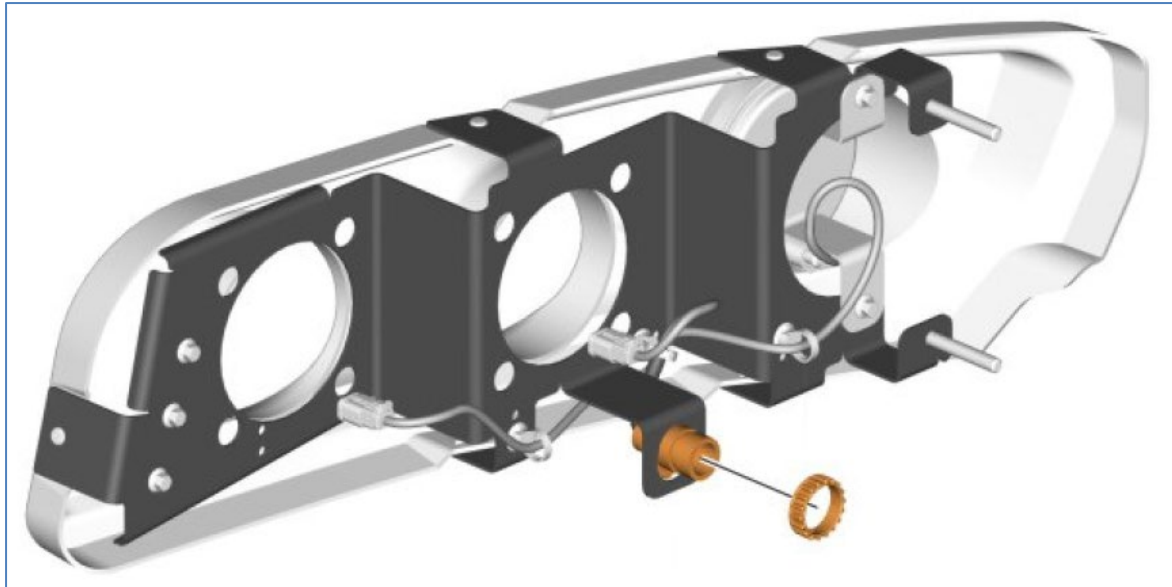
Figure 19: RH headlamp shown

- 2) If not already done, secure the connector with the locking ring 3963413.

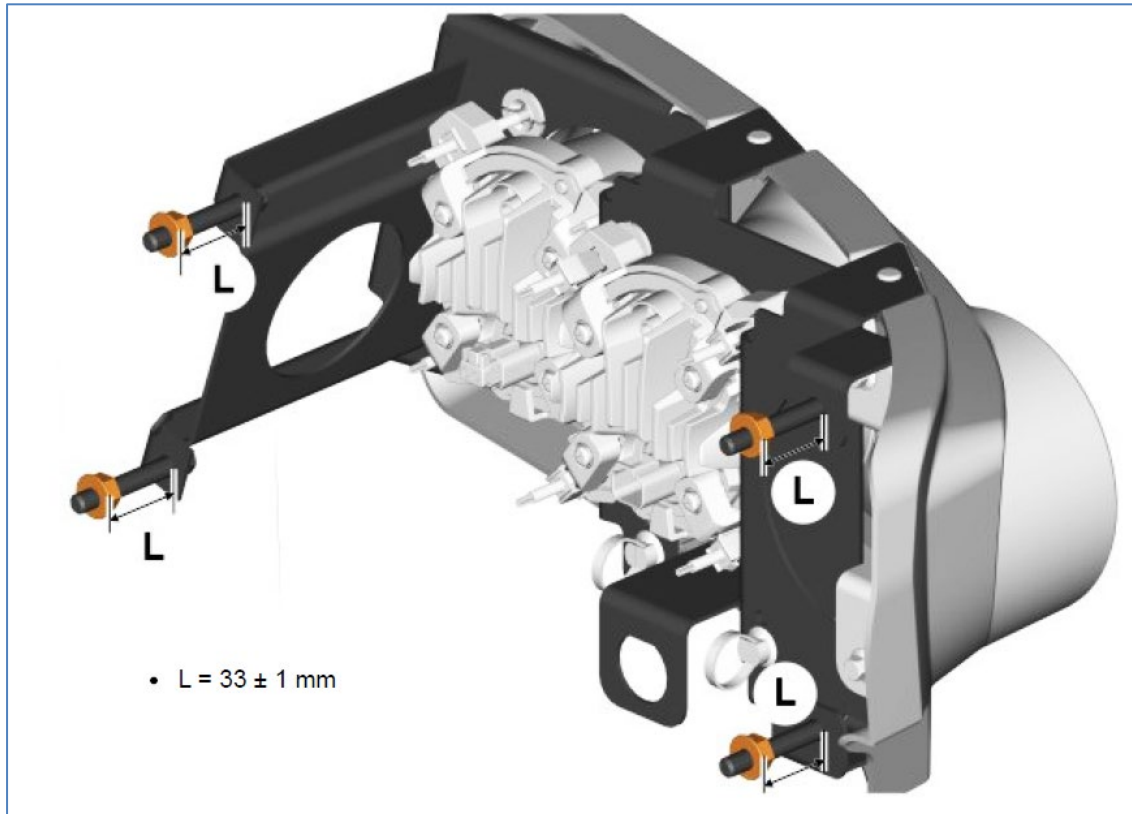
Figure 28

- 9) Check the pre-adjusted measurements of the headlamp unit at the lock nuts. The distance from the bracket base at each fixing screw should be 33 +/- 1 mm.

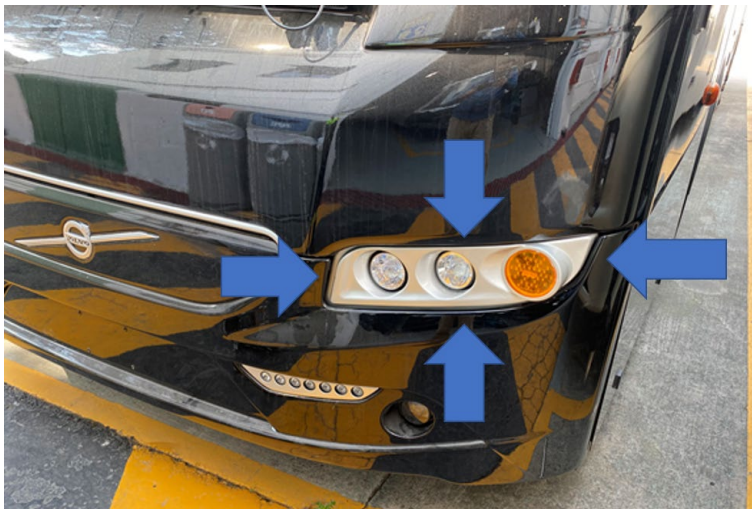
Figure 34

- 15) Close the front hatch and if necessary, adjust the headlamp bezel with the surrounding surfaces of the coach front panel and the bumper. To do so, screw or unscrew the bracket fixing screws locknut, modifying the pre-adjusted measurement of **33 +/- 1 mm** as required.

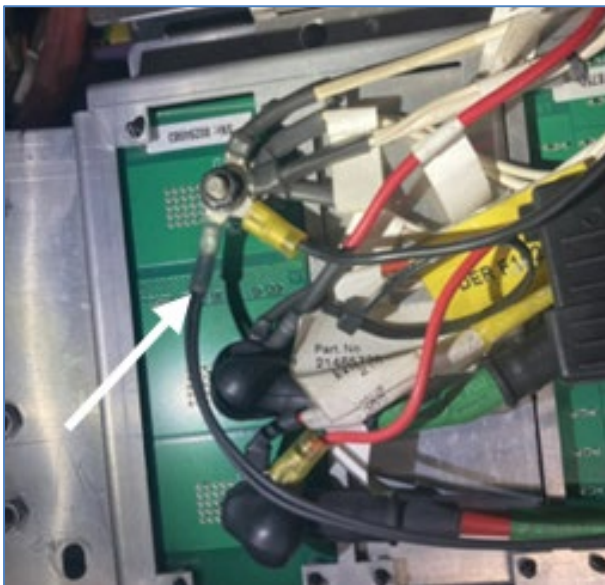
Figure 36

- 3) In the electrical compartment located on the L.H. side of the entrance, connect both black wires of the resistor harness 7775321 on the ground stud terminal.

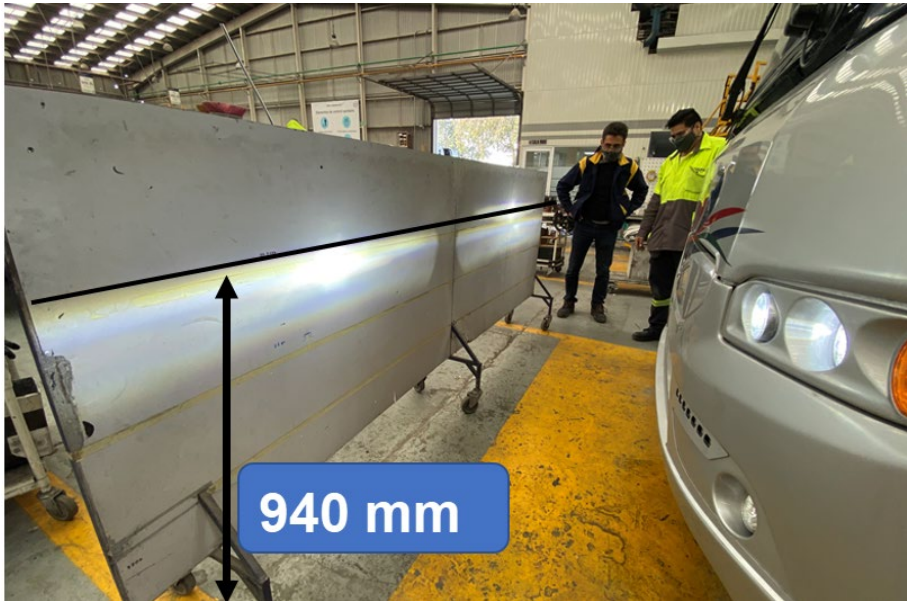
Figure 42: proper low beam height

The highest zone of the light beam must be aligned (and touching) with the 940 mm line.
