SAFETY RECALL

SR19-03V-B

DATE :	April 2019	SECTION :	23 ACCESSORIES
SUBJECT:	EXTINGUISHER CONTROL HEAD INSPECTION

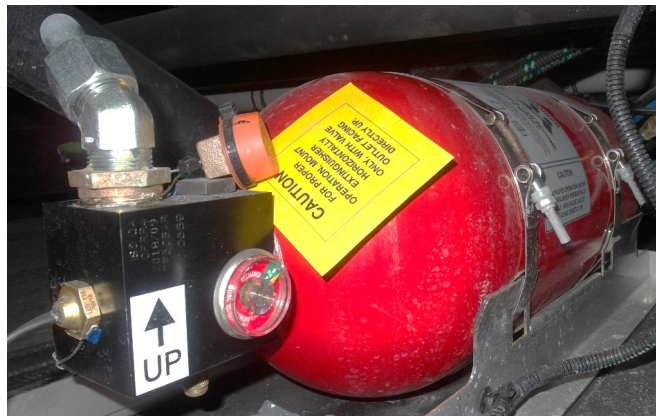
<i>IMPORTANT NOTE</i>
Extinguisher with a black box control head is not impacted. Do not replace this control head.

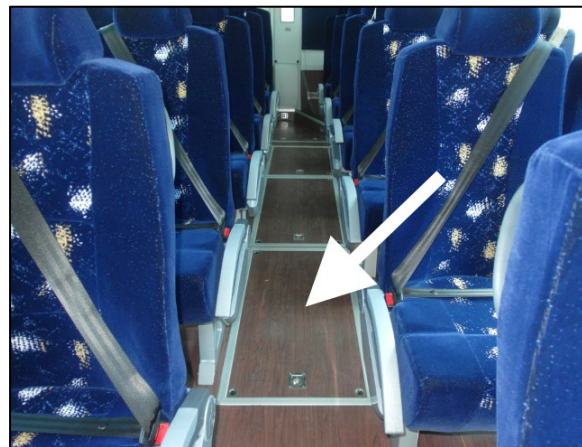
Figure 1 (Volvo 9700 models)

1. Locate the 25 lbs. extinguisher tank:
 - For Volvo 9700 vehicles, it is under the first service floor trap inside the vehicle (Figure 1).

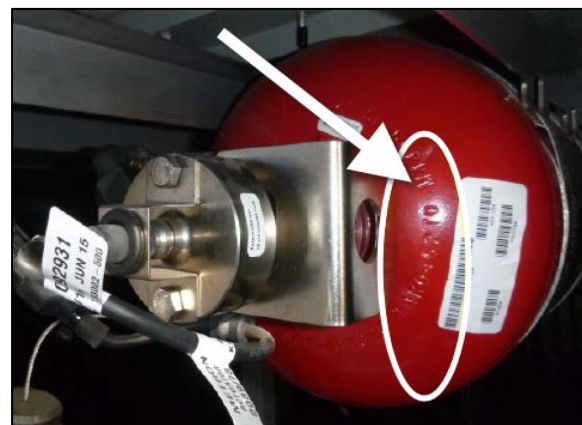
Figure 3

The batch code is located beside the Month/Year information on the label shown in Figure 3.

- Record the extinguisher serial number on the certification sheet at the end of this document.

- If the batch code DOES NOT match any of the recall batch codes shown in the table below, place a GREEN dot decal or a small piece of GREEN tape on the control head. The piston actuator is functional.

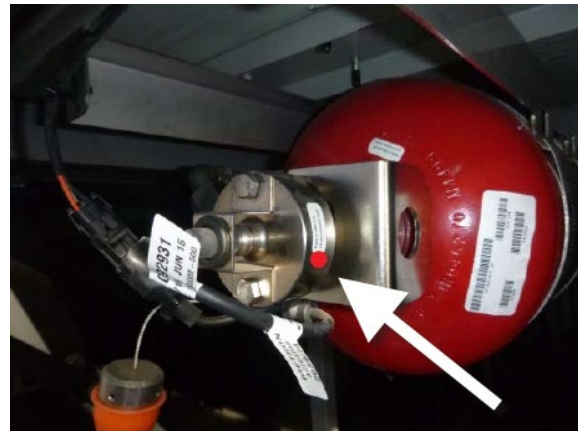
Figure 5

7. If the batch code matches any of the recall batch codes shown in the table ABOVE, place a RED dot decal or a small piece of RED tape on the control head. The piston actuator has to be replaced.
8. If the labels are missing on the extinguisher control head, replace the piston actuator.
9. Call a Prevest Service Center and make an appointment to replace the control head.

Replacement of the control head has to be performed by a certified worker. For the Prevest Service Centers, use SCI19-13 for piston replacement procedure.
